Historic England

# Traditional Windows

Their Care, Repair and Upgrading

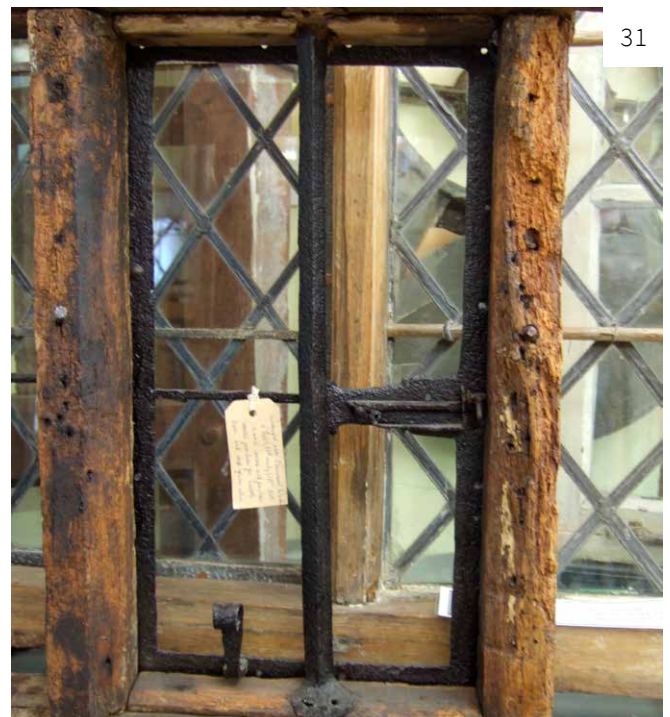
31

31. A late 17th-century/ early 18th-century wrought iron casement window set within its oak frame (from the Brooking Collection).

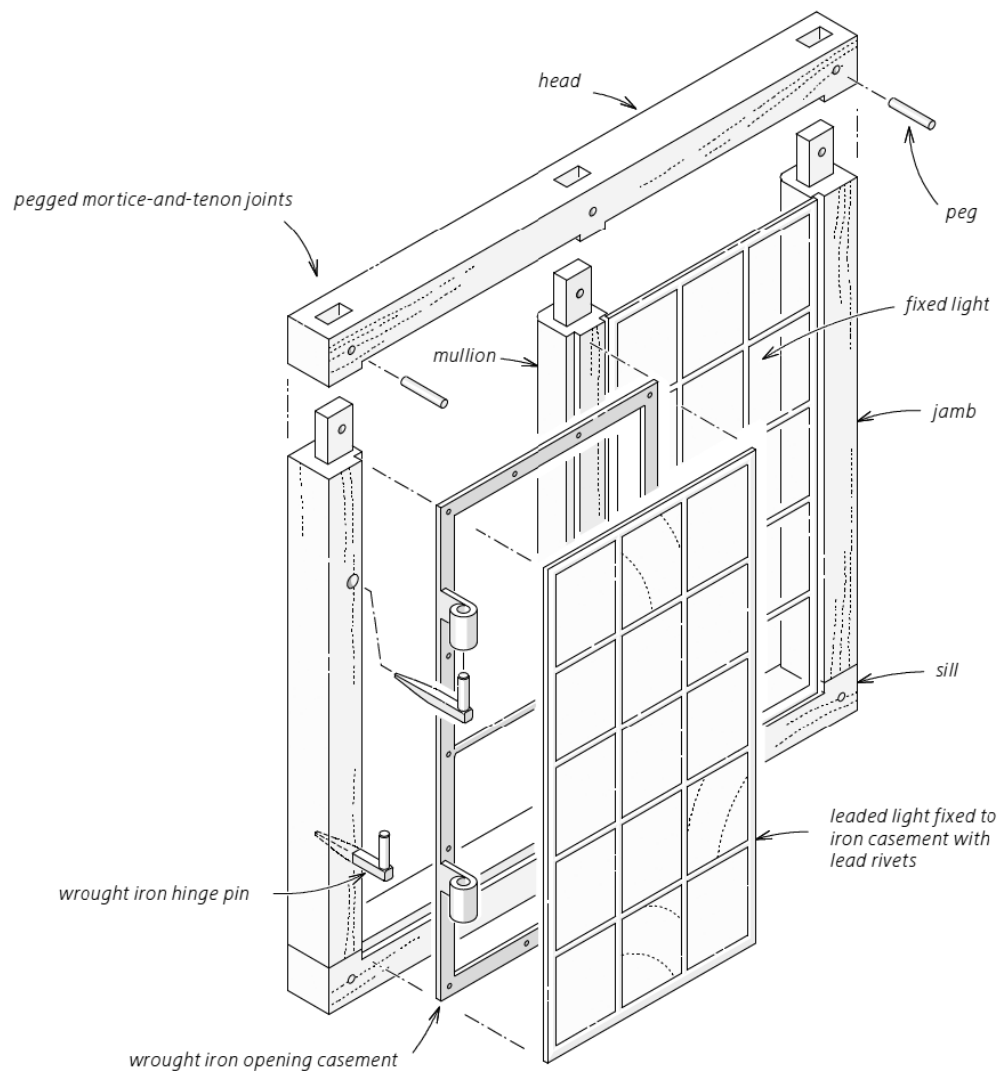
Image 32

When larger panes of glass became available, leaded lights were often replaced, as shown here.

A. Typical oak-framed casement window with leaded lights.

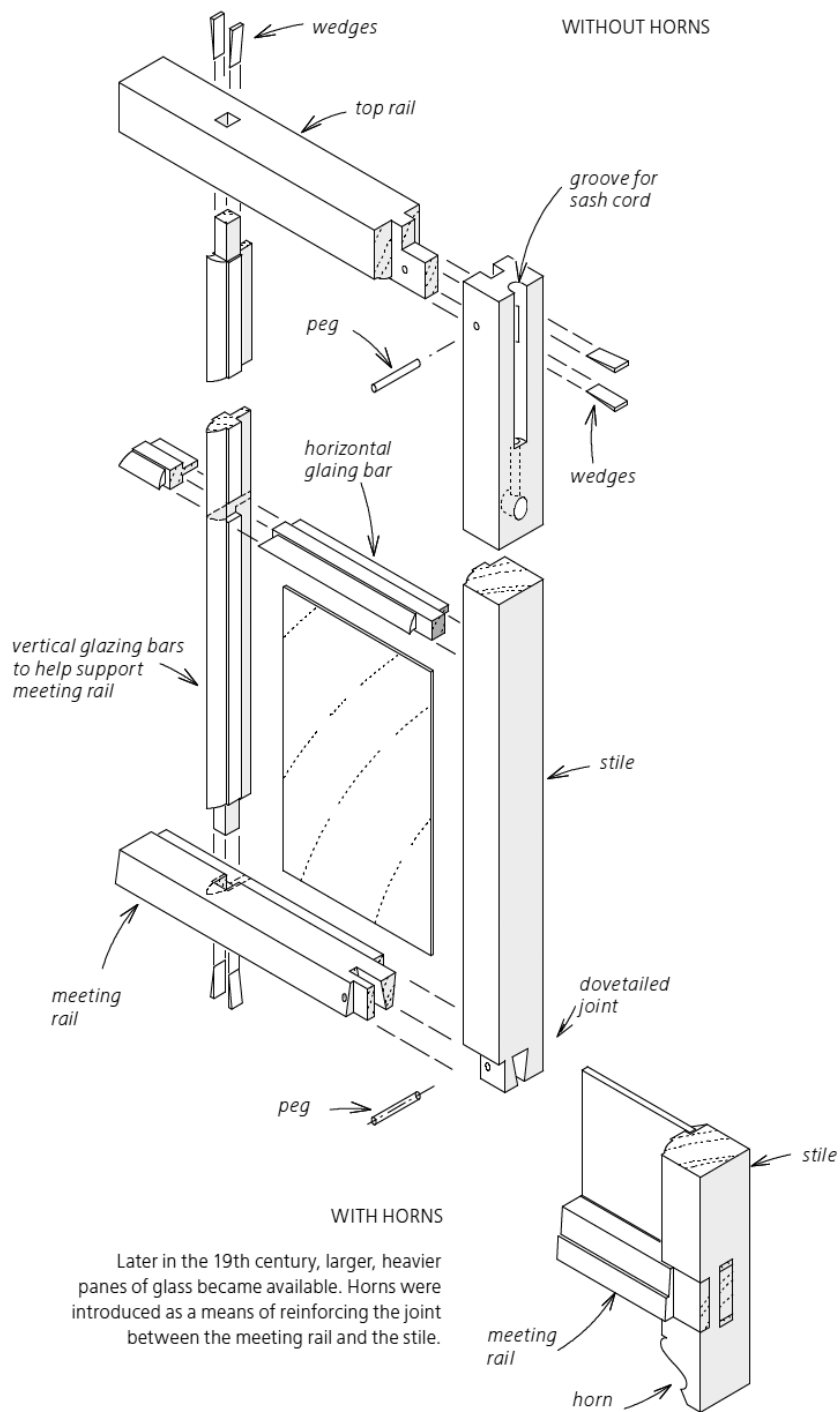
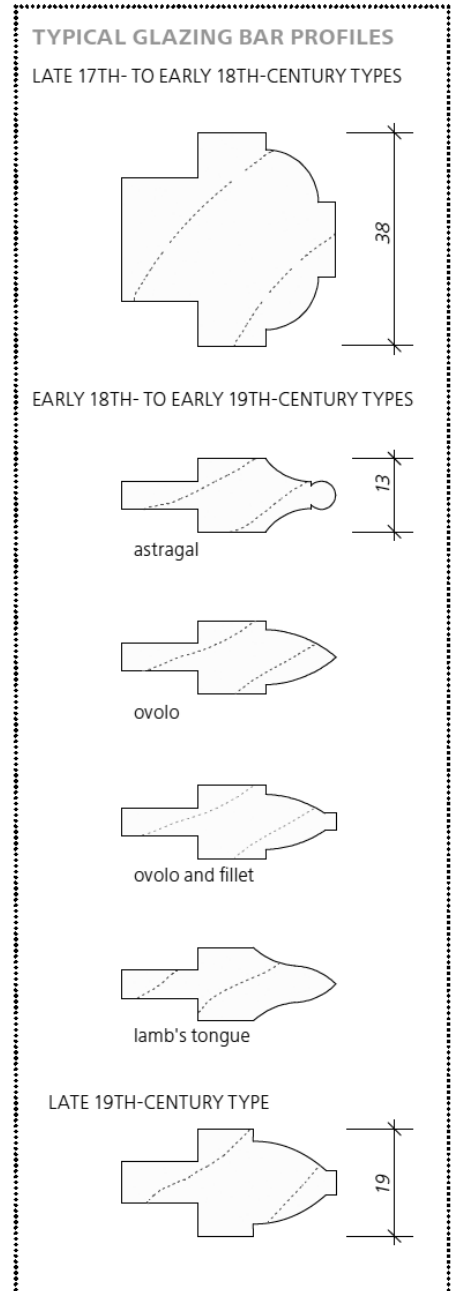
Image 37

A. Sliding sash windows: typical top sash.

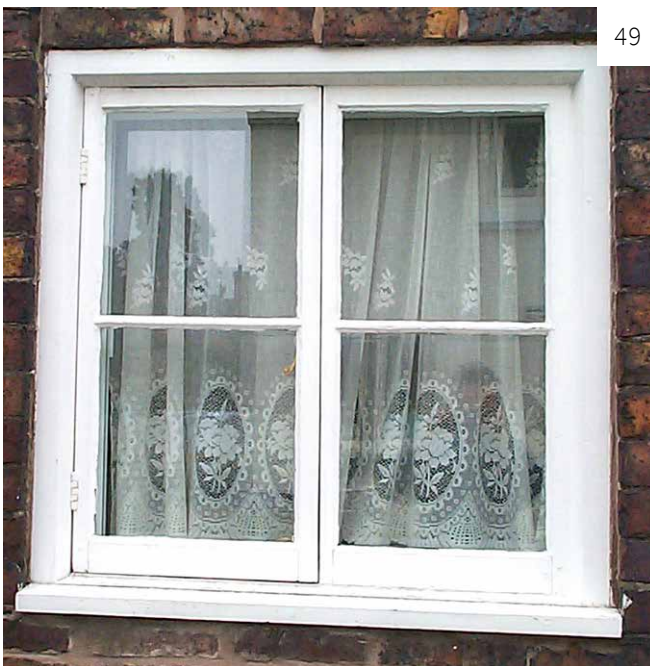
49. A simple 19th-century timber side-hung casement window. The uniformity of the frame proportions is maintained by the split mullion.

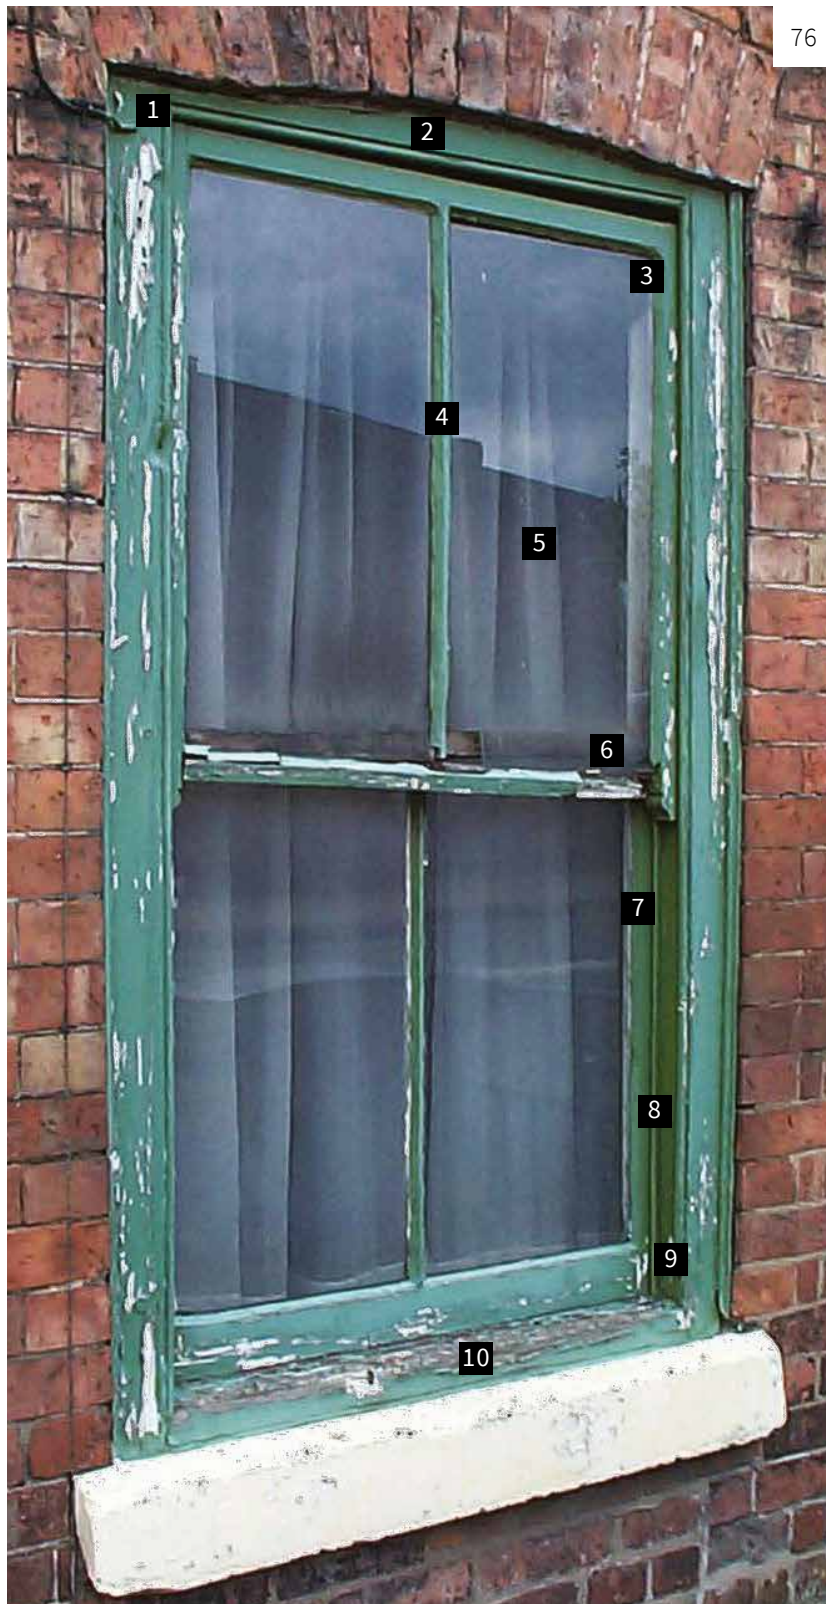
#### Key to Image 76

1. Holes drilled in frame for cable entry may admit water and cause decay.
2. Deformation of window caused by structural movement in wall; sashes no longer fit or slide properly.
3. Broken sash cords.
4. Breakdown of paint and putty caused by lack of regular maintenance; this allows water to penetrate and become trapped, causing decay.
5. Glass displaced or broken due to deformation of sash.
6. Failure of joints, caused by timber decay due to water penetration.
7. Opening parts of window jammed due to accumulation of paint.
8. Worn or damaged beads, causing rattles and draughts.
9. Decay of stile (or jamb) and outer lining at junction with cill due to water penetration.
10. Decay of cill caused by water penetration after breakdown of paint. Water may also creep into the joint between the timber cill and the masonry sub-cill.

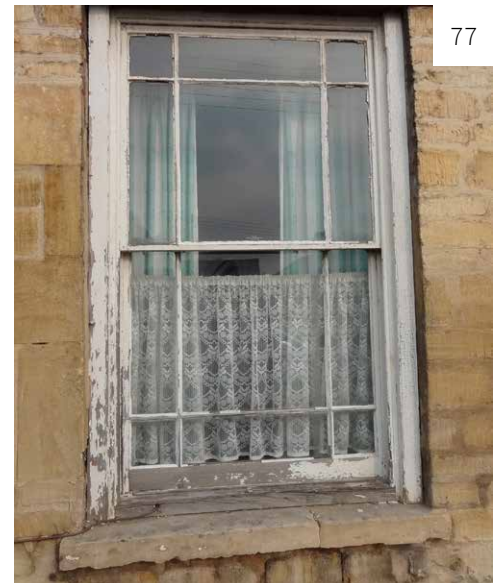
77

77. A double hung sash window lacking maintenance but still easily capable of being overhauled.

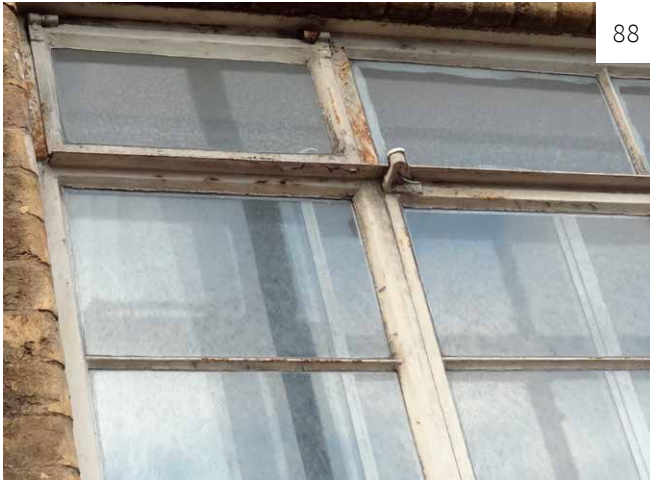
88

88. A steel window showing signs of corrosion with paint blistering.

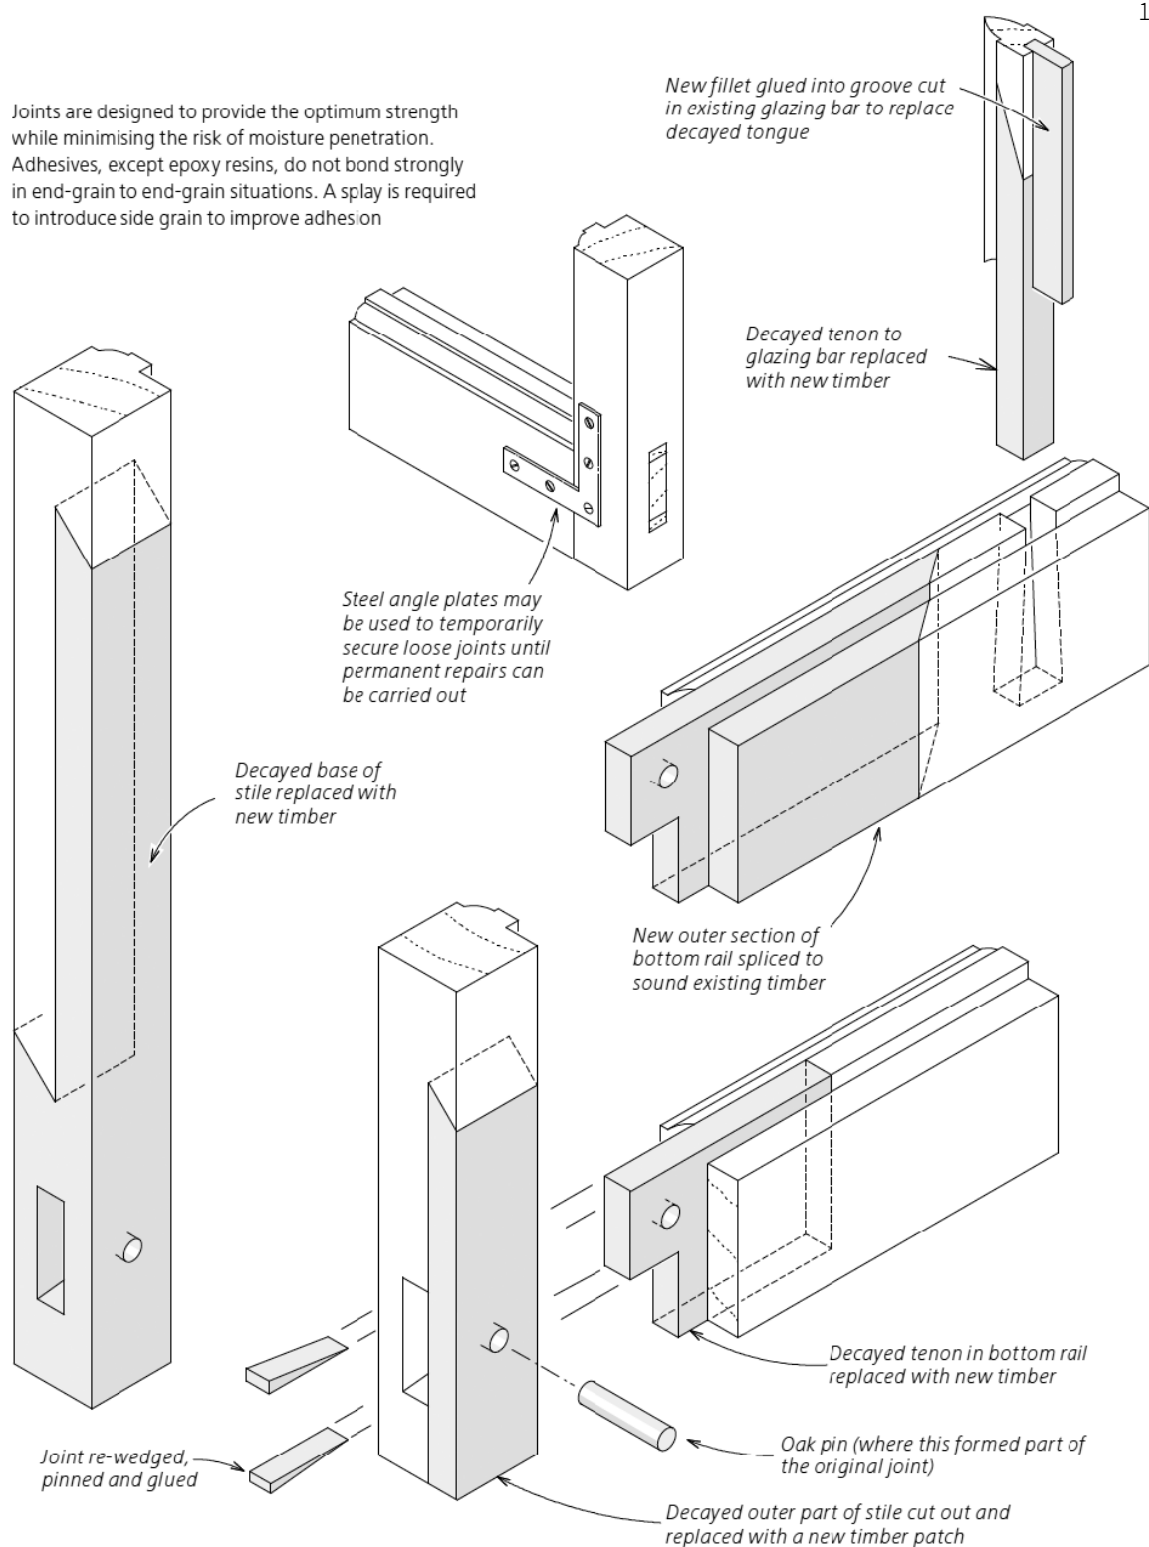
Image 100

Typical timber-to-timber repairs to sash and casement components.

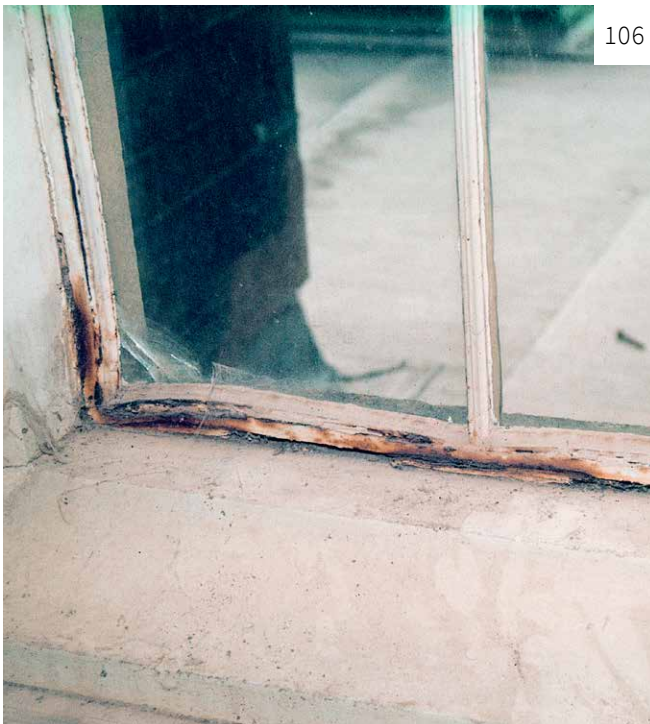
**Image 106**

Steel window showing severe corrosion to the bottom rail of the frame and distortion from 'rust jacking' which has cracked the glass.

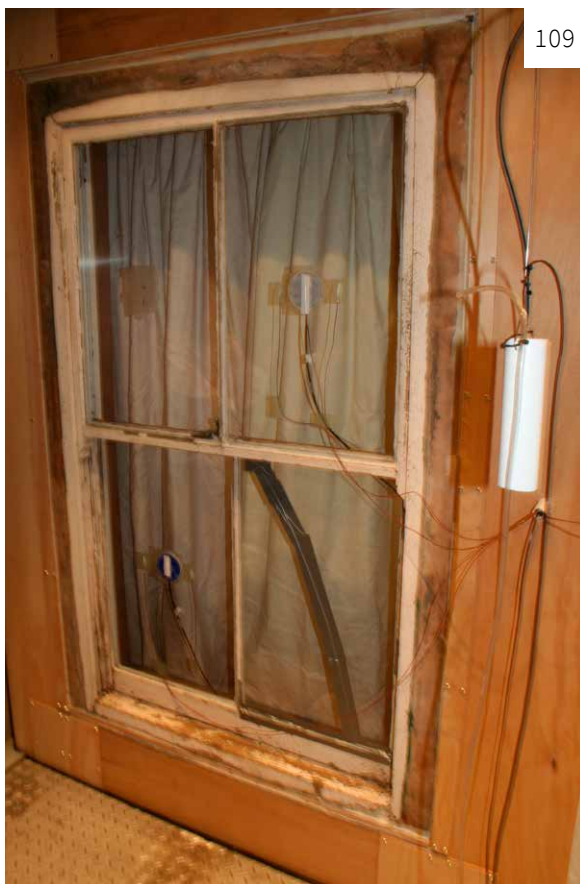
Image 109

Testing windows in the climate chamber at Glasgow Caledonian University.

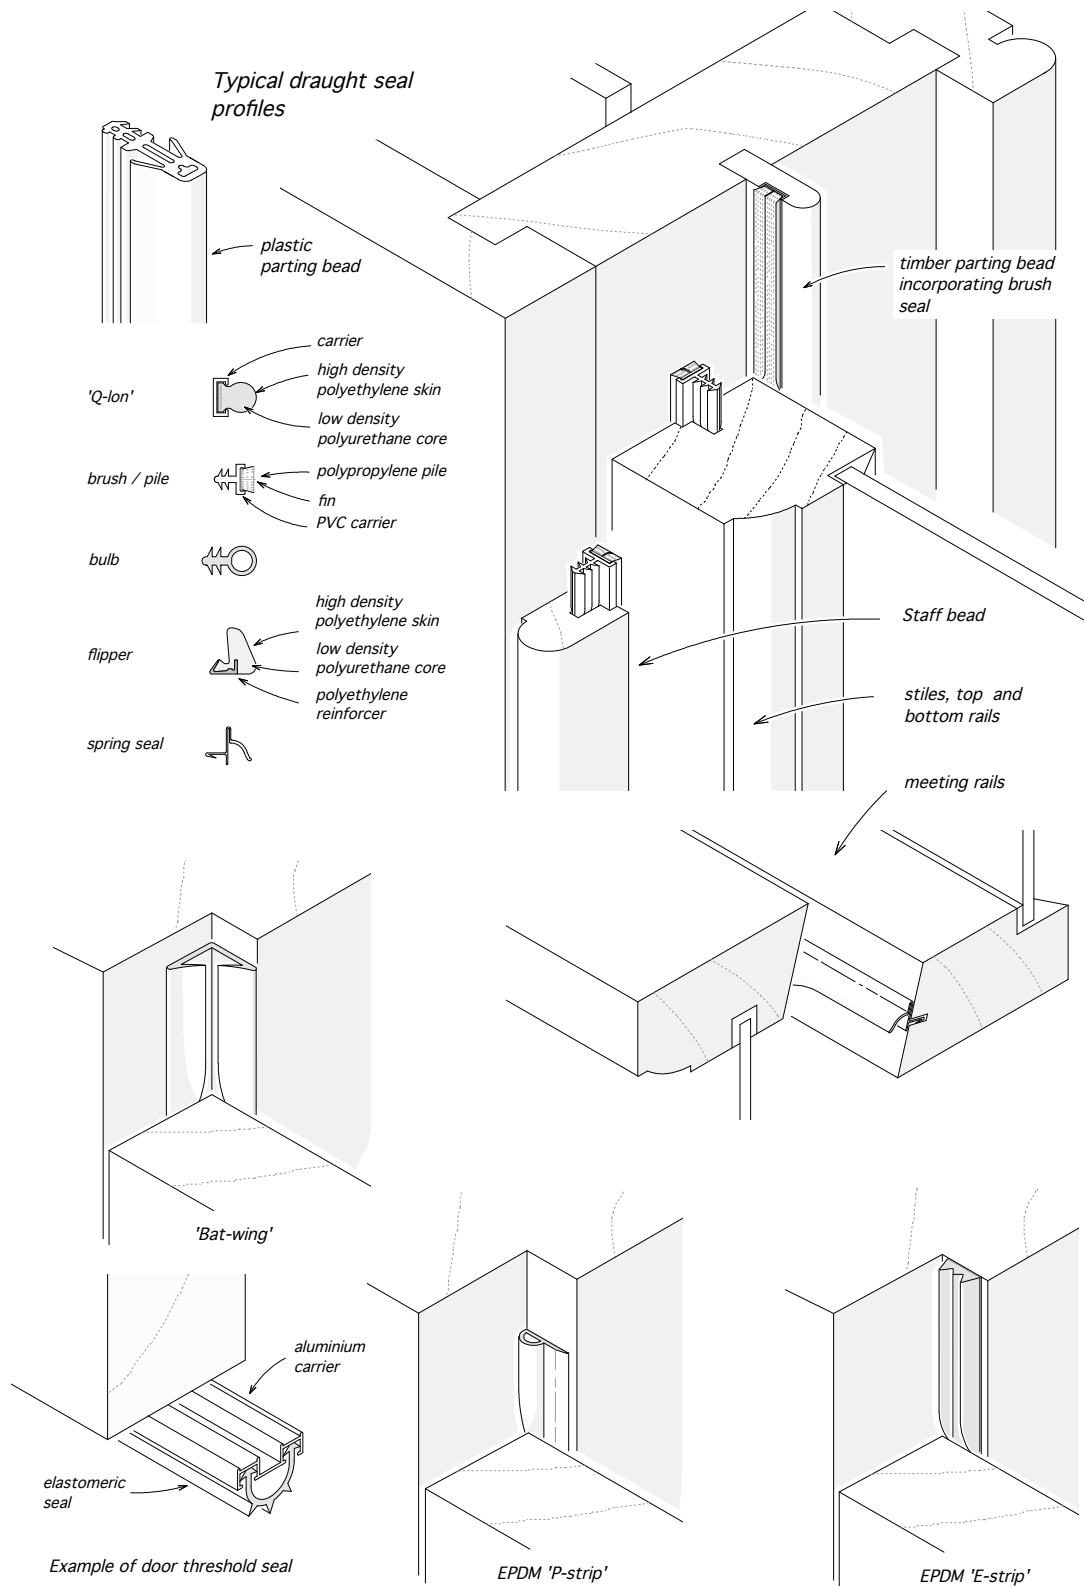
Image 114

- A. Example of draughtproofing for sash windows.  
B. Examples of draughtproofing for casements or doors.

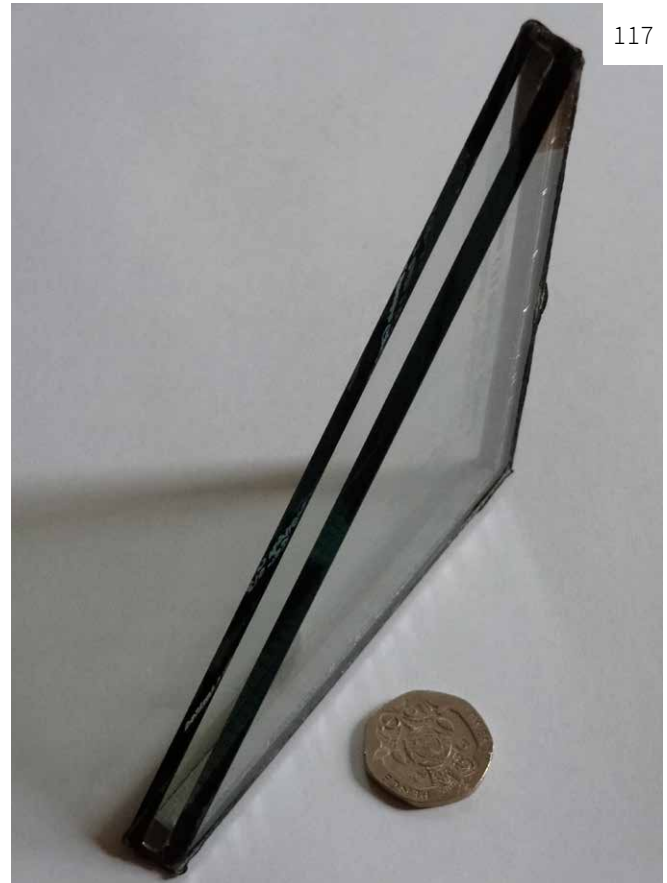
**Image 117**

This slim profile IGU comprises 3mm outer glazing a 3mm gas filled cavity and 4mm Low-E inner glazing giving a total thickness of 10mm.

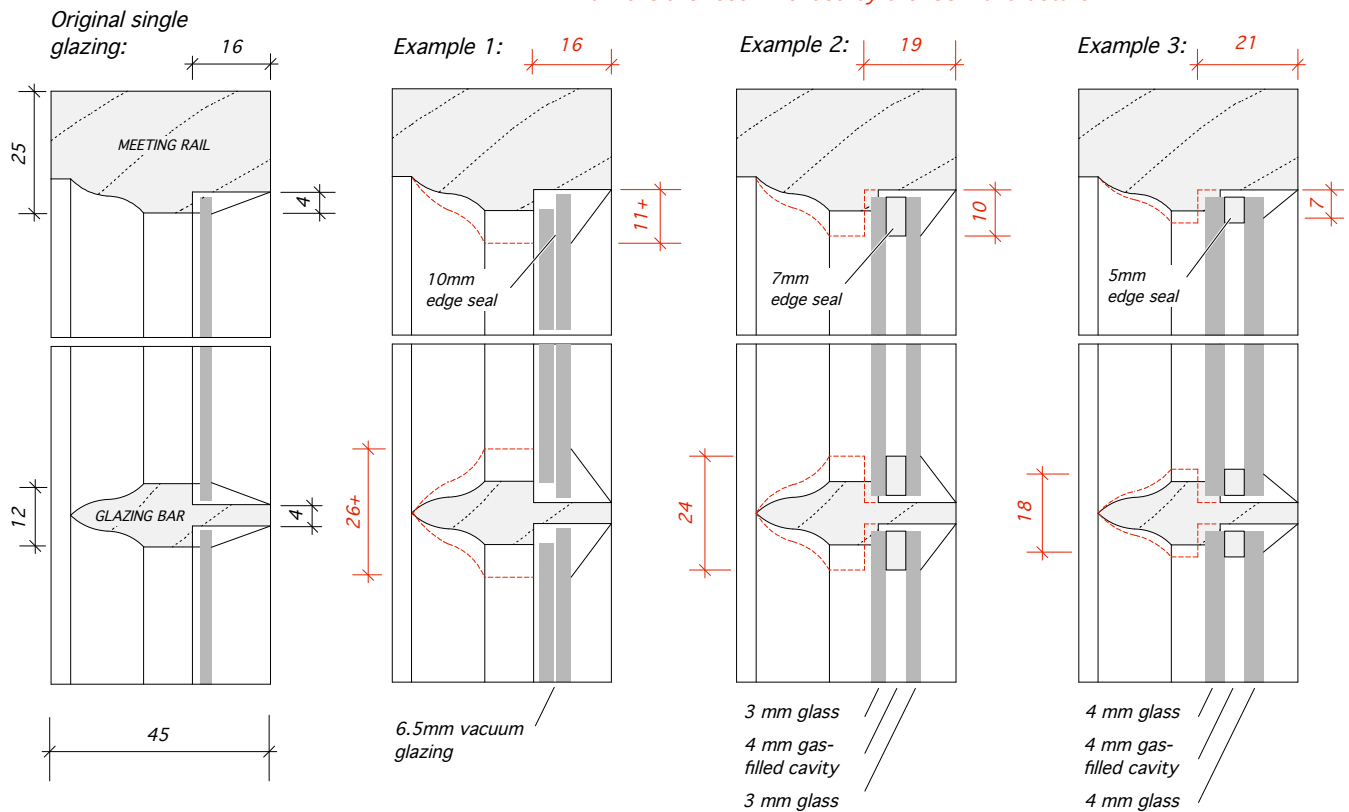
## Images 118-120

Dimensions in red show the minimum rebate and glazing bar dimensions recommended by the IGU manufacturer.

118. This drawing shows the different thicknesses of insulated glass units currently available when applied to a window with slim glazing bars (Dimensions shown are in millimetres).

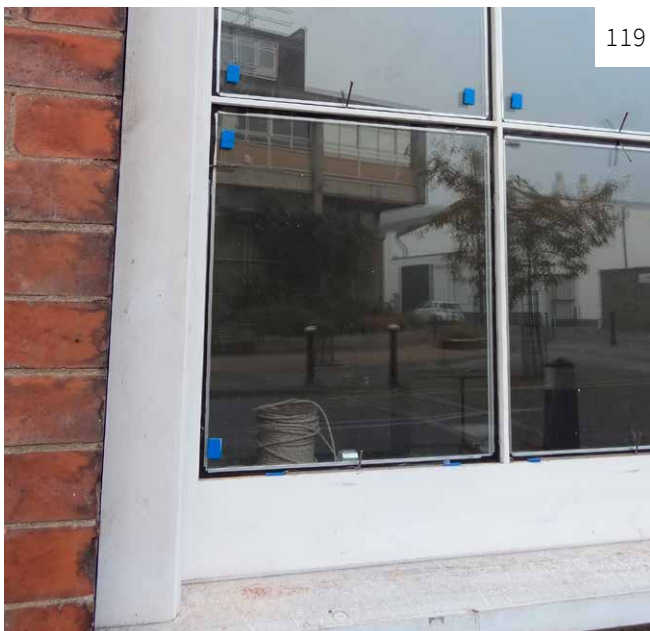
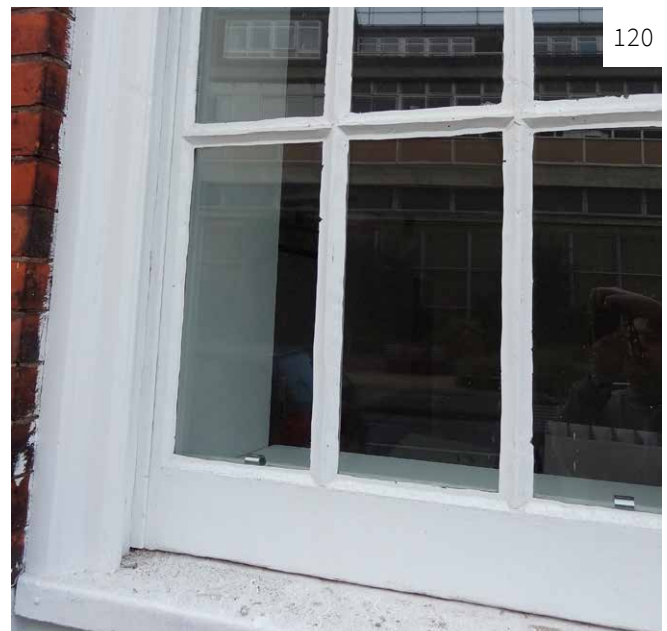
119-120. These existing windows had IGUs fitted but the width of the edge seals necessitated the painting of the glazing bars to be extended over the glass so that the seals are not visible.

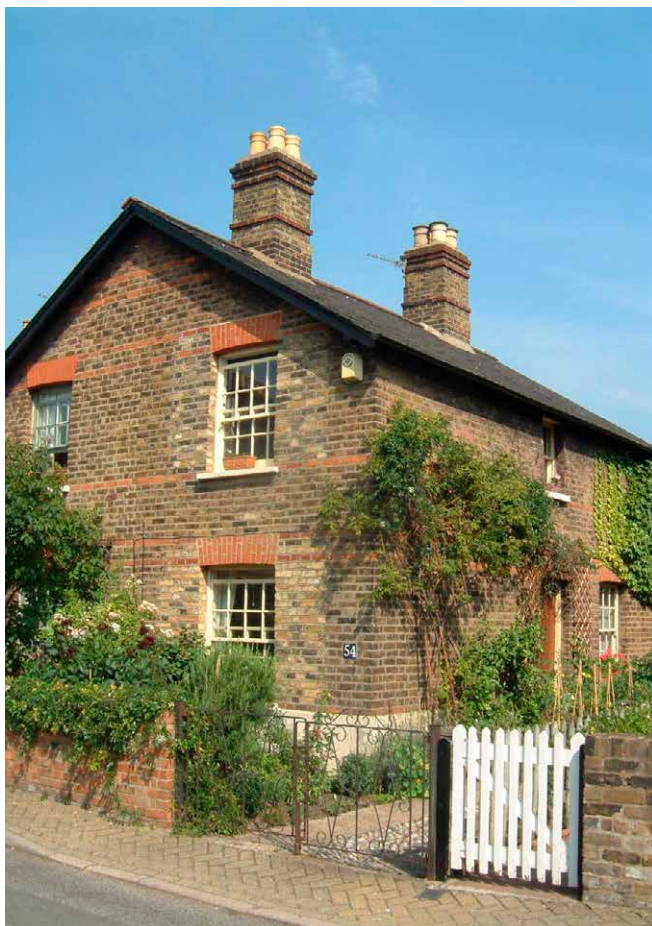
Image 140

Windows of the original size and pattern have been reinstated in this south London conservation area which has involved reinstating the original masonry openings.
