STEPROJECT: RIVER TEME PHASE 2B

TITLE: SITE HAZARD PLAN  
SHEET 2 OF 2

SCALE @ A1:	AS SHOWN	CHECKED:	JM	APPROVED:	PW
PROJECT NO:	70108764	DESIGNED:	AM	DRAWN:	AM
				DATE:	January 25
DRAWING No:	70108764-WSP-WRE-00-DR-CW-1003				REV:
					PO2

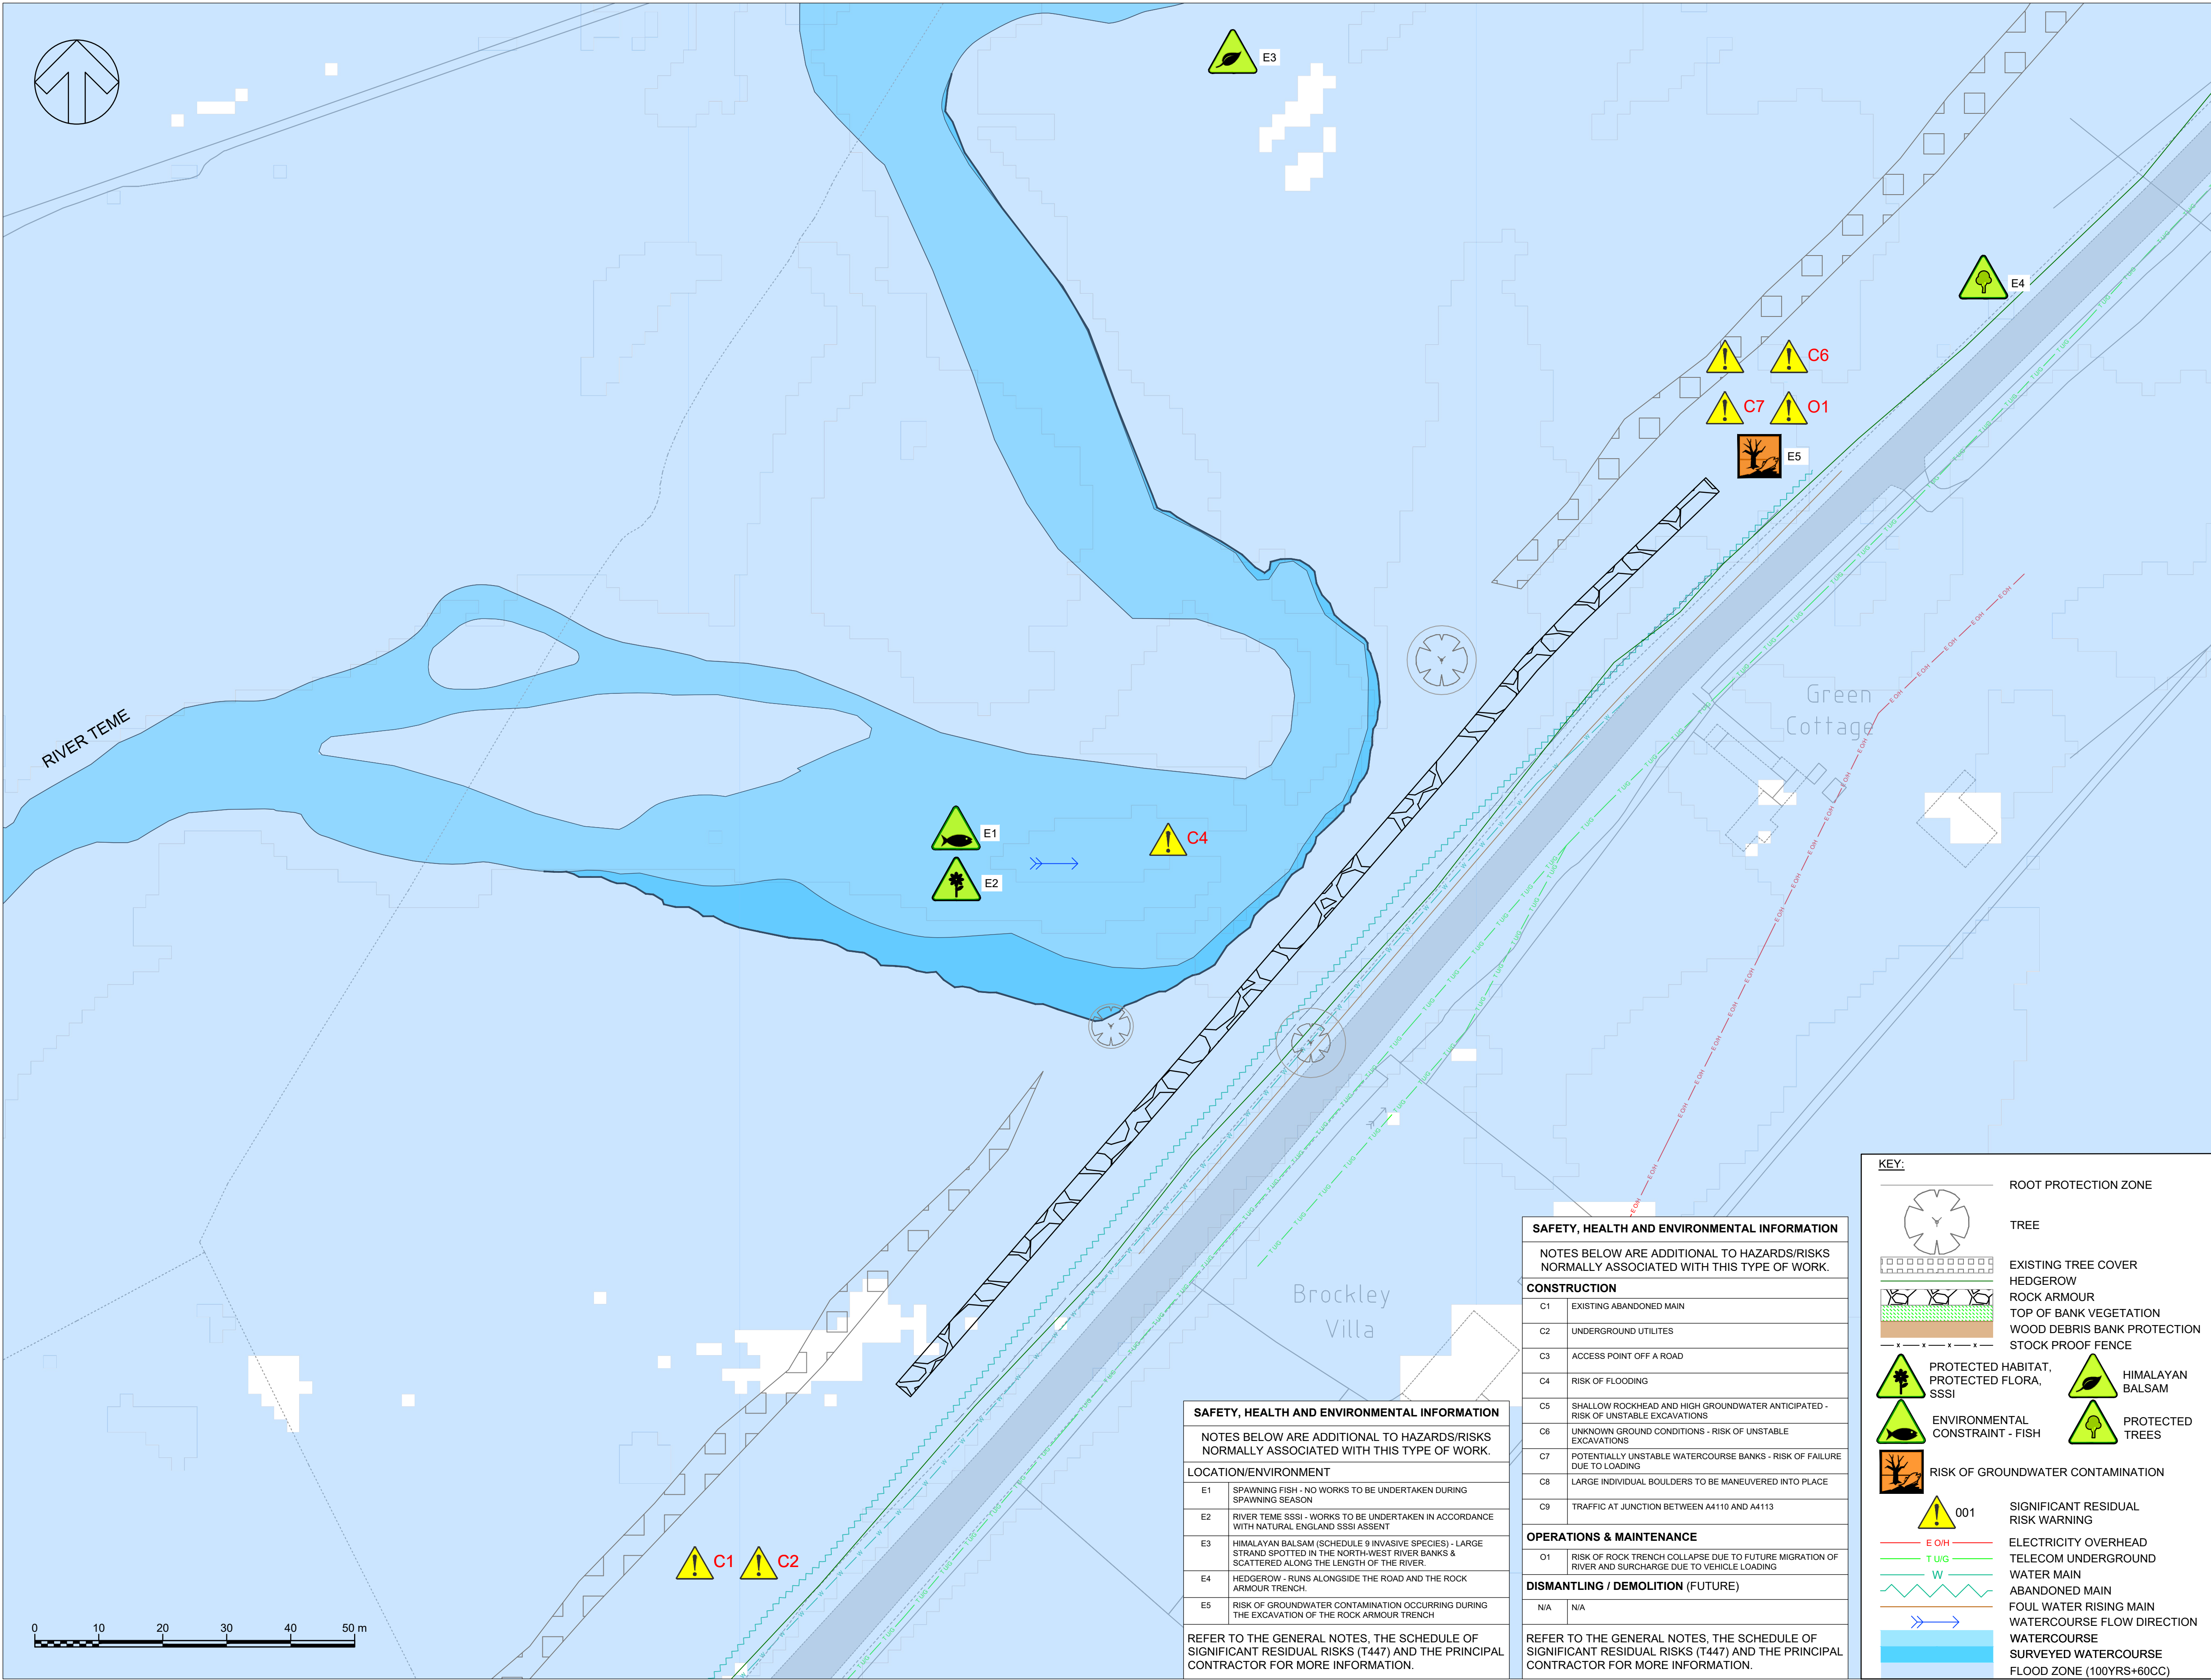
SAFETY, HEALTH AND ENVIRONMENTAL INFORMATION	
NOTES BELOW ARE ADDITIONAL TO HAZARDS/RISKS NORMALLY ASSOCIATED WITH THIS TYPE OF WORK.	
LOCATION/ENVIRONMENT	
E1	SPAWNING FISH - NO WORKS TO BE UNDERTAKEN DURING SPAWNING SEASON
E2	RIVER TEME SSSI - WORKS TO BE UNDERTAKEN IN ACCORDANCE WITH NATURAL ENGLAND SSSI ASSENT
E3	HIMALAYAN BALSAM (SCHEDULE 9 INVASIVE SPECIES) - LARGE STRAND SPOTTED IN THE NORTH-WEST RIVER BANKS & SCATTERED ALONG THE LENGTH OF THE RIVER.
E4	HEDGEROW - RUNS ALONGSIDE THE ROAD AND THE ROCK ARMOUR TRENCH.
E5	RISK OF GROUNDWATER CONTAMINATION OCCURRING DURING THE EXCAVATION OF THE ROCK ARMOUR TRENCH
REFER TO THE GENERAL NOTES, THE SCHEDULE OF SIGNIFICANT RESIDUAL RISKS (T447) AND THE PRINCIPAL CONTRACTOR FOR MORE INFORMATION.

SAFETY, HEALTH AND ENVIRONMENTAL INFORMATION	
NOTES BELOW ARE ADDITIONAL TO HAZARDS/RISKS NORMALLY ASSOCIATED WITH THIS TYPE OF WORK.	
CONSTRUCTION	
C1	EXISTING ABANDONED MAIN
C2	UNDERGROUND UTILITIES
C3	ACCESS POINT OFF A ROAD
C4	RISK OF FLOODING
C5	SHALLOW ROCKHEAD AND HIGH GROUNDWATER ANTICIPATED - RISK OF UNSTABLE EXCAVATIONS
C6	UNKNOWN GROUND CONDITIONS - RISK OF UNSTABLE EXCAVATIONS
C7	POTENTIALLY UNSTABLE WATERCOURSE BANKS - RISK OF FAILURE DUE TO LOADING
C8	LARGE INDIVIDUAL BOULDERS TO BE MANEUVERED INTO PLACE
C9	TRAFFIC AT JUNCTION BETWEEN A4110 AND A4113
OPERATIONS & MAINTENANCE	
O1	RISK OF ROCK TRENCH COLLAPSE DUE TO FUTURE MIGRATION OF RIVER AND SURCHARGE DUE TO VEHICLE LOADING
DISMANTLING / DEMOLITION (FUTURE)	
N/A	N/A
REFER TO THE GENERAL NOTES, THE SCHEDULE OF SIGNIFICANT RESIDUAL RISKS (T447) AND THE PRINCIPAL CONTRACTOR FOR MORE INFORMATION.

- NOTES:
- THIS DRAWING SHOULD BE READ IN CONJUNCTION WITH ALL SITE INFORMATION AND THE FOLLOWING DOCUMENTS:  
T447 - SCHEDULE OF SIGNIFICANT RESIDUAL RISKS  
SITE INFORMATION  
PRE-CONSTRUCTION INFORMATION
  - MINIMUM OF 4m STANDOFF DISTANCE TO BE KEPT BETWEEN EXTENT OF ALL FINISHED BANK PROTECTION WORKS AND DCWW'S LIVE ASSETS
  - CONSTRUCTION TRAFFIC WITHIN THE VICINITY OF LIVE MAINS TO BE DISCUSSED WITH DCWW IN ADVANCE TO ASSESS POTENTIAL IMPACT OF INCURSION
  - WATCHING BRIEF BY BCWW MAY BE REQUIRED DURING CONSTRUCTION
  - FULL UNFETTERED ACCESS TO DCWW ASSETS TO BE MAINTAINED IN PERPETUITY AND ALL H&S ACCESS / EGRESS REQUIREMENTS TO BE AGREED IN ADVANCE OF THE COMMENCEMENT OF THE PROPOSED WORKS
