## Domestic Services Risk Assessment & Written Scheme for the Control and Prevention of Legionellosis

**Tendering District Council  
Walton on the Naze Lifestyles  
Princes Esplanade  
Walton-on-the-Naze  
CO14 8PZ**

**Assessment No:** 12659SI

## Legionella Risk Assessment Survey Report

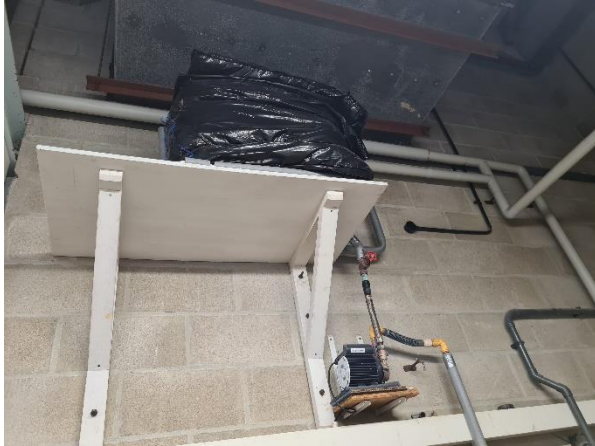
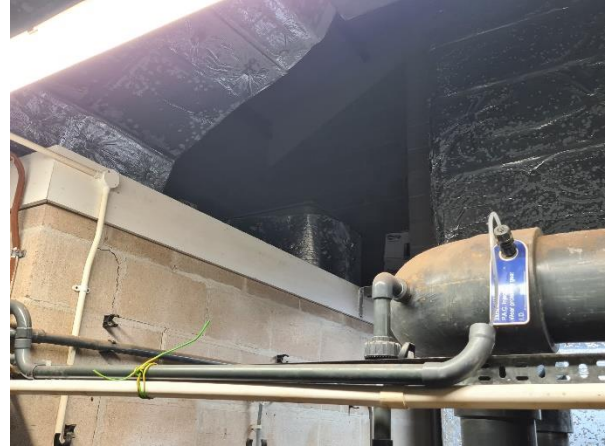
CWST 1 – A cold water storage tank is located plant room which supplies the acid top up only. The tank is of plastic construction and fully insulated.

CWST 2 – Another cold water storage tank was located at ceiling height in the plant room. The tank is of GRP construction and supplies the pool top up only.

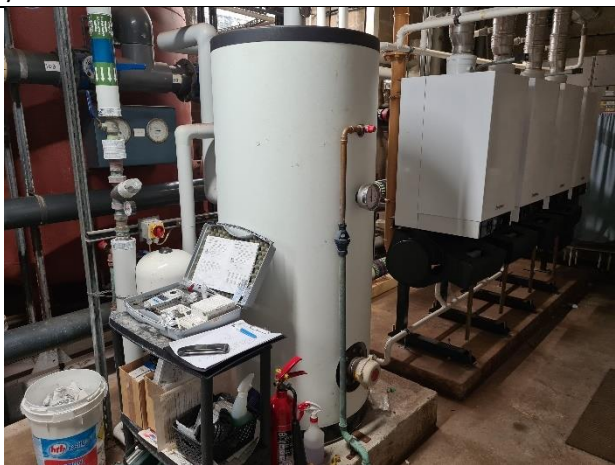
| General Information | | Risk Comment | | |
|---|--|---|---|---|
| Photograph of Hot Water PHE | | | | |

There was a secondary circulation pump noted on the return piping, which feeds into the cold water inlet to the CAL. The unit was fitted with temperature gauges on the flow and return piping which were accurate during the survey. The flow and return piping achieved an acceptable 62°C and 50°C respectively.

| General Information | | Risk Comment | | |
|---|--|---|---|---|
| Stored water Volume | | 350 litres | | |
| Materials of construction | | S/ Steel | | |
| Vessel insulation condition | | Good | | |
| Distribution insulation condition | | Good | | |

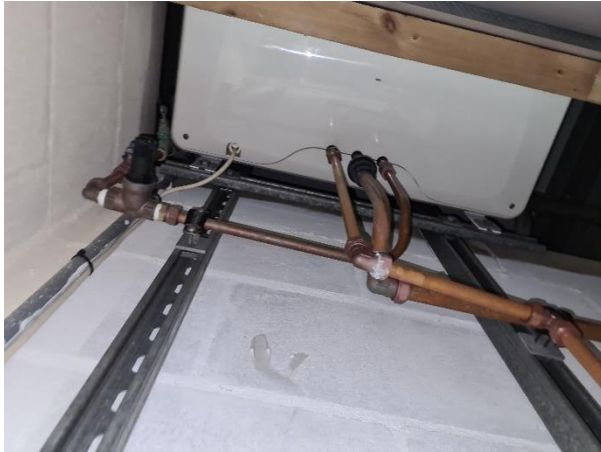
**EWH 1 – Female toilet**

There was one electric water heater (EWH) located in the reception female toilet. The unit is mains fed and supplies the reception male, female and accessible toilets. The unit achieved  $>50^{\circ}\text{C}$  from the piping to the outlets.

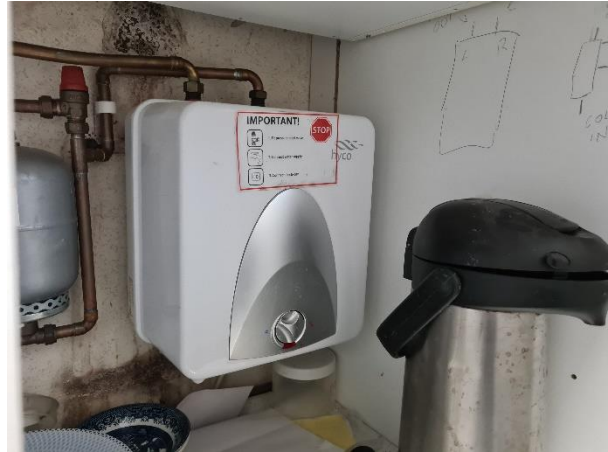
**EWH 2 – Staff room**

A second electric water heater was located in the staff room under the sink. The unit supplies the sink only and achieved an acceptable  $69^{\circ}\text{C}$ .

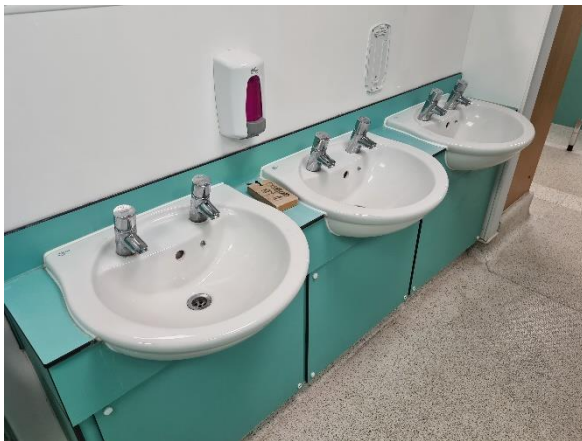
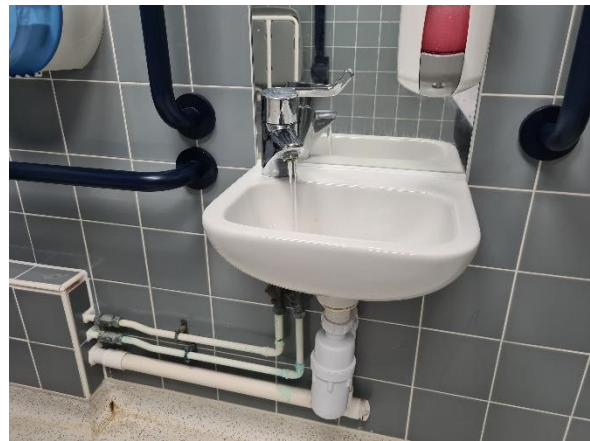
Examples of WHB configuration

All of the outlets were in good working order. All taps were clean and scale free.

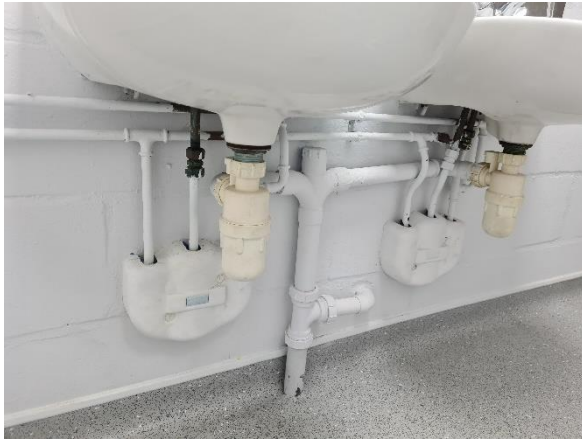
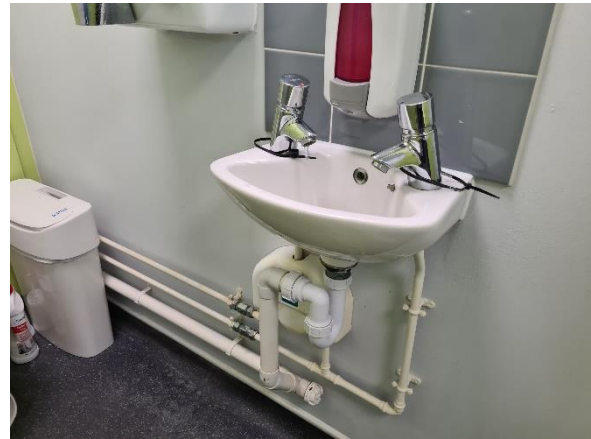
**TMV examples around site**

TMV's are installed on all toilet washbasins in the building. The recommended temperature for TMV's is between  $39-42^{\circ}\text{C}$ . All TMV's tested achieved between  $39 - 42^{\circ}\text{C}$ . The TMV's are serviced regularly. This action is recorded in the log book.

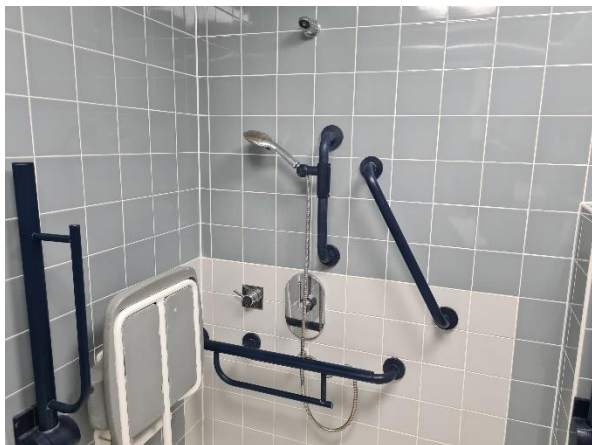
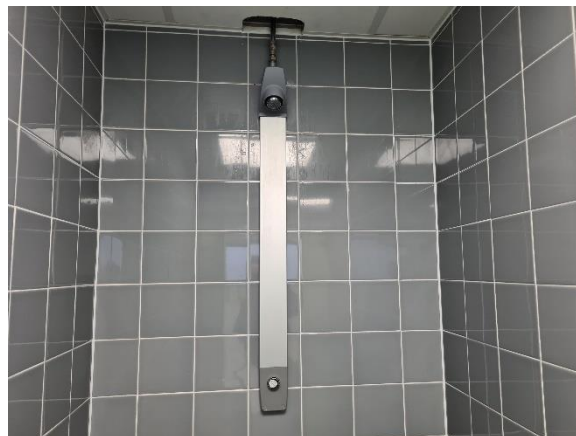
Typical shower configuration

Showers were located in all changing rooms. All units are of similar construction and appeared to be operating correctly. The showerheads are clean and scale free.

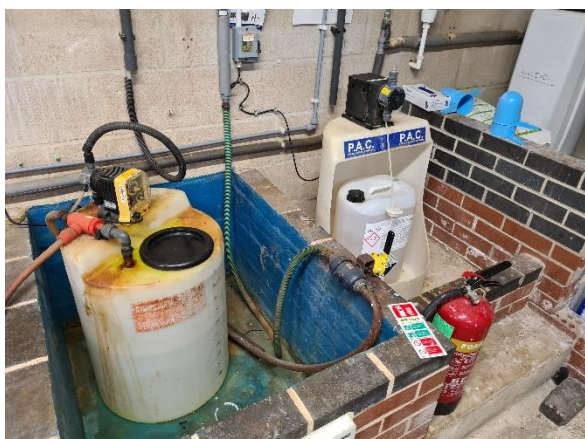
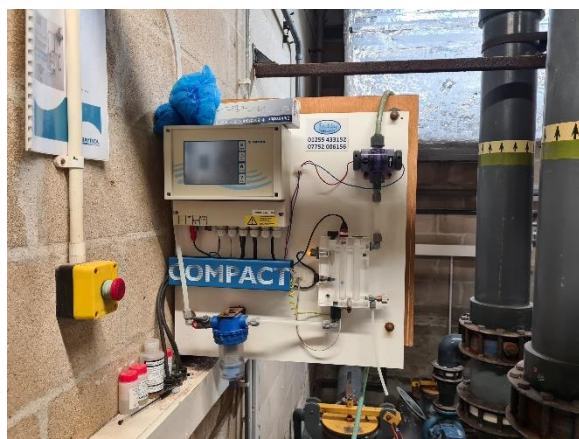
Chemical dosing plants & unit

The chemical plants consist of **Calcium Hypochlorite** for bacteria control and Acid for PH Control. Both plants were operational at the time of inspection and in good condition.

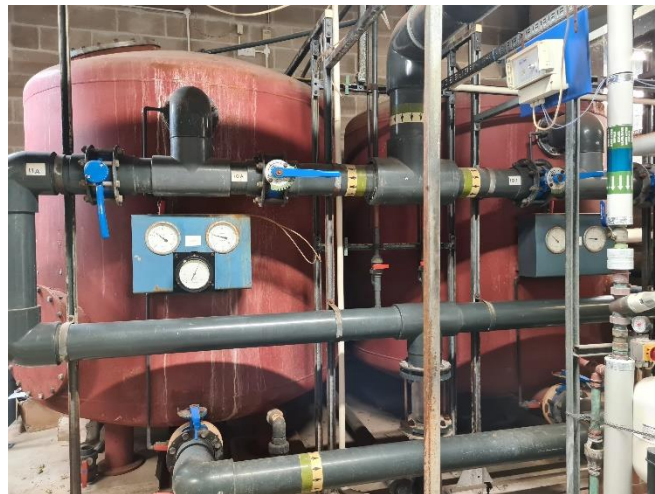
The pool has its own filtration system. Pool Management ensures that all filters are inspected and cleaned if necessary, every 5 years to include media replacement.
