Asbestos Refurbishment and Demolition Survey Report

Site Address: High Cross
Madingley Road
Cambridge,
CB3 0ET

Survey Reference: J178267
Survey Date: 11 Dec 2019 to 18 Feb 2020

Client: British Antarctic Survey
Client Address: High Cross
Madingley Road
Cambridge

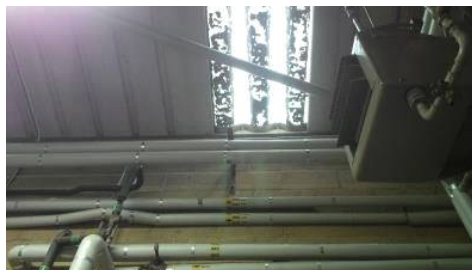
Asbestos Content: **Strongly presumed to contain (1) Chrysotile asbestos fibres.**

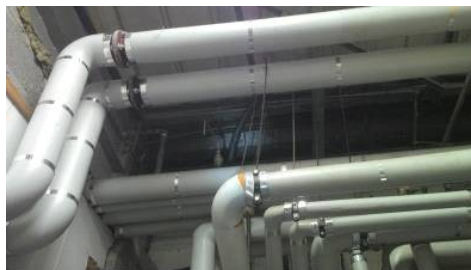
Asbestos Content: **Strongly presumed to contain (1) Chrysotile asbestos fibres.**

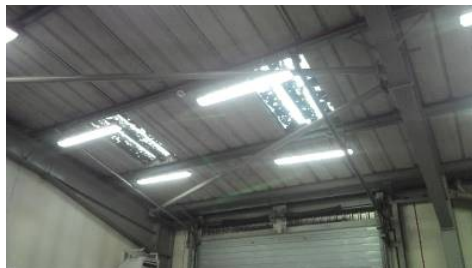
Asbestos Content: **Strongly presumed to contain (1) Chrysotile asbestos fibres.**

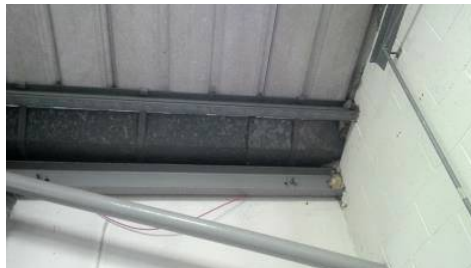
Asbestos Content: **Strongly presumed to contain (1) Chrysotile asbestos fibres.**

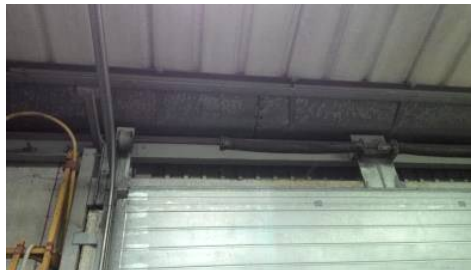
Asbestos Content: **Strongly presumed to contain (1) Chrysotile asbestos fibres.**

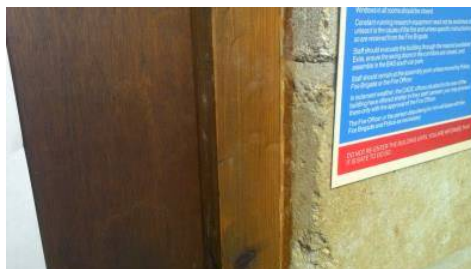
Asbestos Content: **Contains (1) Chrysotile asbestos fibres.**

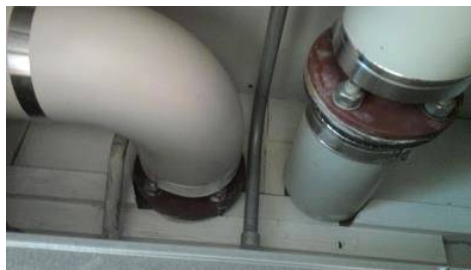
Asbestos Content: **Contains (1) Chrysotile asbestos fibres.**

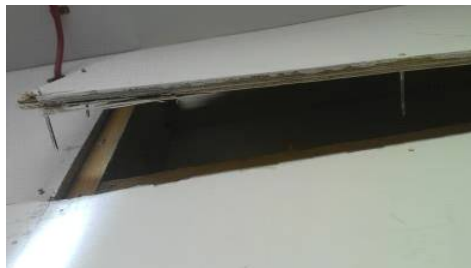
Inspection photograph of internal timber stud wall to timber frame with no internal insulation/fire break

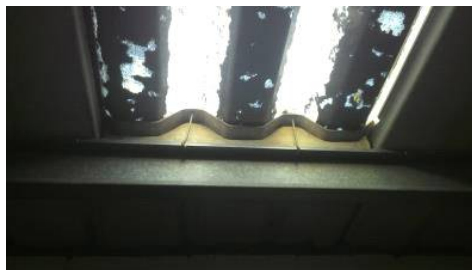
Asbestos Content: **Strongly presumed to contain (1) Chrysotile asbestos fibres.**

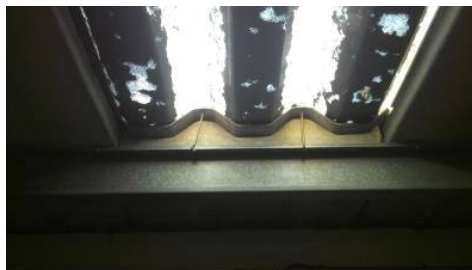
Asbestos Content: **Strongly presumed to contain (1) Chrysotile asbestos fibres.**

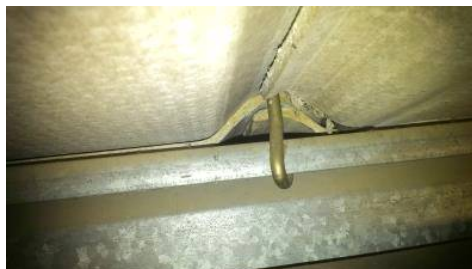
Profile ceiling - cement - rough edging with loose material at fixings and visible debris in framework troughs (as sample CE003428)

Asbestos Content: **Strongly presumed to contain (1) Chrysotile asbestos fibres.**

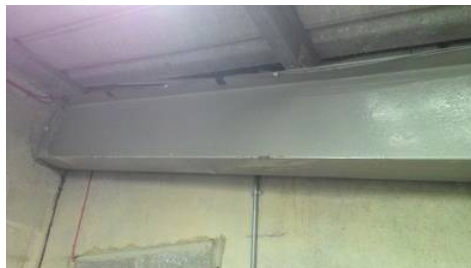
Inspection photograph - concrete wall rises above ceiling level with metal topper above roof level

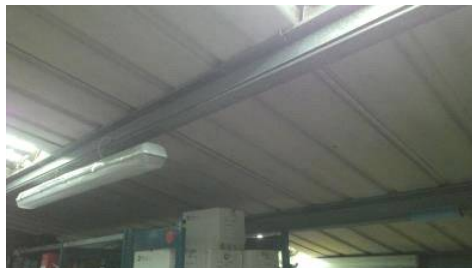
Profile ceiling - cement - rough edging with some loose material at fixings (as sample CE003428)

Asbestos Content: **Strongly presumed to contain (1) Chrysotile asbestos fibres.**

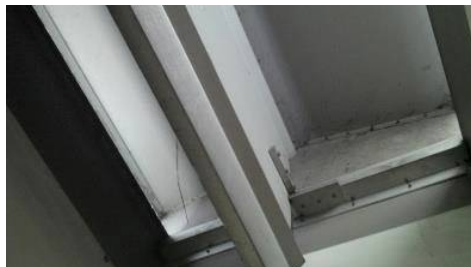
Inspection photograph - metal roof vent

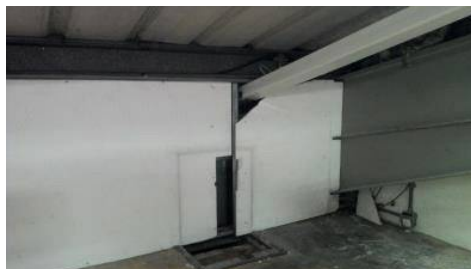
Panels to front wall - insulating board - high damage with visible ground debris and debris within floor void (as sample CE003560)

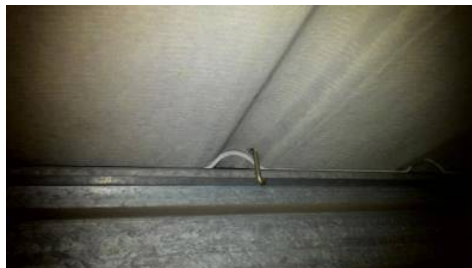
Profile ceiling - cement - rough edging with some loose material at fixings (as sample CE003431)

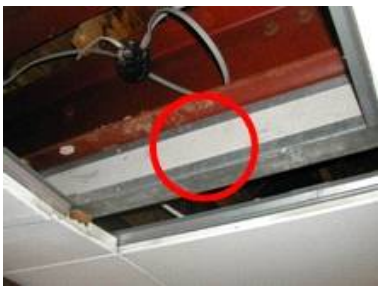
<p><i>Hidden behind fibreboard wall partition – asbestos felt damp proof membrane</i></p>
