Project Name: Mayfield House

Project Date: 26/08/2022

Inspection Standard: MSCC5 Sewers & Drainage GB (SRM5
Scoring)

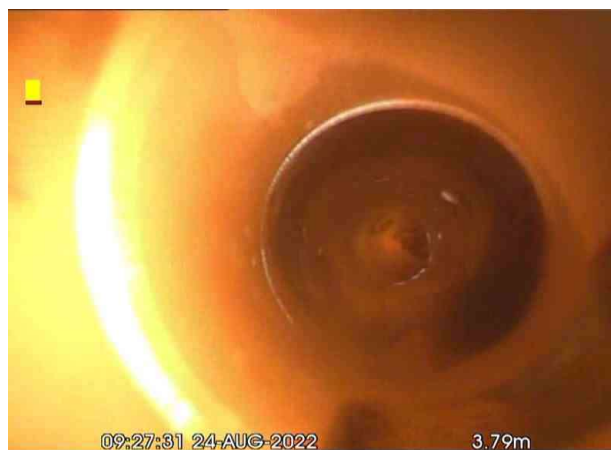
AX_a152e9e8-e048-4573-a99a-20447036e6e5_20220826_10
 4047_112.jpg, 00:00:18, 3.79 m
 Junction at 1 o'clock, 100mm dia

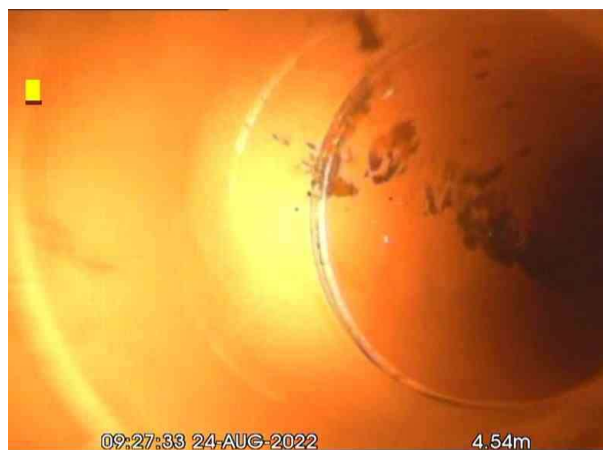
AX_b66f36bc-0cfb-48b7-8262-cbbbac2262e2_20220826_104
 243_891.jpg, 00:00:20, 4.54 m
 Line deviates right

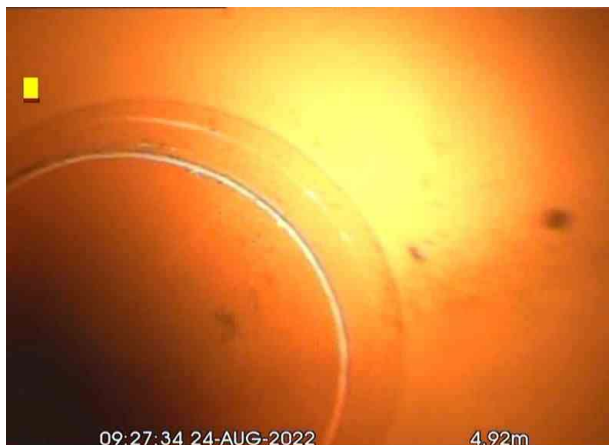
AX_8ca9ed2e-f5b2-4f4e-8304-9fed9c07b617_20220826_104
307_190.jpg, 00:00:21, 4.92 m
Line deviates left

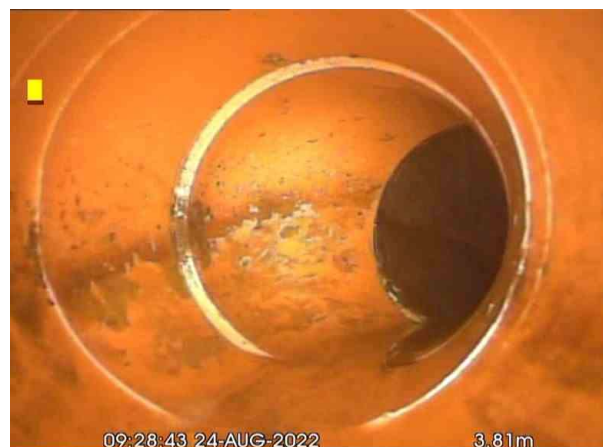
FMH1X_65d60478-abd0-40c1-84bb-baf347cda3a2_20220826_105030_744.jpg, 00:00:16, 3.81 m
Line deviates right

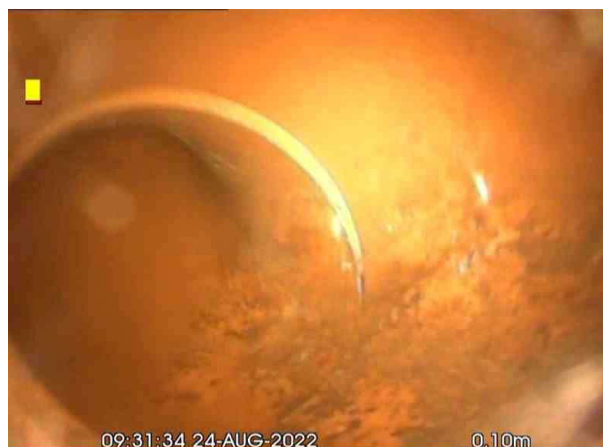
AX_b035f1b8-4dfe-4a44-ba01-dc4af7383c83_20220826_105
637_252.jpg, 00:00:06, 0.10 m
Line deviates left

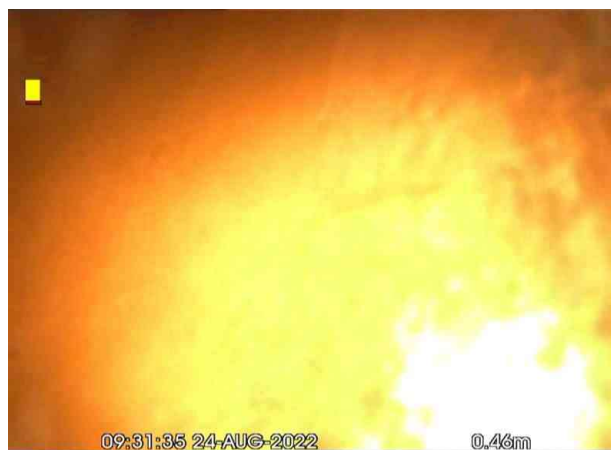
AX_c4f8aa88-824b-459f-b71e-fe2fcd5f492_20220826_1056
47_266.jpg, 00:00:07, 0.46 m
Line deviates up

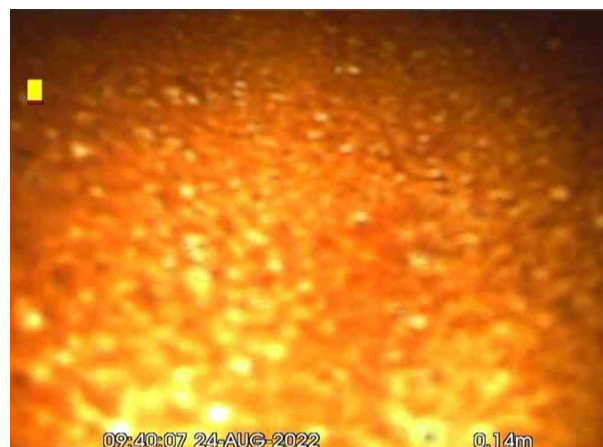
AX_b6dca5df-1087-45e2-a96e-989fa3748bc6_20220826_110
554_687.jpg, 00:00:07, 0.14 m
Line deviates up

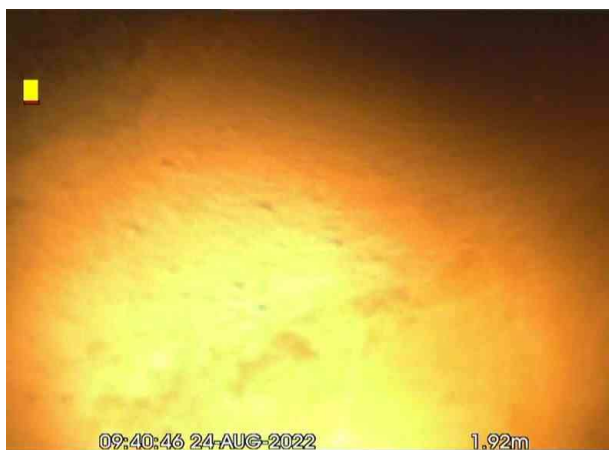
BX_76cd801c-34dc-4ee2-8074-8fad147063fe_20220826_111
856_333.jpg, 00:00:12, 1.92 m
Line deviates up

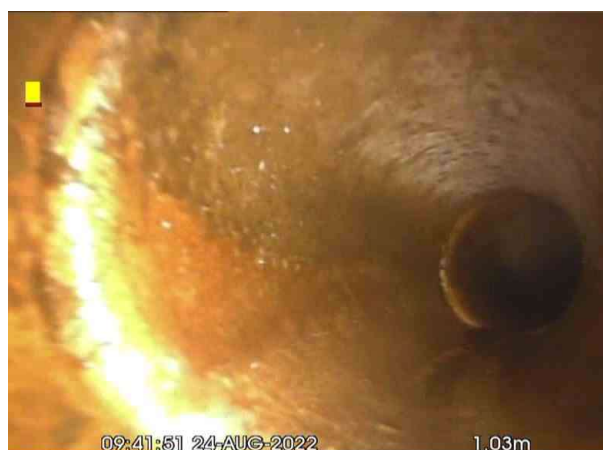
FMH3X_4356a4ec-7d7c-44e7-b8e5-65add26ca597_20220826_121004_884.jpg, 00:00:09, 1.03 m
Line deviates right

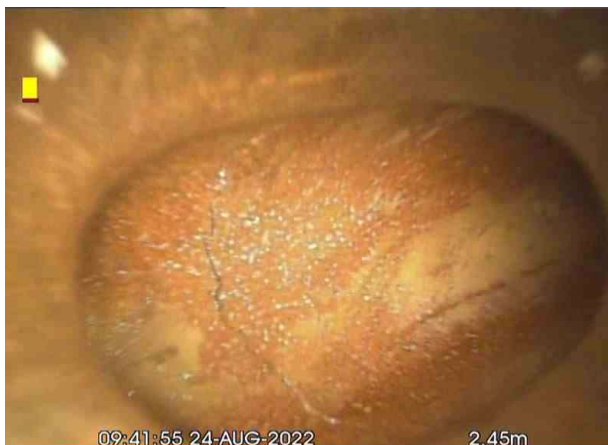
FMH3X_21f5451c-be09-4a81-8812-a3f63d96a9f9_20220826_121033_094.jpg, 00:00:13, 2.45 m
Line deviates right, Junction on to secondary main

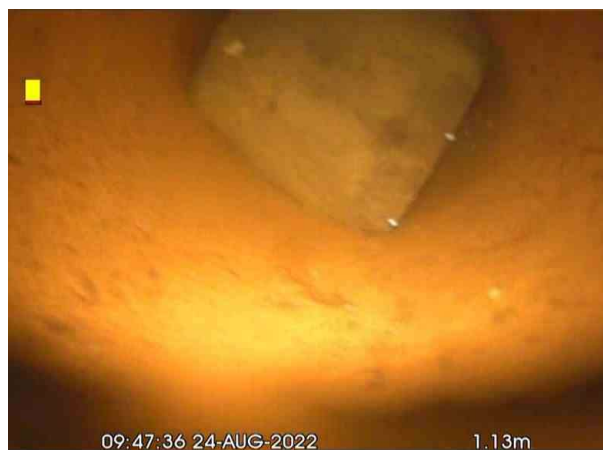
AX_c502f8ce-308e-4eca-8ddb-2a150e208aa8_20220826_123
949_533.jpg, 00:00:16, 1.13 m
Finish node, other special chamber, reference: A, End of
Survey / Suspected Capped off

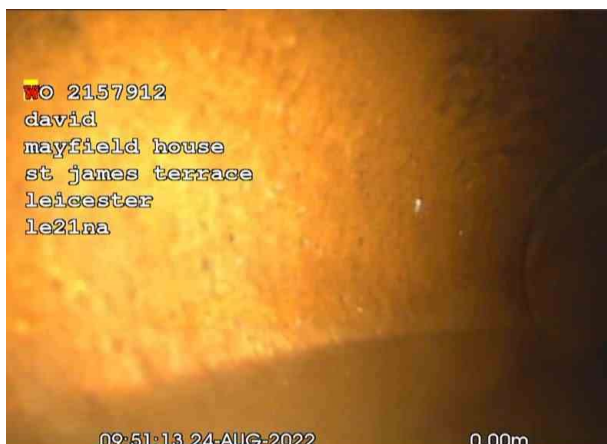
FMH5X_cc2e27df-ec87-44ce-8129-cb6c0a714a54_20220826_124346_385.jpg, 00:00:00, 0.00 m
Start node, manhole, reference: FMH4

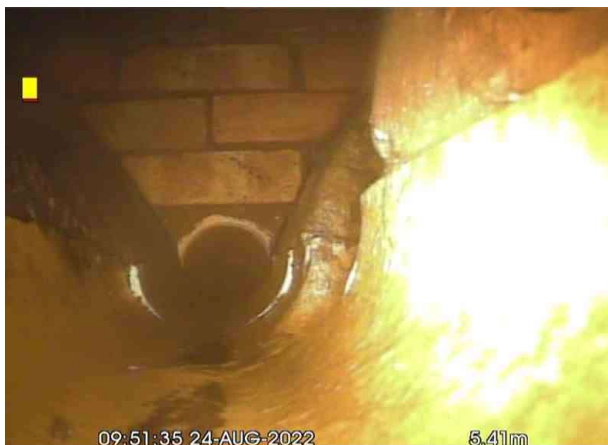
FMH5X_7b70c2b3-bf17-4651-aade-82717d97cc69_20220826
_124555_515.jpg, 00:00:24, 5.41 m
Finish node, manhole, reference: FMH5

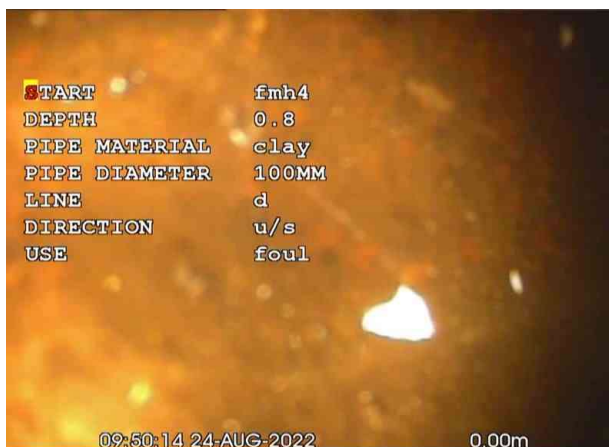
DX_2e600f9b-ea6f-4815-9cfd-54ac68f0b770_20220826_1403
39_066.jpg, 00:00:00, 0.00 m
Start node, manhole, reference: FMH4

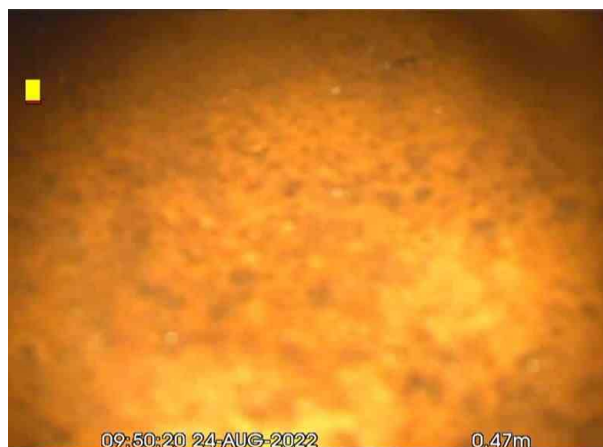
DX_86090ebc-2a77-486f-8815-e0451f45eb0f_20220826_140
932_886.jpg, 00:00:10, 0.47 m
Line deviates up

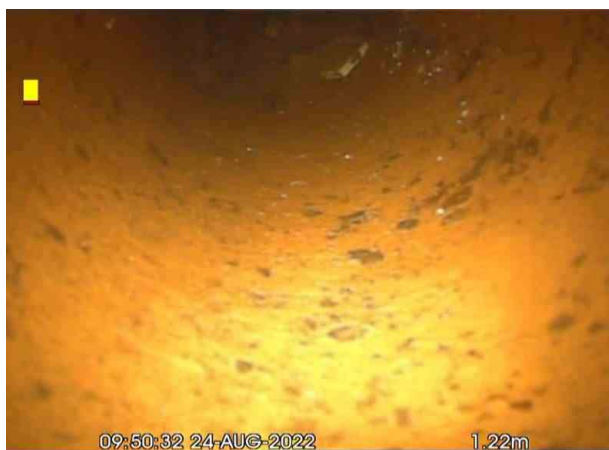
DX_50234c2a-5bd0-4c17-9c62-1e256f580dfe_20220826_141
105_512.jpg, 00:00:21, 1.22 m
Finish node, other special chamber, reference: D, End of
Survey

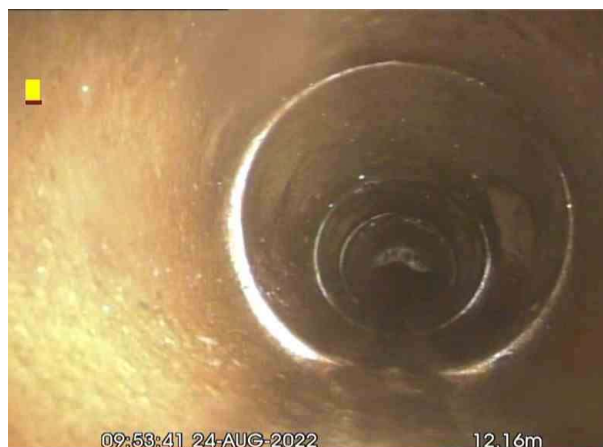
FMH4X_d52bada0-9063-49a8-9b20-ceb42b8be696_20220826_141905_096.jpg, 00:00:40, 12.16 m
Line deviates right

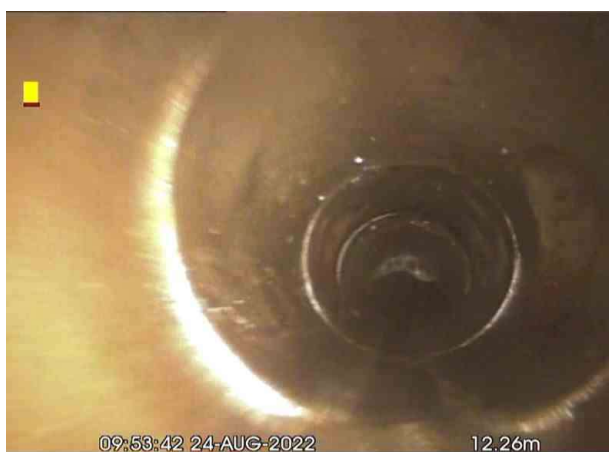
FMH4X_cc543651-f991-4fbf-80b3-b1434c4b92b7_20220826_141926_019.jpg, 00:00:41, 12.26 m
Junction at 3 o'clock, 100mm dia

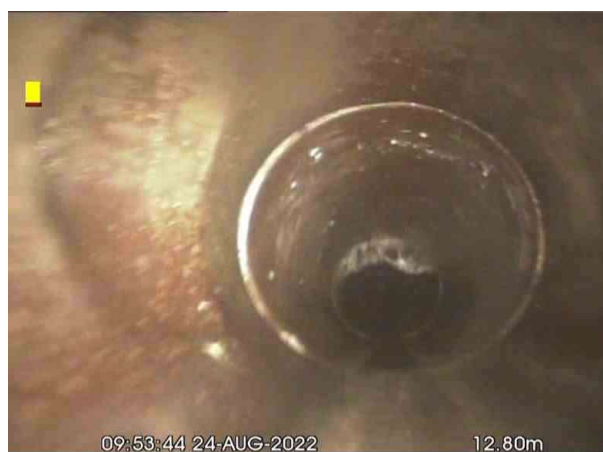
FMH4X_e97644c5-db3c-48b9-aa78-c2b2a3132fb6_20220826_141954_683.jpg, 00:00:43, 12.80 m
Junction at 9 o'clock, 100mm dia

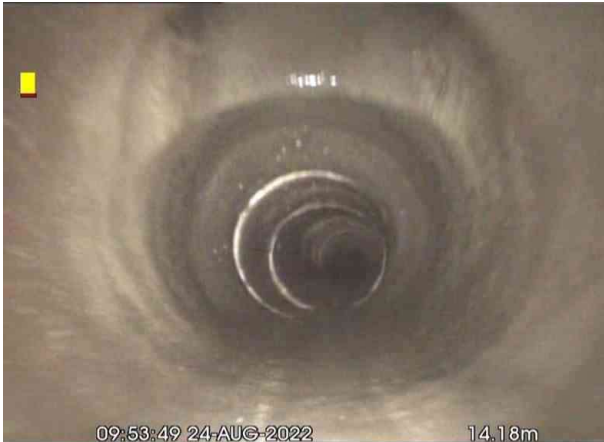
FMH4X_6c26063d-3ac3-4a37-9971-b9b53f614eaf_20220826_142014_936.jpg, 00:00:48, 14.18 m
Junction at 12 o'clock, 100mm dia

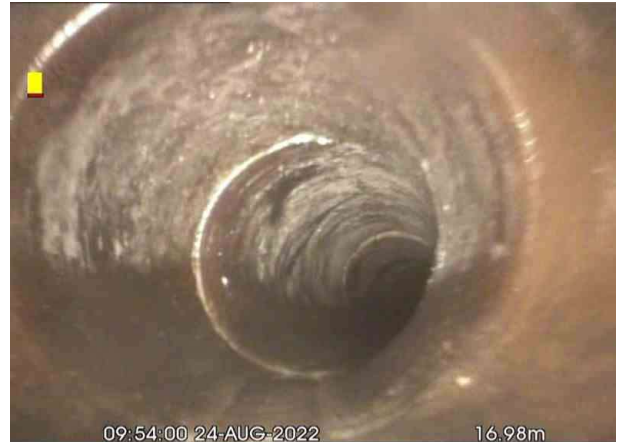
FMH4X_33add05e-5e43-4749-bb94-44b17bb806a5_20220826_142142_418.jpg, 00:00:59, 16.98 m
Line deviates right

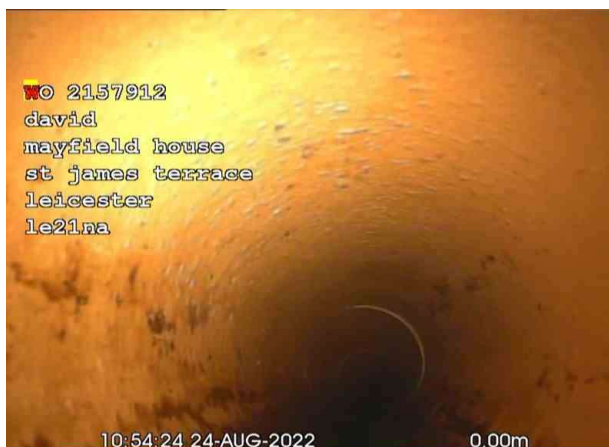
MH5aX_ce78c1b4-9f9d-428b-b411-2de9875ea4ea_20220826_142641_392.jpg, 00:00:00, 0.00 m
Start node, manhole, reference: FMH5

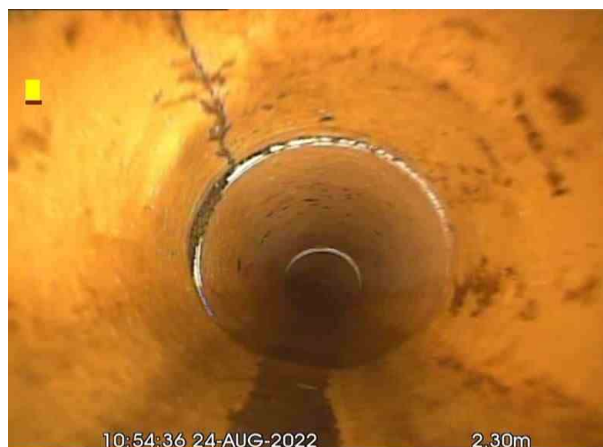
MH5aX_8c73f97d-d529-49aa-b717-17aa70eb161c_20220826_142925_823.jpg, 00:00:12, 2.30 m
Roots, fine at joint

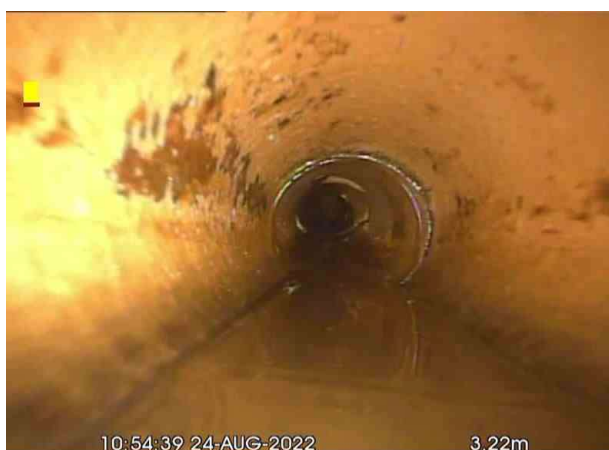
MH5aX_41d07ac9-d9c4-4869-9bb7-9788e3fc5b47_20220826_142943_326.jpg, 00:00:16, 3.22 m
Water level, 10% of the vertical dimension

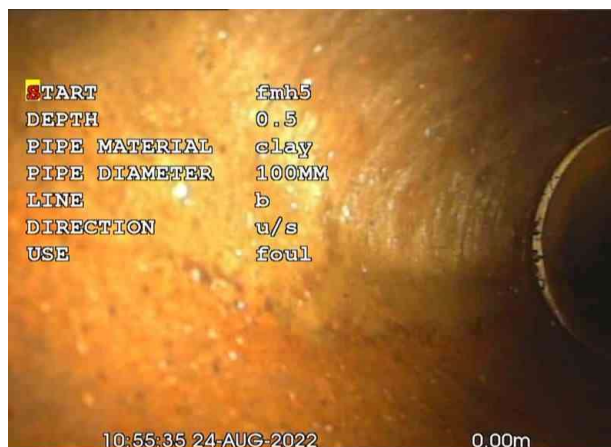
BX_a75c2c17-fd64-47f1-96ed-9415302a1dc6_20220826_143
720_461.jpg, 00:00:00, 0.00 m
Start node, manhole, reference: FMH5

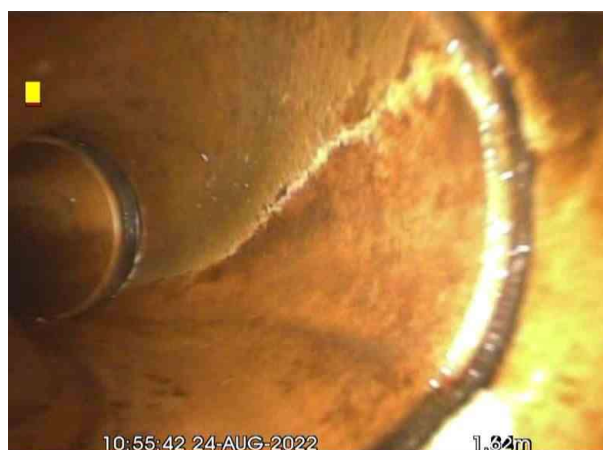
BX_ab3ec797-15f8-4b2c-a4aa-2d8e63d9aa1f_20220826_144
059_050.jpg, 00:00:11, 1.62 m
Line deviates left

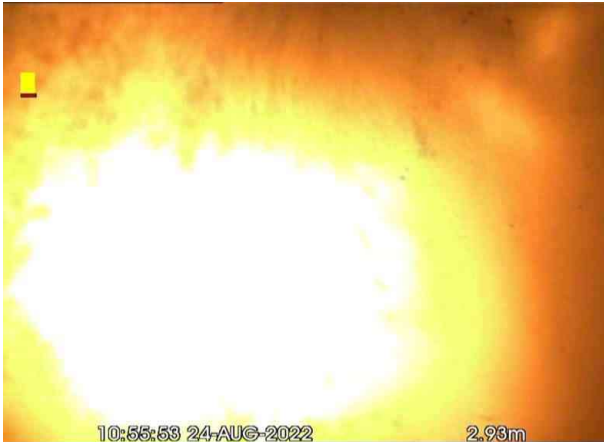
BX_bd218332-10b4-41f5-a3d9-18fd471e4bb4_20220826_144
214_270.jpg, 00:00:22, 2.93 m
Line deviates up

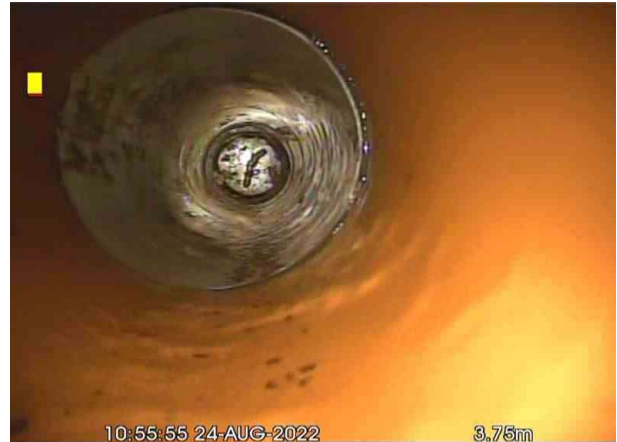
BX_ada3fc9d-8dd5-4fc8-9747-54075dc41aa0_20220826_144
250_010.jpg, 00:00:24, 3.75 m
Finish node, other special chamber, reference: B, End of
Survey

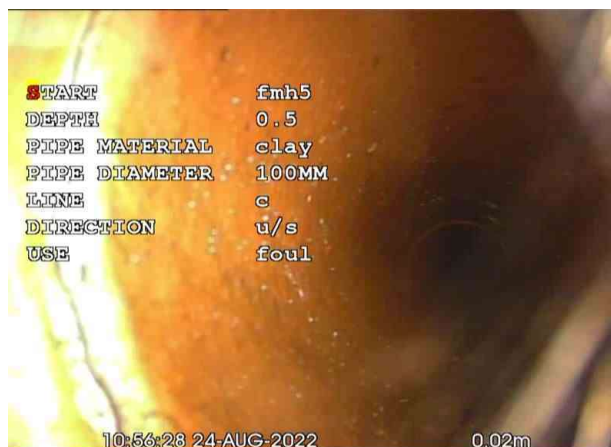
CX_3d61e0a4-39d0-40e5-8c0e-54ffa6ad66d5_20220830_120
523_840.jpg, 00:00:00, 0.00 m
Start node, manhole, reference: FMH5

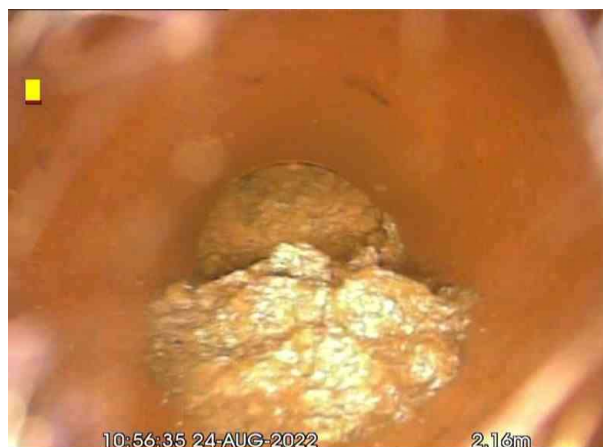
CX_d38bf258-8cdb-428f-bb34-b1031d1f510b_20220830_120
557_855.jpg, 00:00:10, 2.16 m
Settled deposits, hard or compacted, 90% cross-sectional area
loss

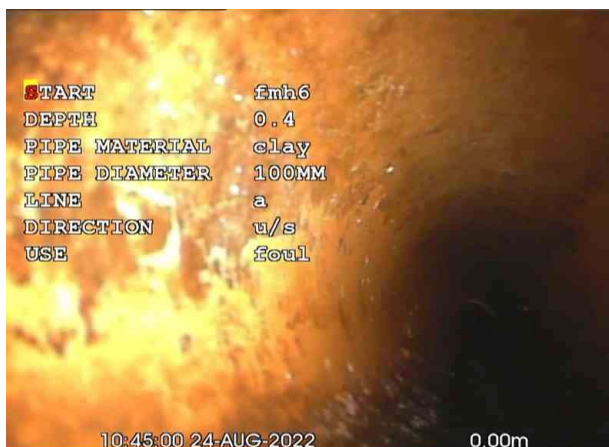
AX_4a1c21cd-0a9f-4480-8338-ebbf1b916fd_20220830_1211
08_102.jpg, 00:00:00, 0.00 m
Start node, manhole, reference: FMH6

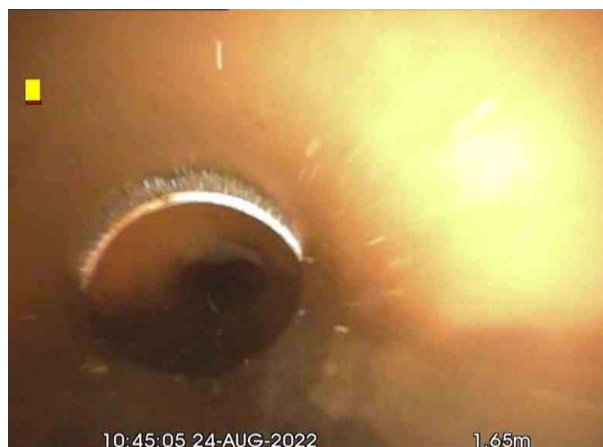
AX_b86a5d62-cf0d-4d0b-b385-77dd92a516f6_20220830_121
949_040.jpg, 00:00:13, 1.65 m
Joint displaced, medium

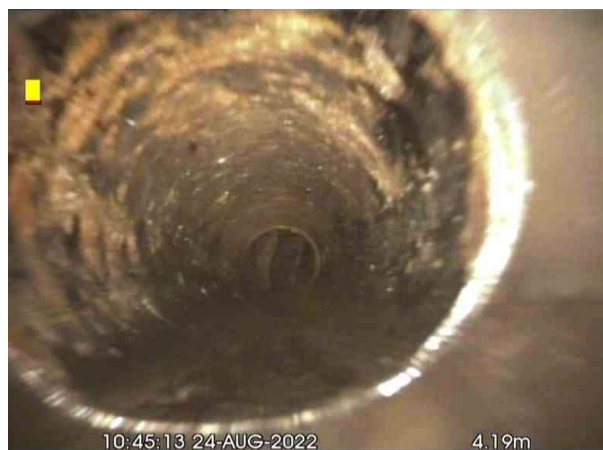
AX_7ebb41a0-5632-461a-ae39-fd359fe7652f_20220830_122
143_174.jpg, 00:00:21, 4.19 m
Line deviates right

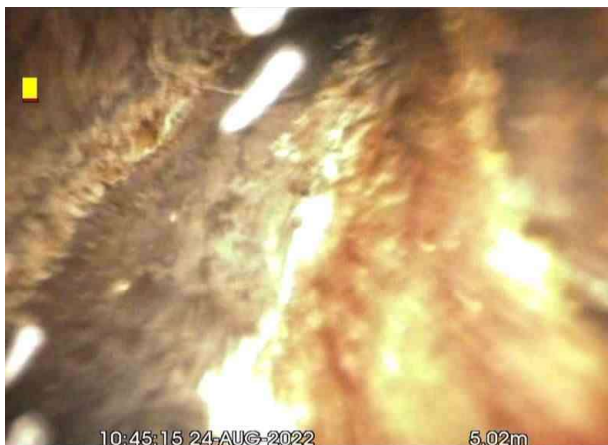
AX_39e1e0c9-407b-4d76-b147-21194ecba6c6_20220830_122210_028.jpg, 00:00:23, 5.02 m
Line deviates up

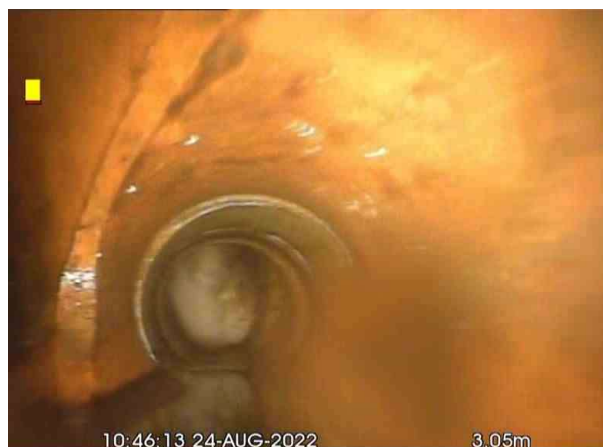
BX_60c548bf-789f-483f-9b0d-0cbf1cc3838a_20220830_123537_374.jpg, 00:00:15, 3.05 m
Junction at 9 o'clock, 100mm dia

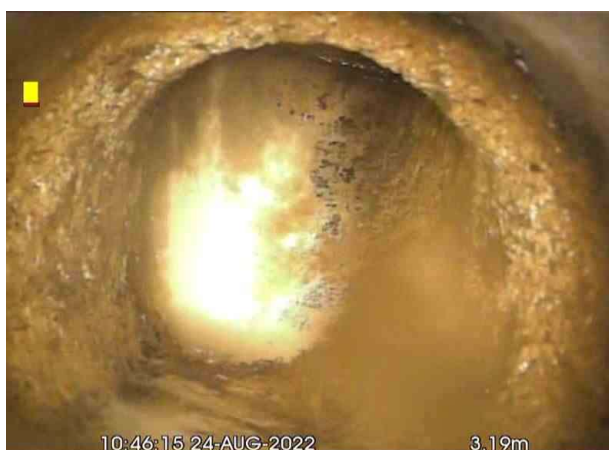
BX_6c7af187-6507-419c-a1c8-22f003c56d64_20220830_123935_478.jpg, 00:00:16, 3.19 m
Line deviates up

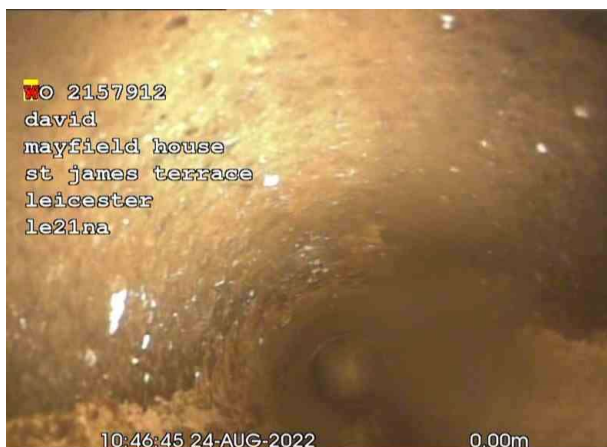
CX_f3397c7c-f5cd-48bf-82b8-8b74b85bdba9_20220830_141
430_185.jpg, 00:00:00, 0.00 m
Start node, manhole, reference: FMH6

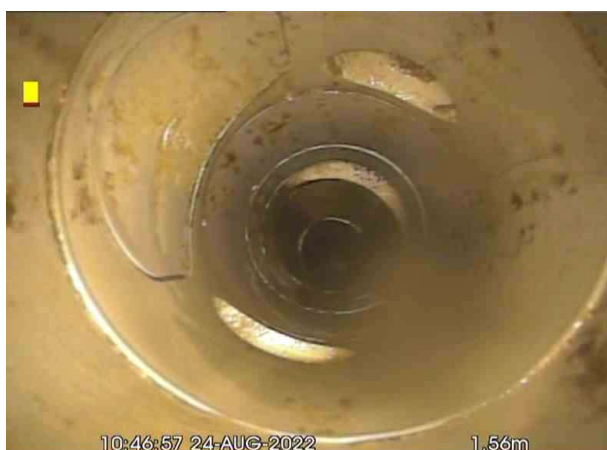
CX_0898d904-55dd-460c-9172-8ac5edc14217_20220830_14
1522_574.jpg, 00:00:12, 1.56 m
Finish node, other special chamber, reference: C, End of
Survey

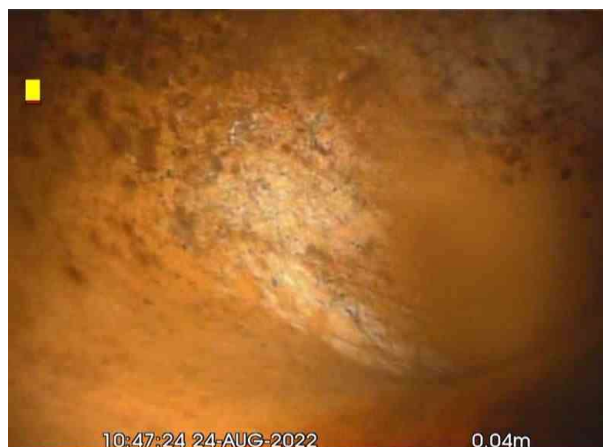
DX_1b5567a1-2938-4ff0-afdd-c0d29b063a3b_20220831_084
006_335.jpg, 00:00:06, 0.04 m
Line deviates up

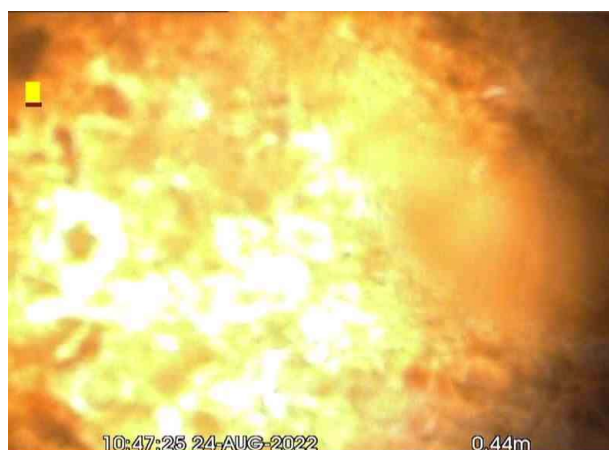
DX_471ff1a2-ce3c-4a5d-a60a-a3318c8ac937_20220831_084
033_860.jpg, 00:00:07, 0.44 m
Finish node, other special chamber, reference: D, End of
Survey

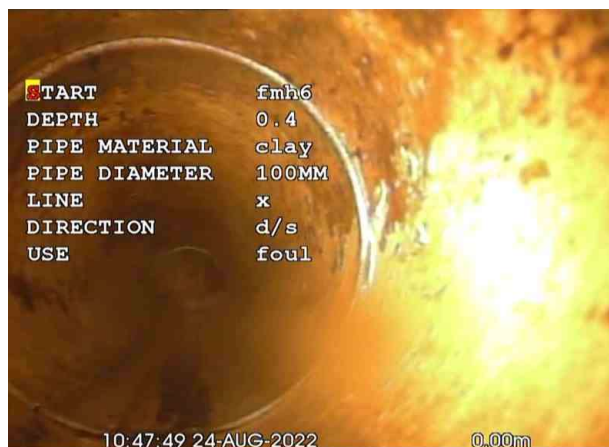
FMH6X_2ec624e6-e24b-4904-9b5f-b8d1b2ea1bba_20220831_084218_366.jpg, 00:00:00, 0.00 m
Start node, manhole, reference: FMH6

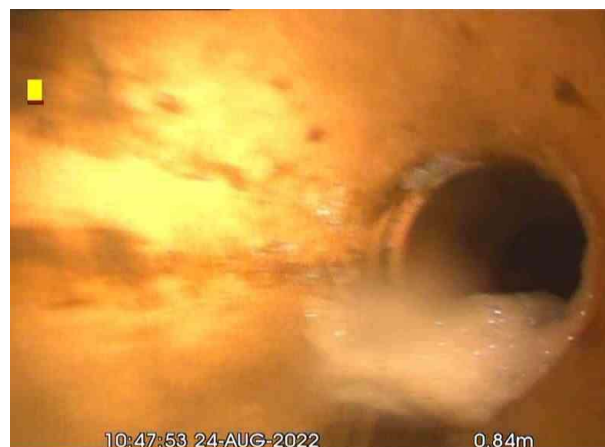
FMH6X_29790e47-512a-4eda-b7a0-491f57237c0f_20220831_084246_157.jpg, 00:00:07, 0.84 m
Line deviates right

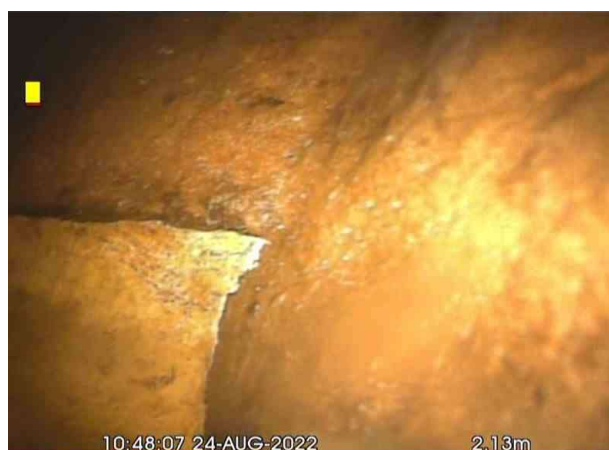
FMH6X_3d338432-29db-40c2-8109-5eefa110c068_20220831_084315_639.jpg, 00:00:21, 2.13 m
Finish node, manhole, reference: FMH5a

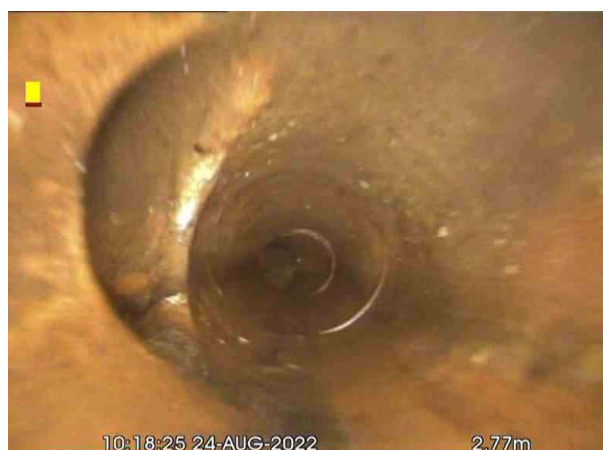
AX_714b0301-ffff-4b39-8712-293769aeea37_20220831_0900
26_932.jpg, 00:00:14, 2.77 m
Junction at 9 o'clock, 100mm dia

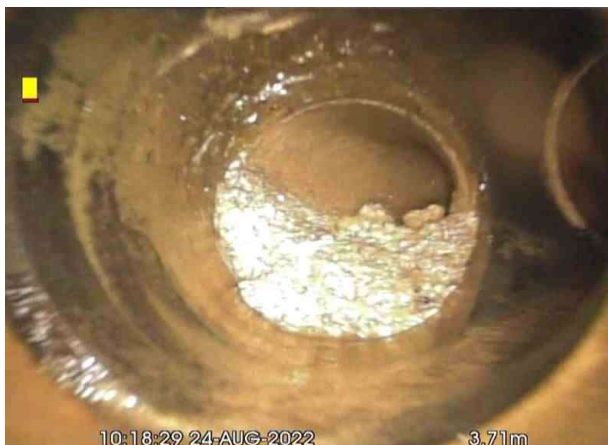
AX_2704cce3-6c8d-4109-9012-aa64dd096d45_20220831_090046_808.jpg, 00:00:17, 3.71 m
Junction at 3 o'clock, 100mm dia

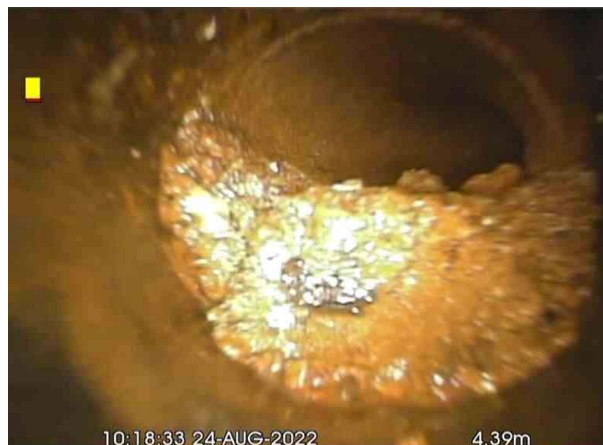
AX_2e6446a5-cc8a-4fc6-97dd-6214c854a780_20220831_090858_943.jpg, 00:00:22, 4.39 m
Attached deposits, fouling from 4 o'clock to 8 o'clock, 60% cross-sectional area loss

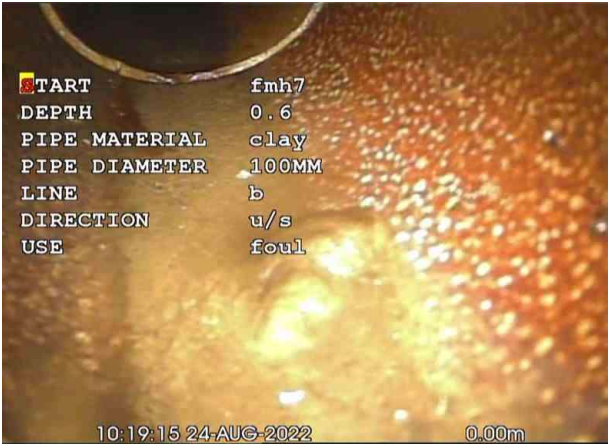
BX_38bbc693-df33-4df4-8db6-8b2c25bdefe4_20220831_111
 048_088.jpg, 00:00:00, 0.00 m
 Start node, manhole, reference: FMH7

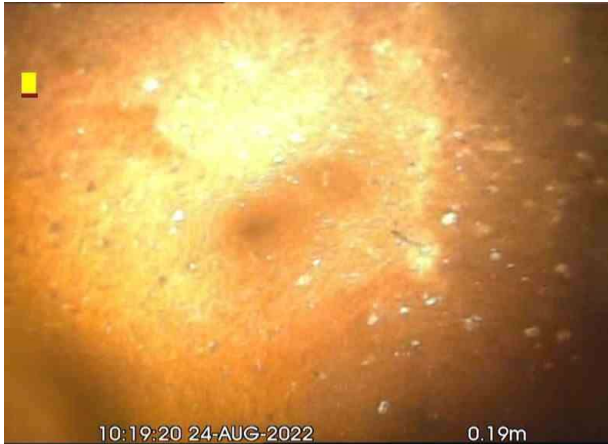
BX_60f6b969-5b36-4d4c-8429-6033eef0a5f8_20220831_111
 134_818.jpg, 00:00:08, 0.19 m
 Line deviates down

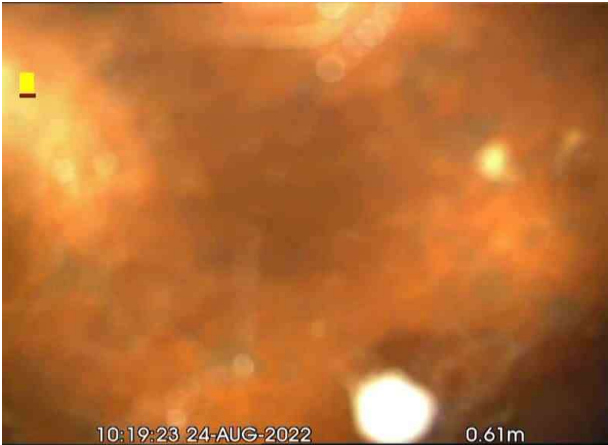
BX_43c180bd-3952-4171-bf96-53e9988c0bfd_20220831_111
 156_457.jpg, 00:00:11, 0.61 m
 Finish node, other special chamber, reference: B, End of Survey

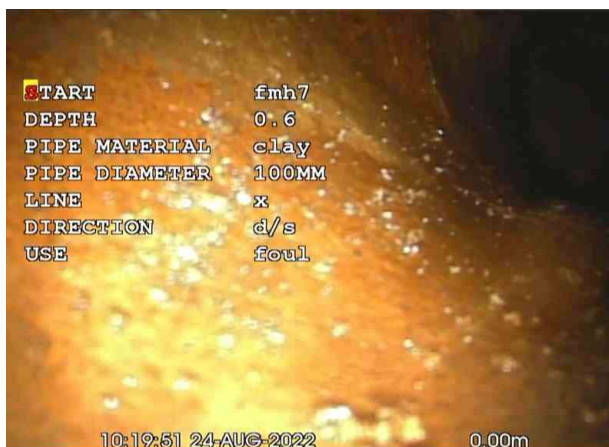
FMH7X_4ee7574b-b2f9-4e94-968f-b54cc91ee8f6_20220831_111424_137.jpg, 00:00:00, 0.00 m
Start node, manhole, reference: FMH7

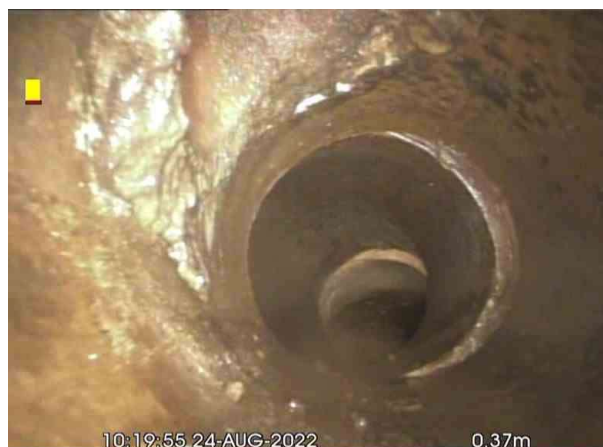
FMH7X_22c38e2c-a497-49a9-80a5-db67249a7b87_20220831_111515_842.jpg, 00:00:08, 0.37 m
Connection other than junction at 10 o'clock, 100mm dia

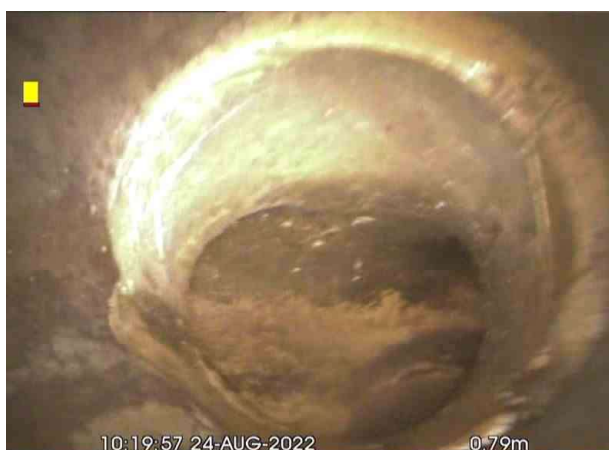
FMH7X_f9cedc1c-d439-4f12-8ebf-7563401176b6_20220831_111527_376.jpg, 00:00:10, 0.79 m
Line deviates right

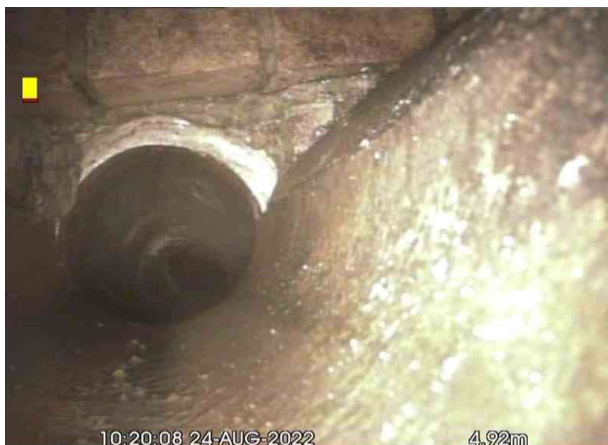
FMH7X_d1664617-3deb-4ae3-affb-8ecf79cd83b6_20220831_
111609_362.jpg, 00:00:21, 4.92 m
Finish node, manhole, reference: FMH8

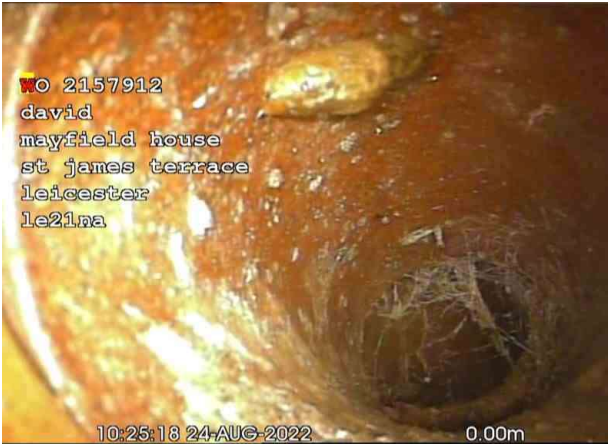
BX_1f98c25d-d693-4a83-a900-df6f145c5287_20220831_111822_276.jpg, 00:00:00, 0.00 m
Start node, manhole, reference: FMH8

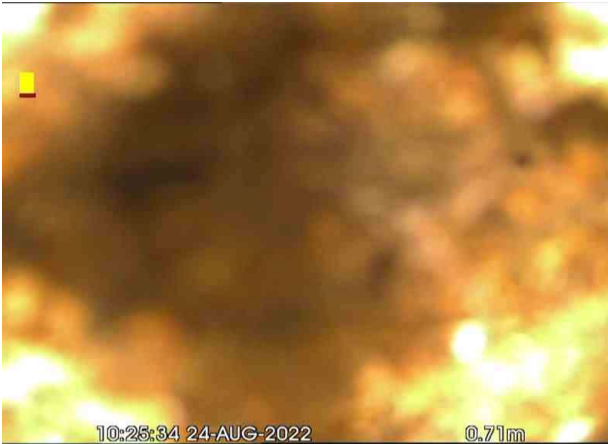
BX_ca9c76ee-a425-49b5-bef4-075fc173a19c_20220831_135844_989.jpg, 00:00:17, 0.71 m
Finish node, other special chamber, reference: B, End of Survey

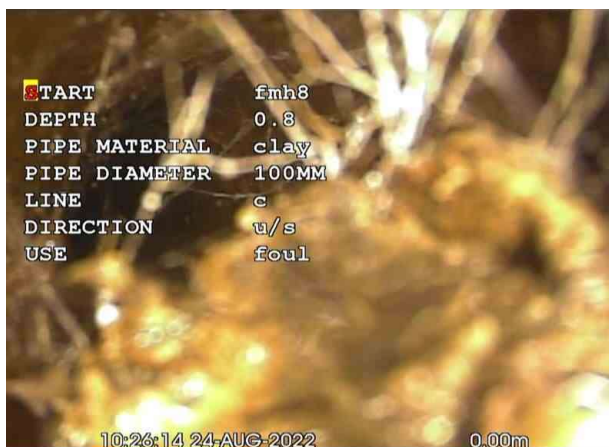
CX_895e2851-8c84-49eb-9f5f-df4deccc02b6_20220831_1401
01_309.jpg, 00:00:00, 0.00 m
Start node, manhole, reference: FMH8

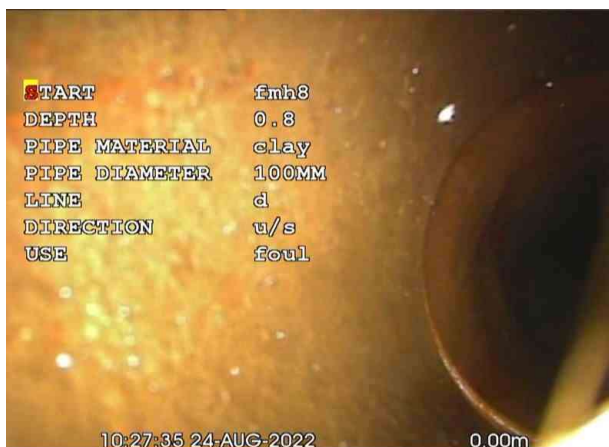
DX_9a6deb59-ded5-4d05-b141-93ebf2e4cf14_20220831_141
318_591.jpg, 00:00:00, 0.00 m
Start node, manhole, reference: FMH8

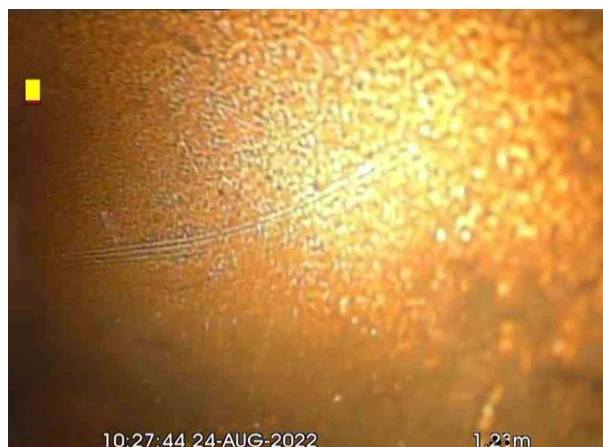
DX_79a51984-81b6-45de-8f5e-51a679451a55_20220831_14
1412_997.jpg, 00:00:12, 1.23 m
Line deviates left

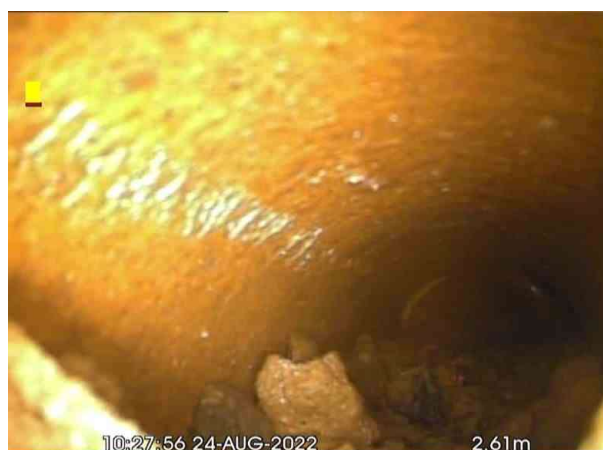
DX_77d46cff-30d7-4e90-8774-accdf58b7f54_20220831_1417
01_937.jpg, 00:00:24, 2.61 m
Survey abandoned, Unable to continue

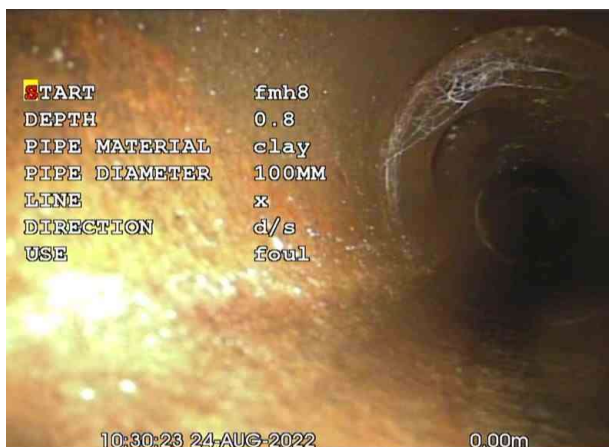
FMH8X_223f5c17-2ce0-4053-9505-8ae00a081fe1_20220831_142353_574.jpg, 00:00:00, 0.00 m
Start node, manhole, reference: FMH8

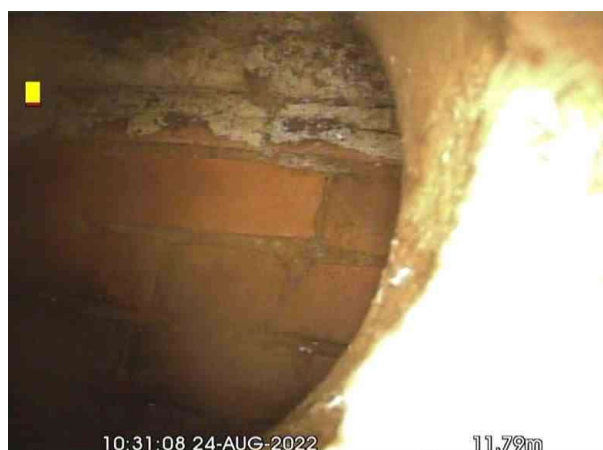
FMH8X_494476e5-2144-4431-8b7a-68836aaab3f0_20220901_084303_716.jpg, 00:00:49, 11.79 m
Finish node, manhole, reference: Downstream, Chamber

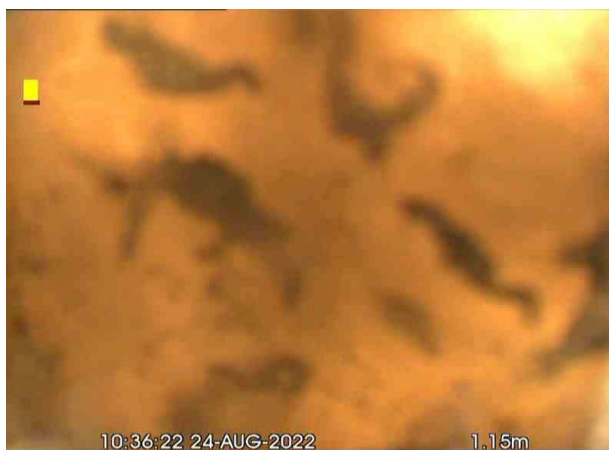
AX_f8e5ede1-084c-4c1b-b412-d946d3629cec_20220901_084
511_556.jpg, 00:00:11, 1.15 m
Finish node, other special chamber, reference: A, End of
Survey

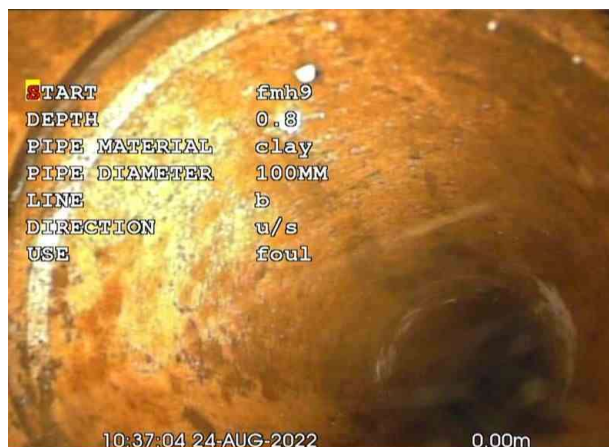
BX_196b6c23-64fb-45f5-8ffc-18552aa3a36e_20220901_0846
37_941.jpg, 00:00:00, 0.00 m
Start node, manhole, reference: FMH9

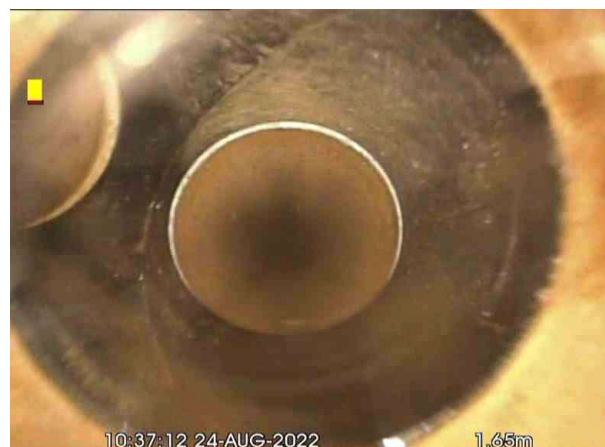
BX_624ca70e-b251-4dea-83eb-c4dae055e49c_20220901_09
0019_433.jpg, 00:00:11, 1.65 m
Junction at 10 o'clock, 100mm dia

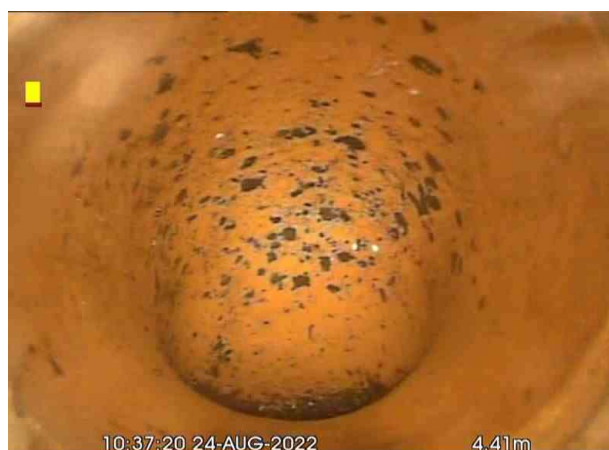
BX_e74b59b0-1514-494f-887e-9b2284369a88_20220901_09
0308_706.jpg, 00:00:19, 4.41 m
Finish node, other special chamber, reference: B, End of
Survey

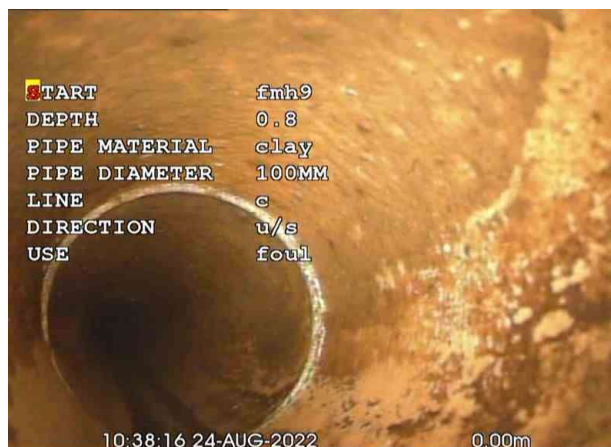
CX_f532fc0d-6cdb-44f9-b7c2-00b9749ba685_20220901_090
423_212.jpg, 00:00:00, 0.00 m
Start node, manhole, reference: FMH9

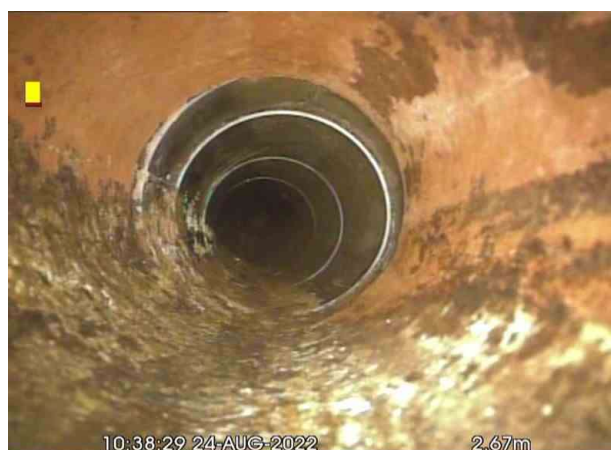
CX_231200cd-1676-436e-8d14-c35f466352dd_20220901_09
0505_445.jpg, 00:00:16, 2.67 m
Finish node, other special chamber, reference: C, End of
Survey

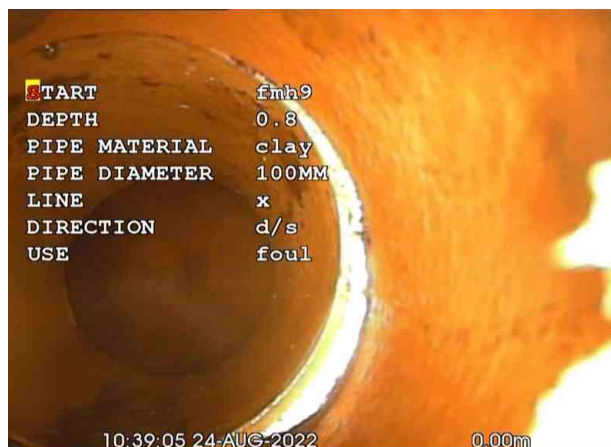
FMH9X_9407fc40-9942-471a-ac76-13b32878fa63_20220901_091049_297.jpg, 00:00:00, 0.00 m
Start node, manhole, reference: FMH9

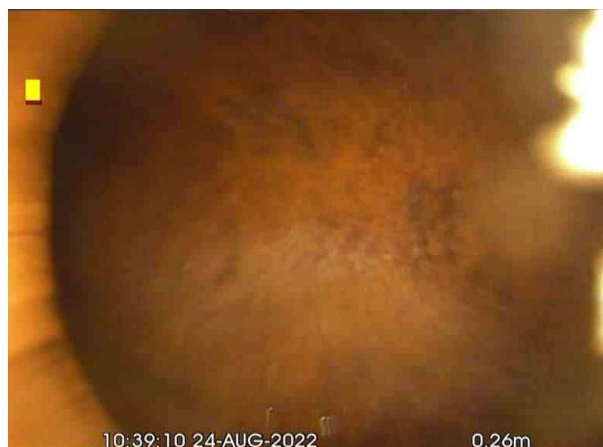
FMH9X_2c039e0d-81eb-4de1-9118-f13f0521790c_20220901_091119_710.jpg, 00:00:08, 0.26 m
Finish node, major connection without manhole, reference: Main, End of Survey
