**Inspection of: Link Bridge
St. Catherine's College
Priory Road
Eastbourne
BN23 7BL**

Project No: 778
Document Title: Special Inspection
Document No: CRM060619778
Revision: Rev 4.
Date: Tuesday 30th August 2022

Principal Inspection of Link Bridge – St Catherine’s College

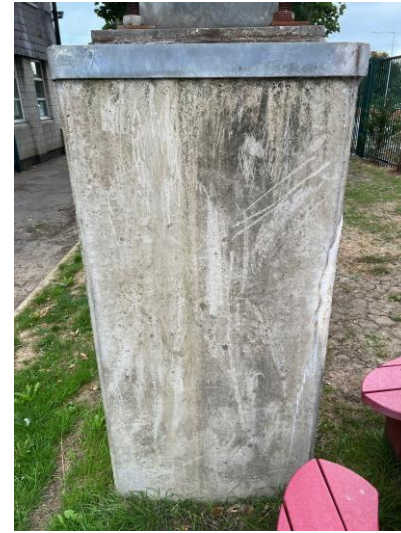
Figure 2: Foundation block East seepage

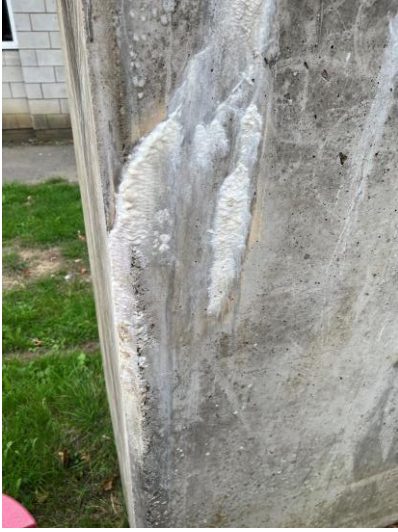
Figure 3: Foundation block seepage

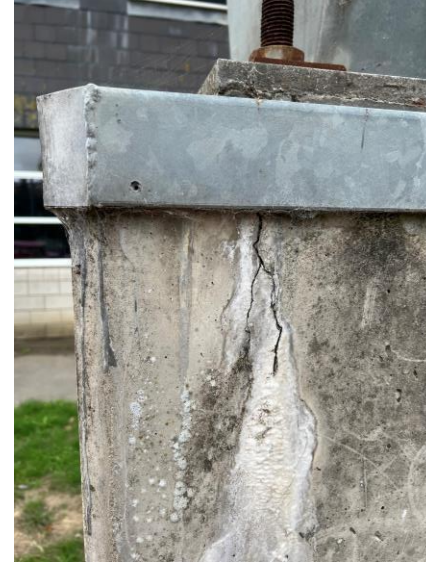
Figure 4: HD Bolt damage

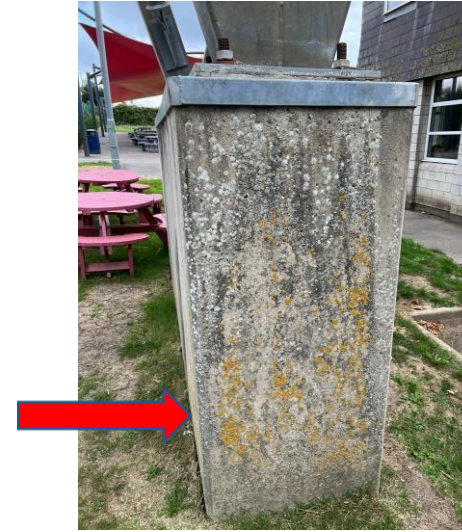
Figure 6: Moss to foundation block

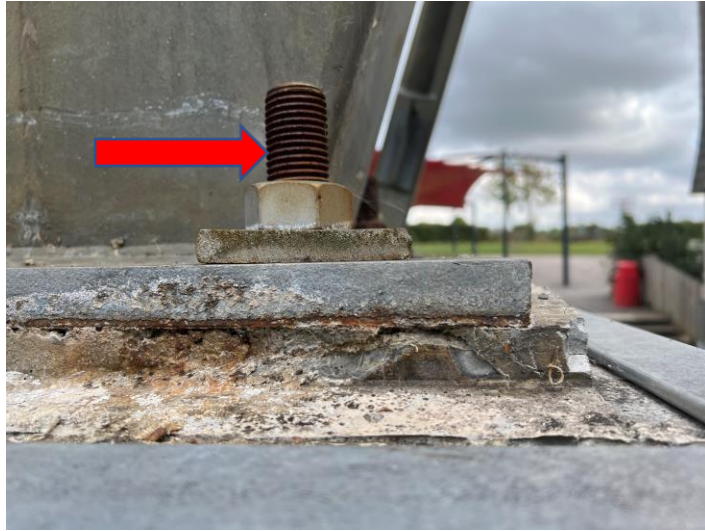
Figure 7: Corrosion to HD bolt & thread

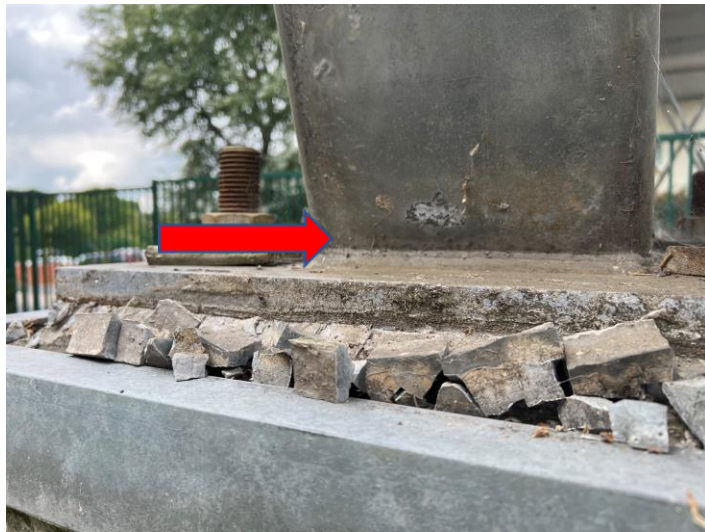
The East block foundation appeared to require remedial works in order for the block and associated fixings to be in the expected condition see (East Block section photos 1-28). Extensive degradation to the grout is evident as detailed in figures 7-10. Minor staining to the block is evident, but not significant to affect the long-term condition. There is moderate corrosion to all bolts, threads and washers/packers, but not as extensive as the West block. It was also noted that bolts and washers are driven home at this location. Corrosion to the baseplates on this block is light, but still evident. There is cracking and leaching to this block as identified in photo 27. Crack widths extend to 2mm max as seen in photo 27-28. The cracking to this area is likely to be a result of corrosion to the holding down rod which is possible due to it being cast too close to the surface and not having adequate cover, leaching as a result of the fracture. This should be investigated further and repaired.

Figure 8: Degradation to grout

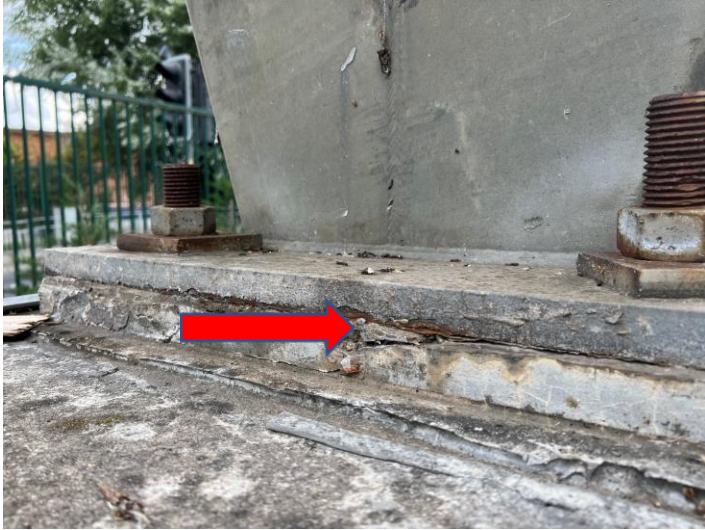
Figure 11: Light corrosion to baseplate

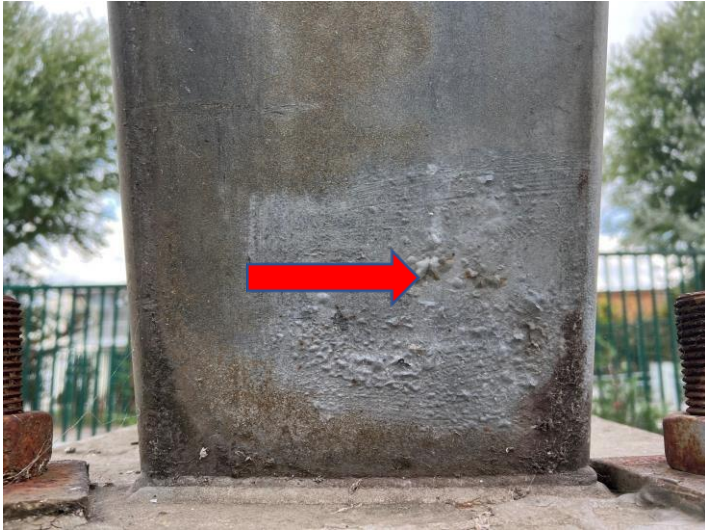
Figure 13 – Pitting damage & corrosion

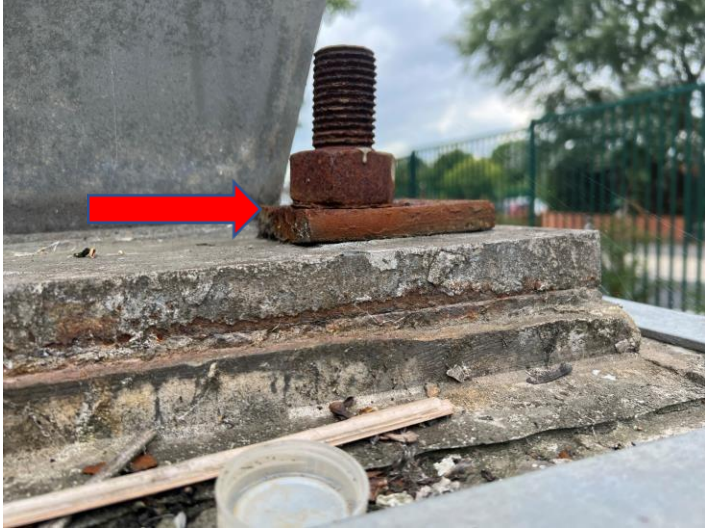
Figure 15: Moderate corrosion to HD bolt & packer

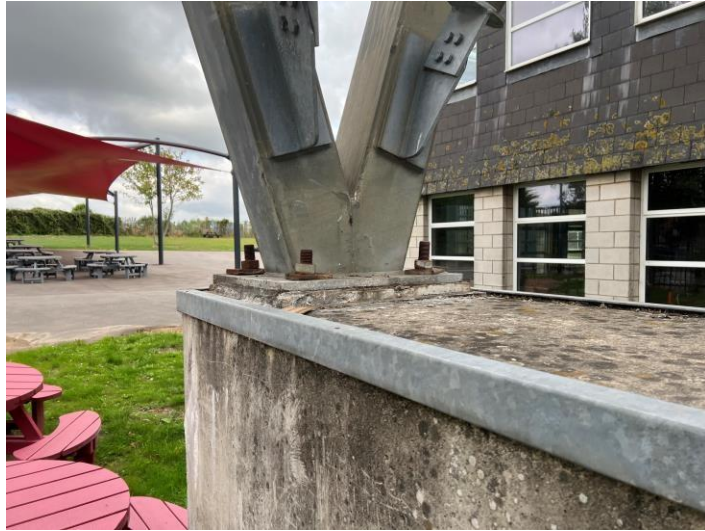
Figure 20: Moderate corrosion

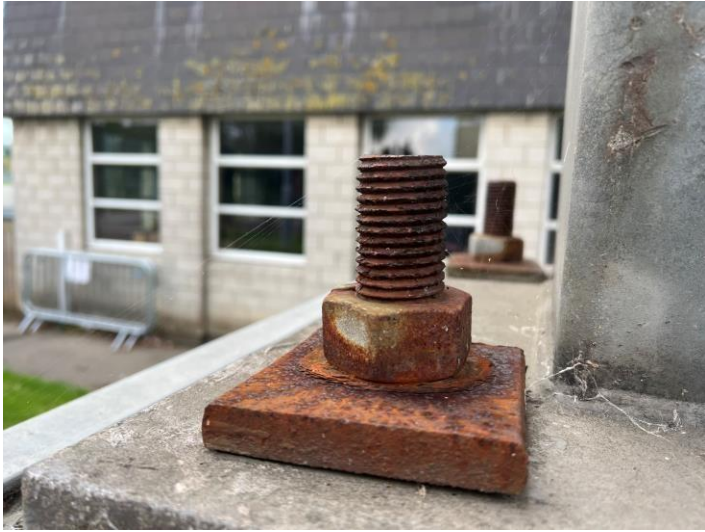
Figure 22 – Corrosion to HD bolt and washer

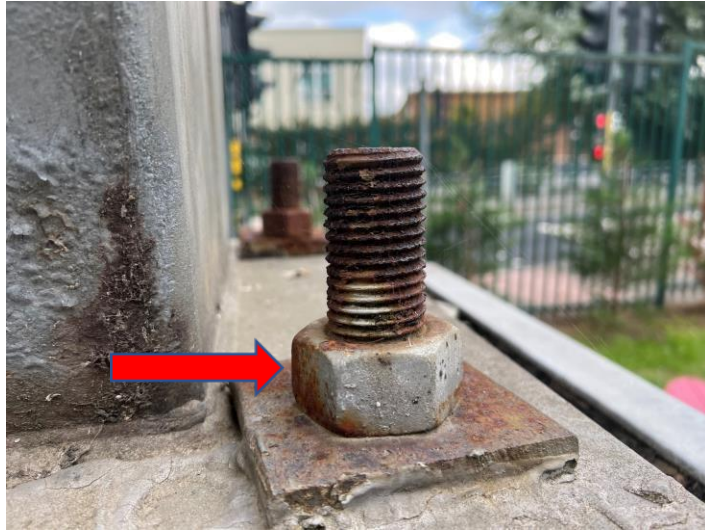
Figure 25: Moderate corrosion

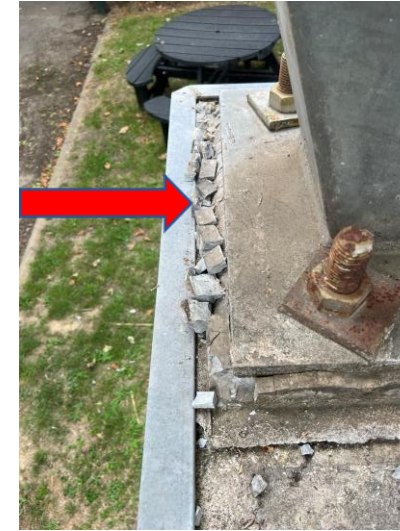
Figure 26: Degradation of grout to baseplate

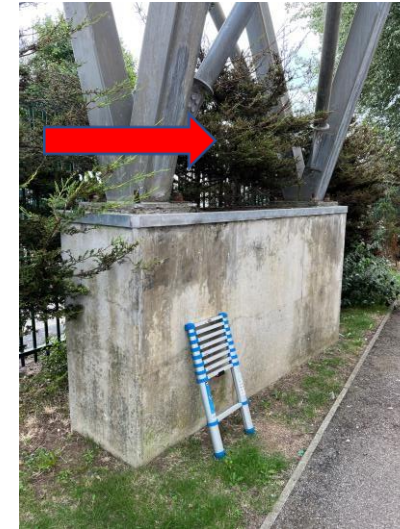
The West block foundation appeared to require remedial works in order for the block and associated fixings to be in the expected condition see (West Block section photos 29-38). Light cracking to the grout is evident as detailed in figure 29 at approx. 1mm in width. Vegetation is also encroaching on to the block and this should be cut back to prevent excessive weathering to the block. Minor staining to the block is evident, but not significant to affect the long-term condition. There is a missing holding bolt and washer/packer which should be replaced. There is moderate corrosion to all bolts, threads and washers. It was also noted that some washers/packers are not driven home and level to the block head. There is minor corrosion evident to the baseplates.

Figure 29: Cracking to grout

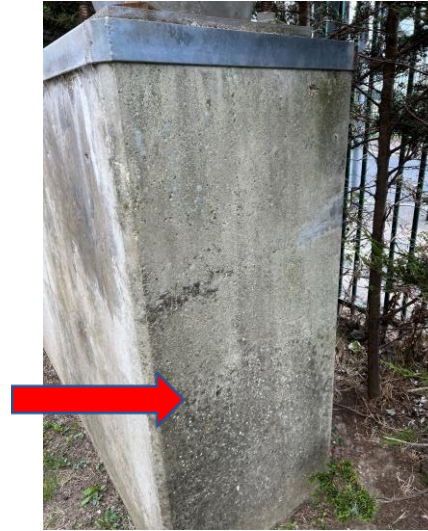
Figure 30: West block vegetation

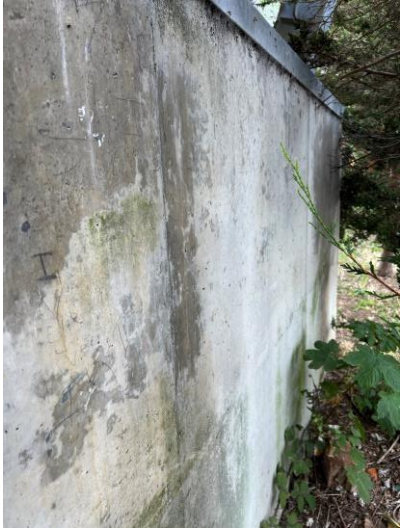
Figure 32: Light staining to West Block

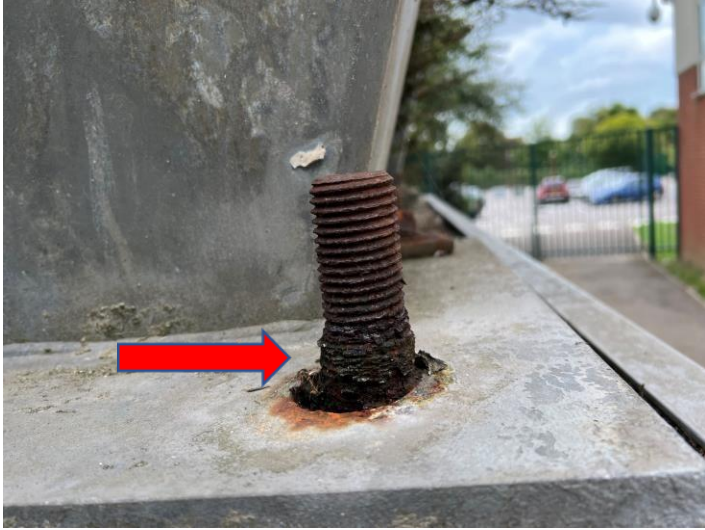
Figure 38: Moderate to significant corrosion to thread

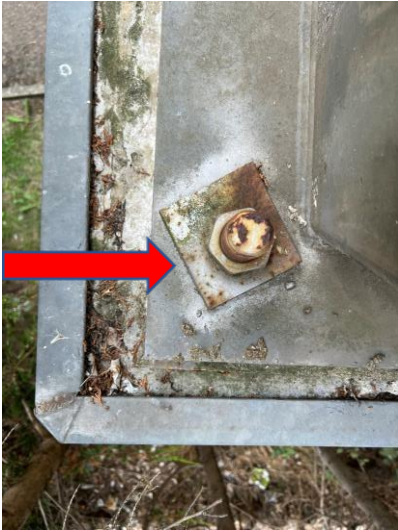
Figure 40: Moderate corrosion

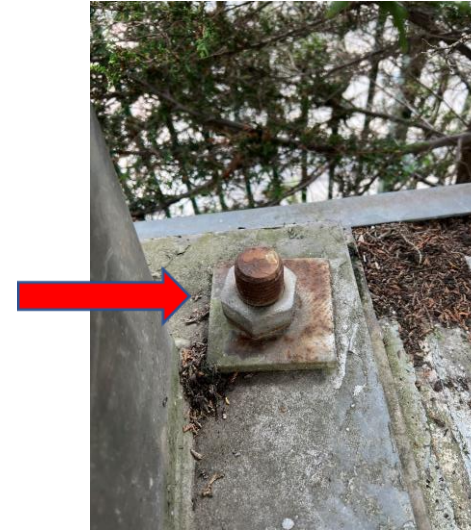
Figure 41: Moderate corrosion

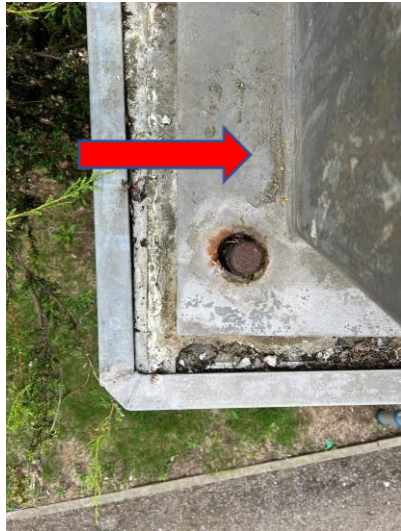
Figure 43: Light pitting to baseplate

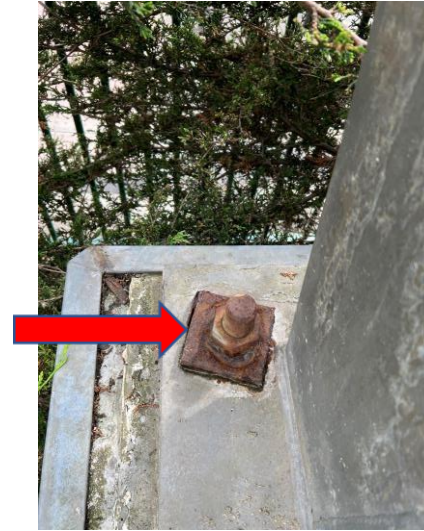
Figure 44: Moderate corrosion

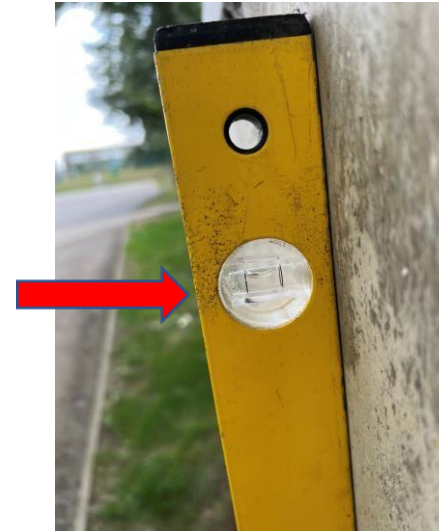
Figure 57 – Very minor listing

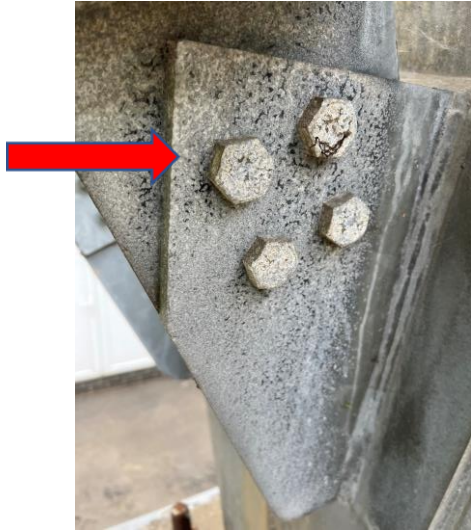
There is light moderate corrosion to the hollow box section piers which is consistent across all piers which requires attention in order to address the long-term condition of the structure (See Pier & Struts Section Photos 1-38). Pitting can be seen in photos 3,4,7,8,14,15,31,32,34,37,38. This requires treatment and repair in order to prevent degradation of the sections further.

Fig 3: Pitting to connection plate

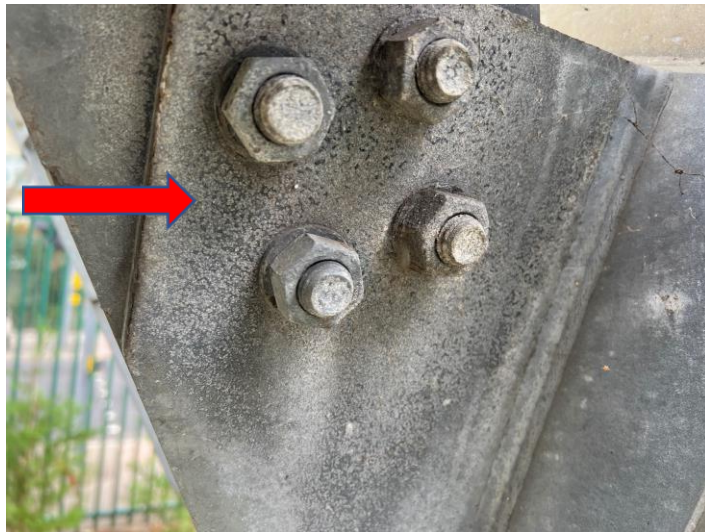
Fig 7: Pitting & light corrosion

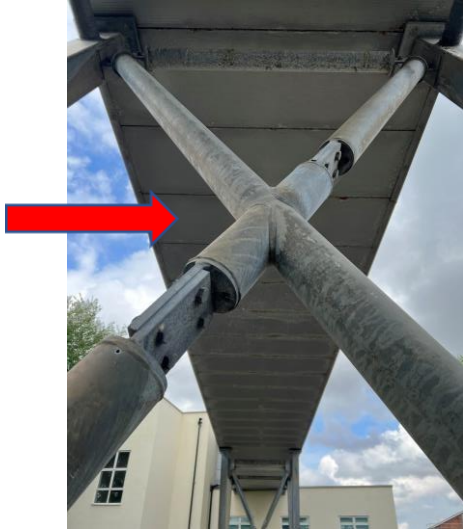
Fig 8: Pitting

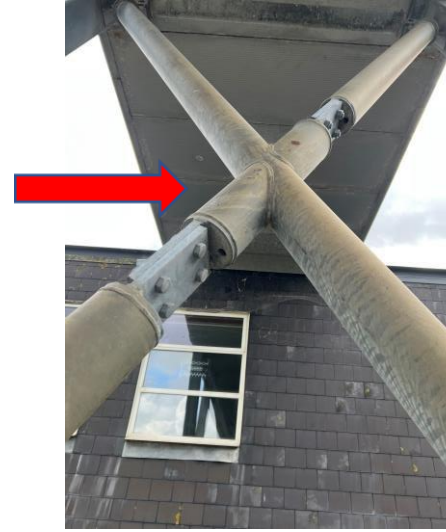
Fig 9: Light corrosion to bracing strut

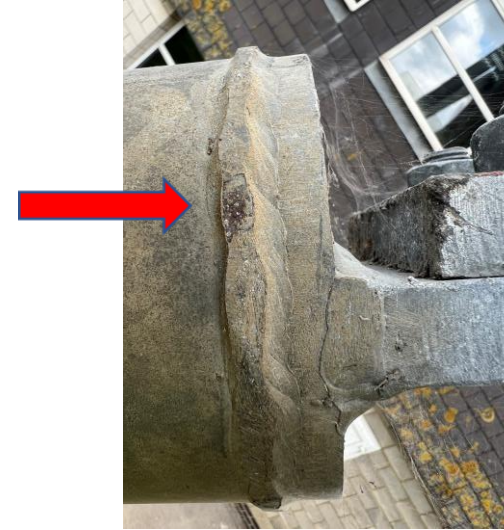
Fig 12: Light corrosion

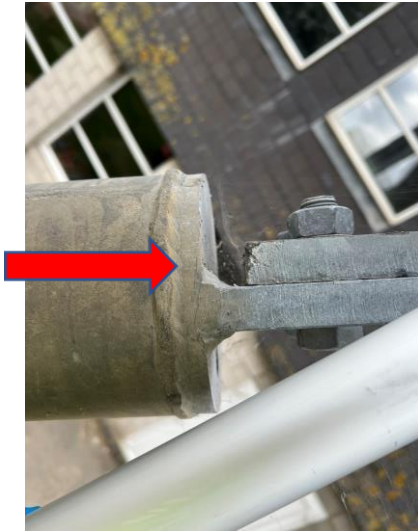
Fig 13: Light corrosion

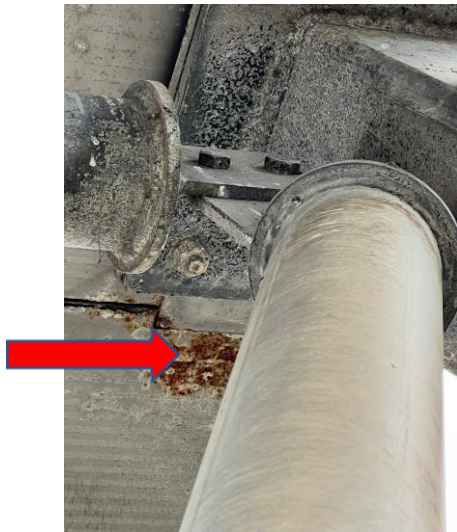
Fig 14: Corrosion to struts

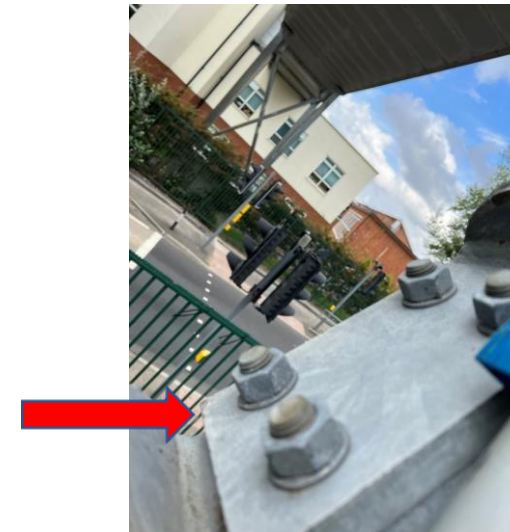
Fig 15: Moderate corrosion

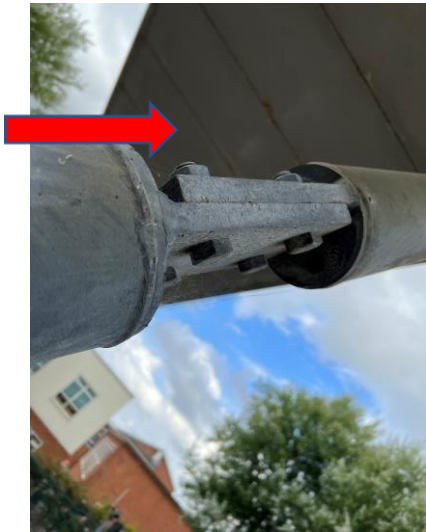
Fig 17: Light corrosion

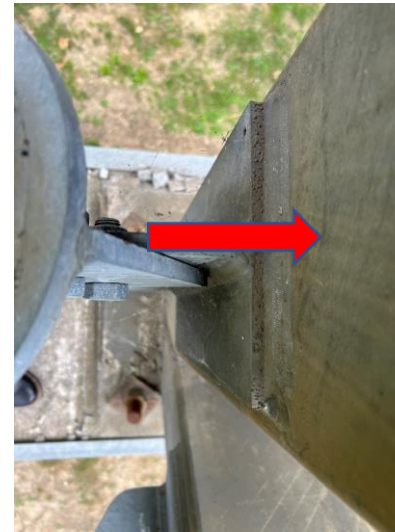
Fig 18: Light corrosion

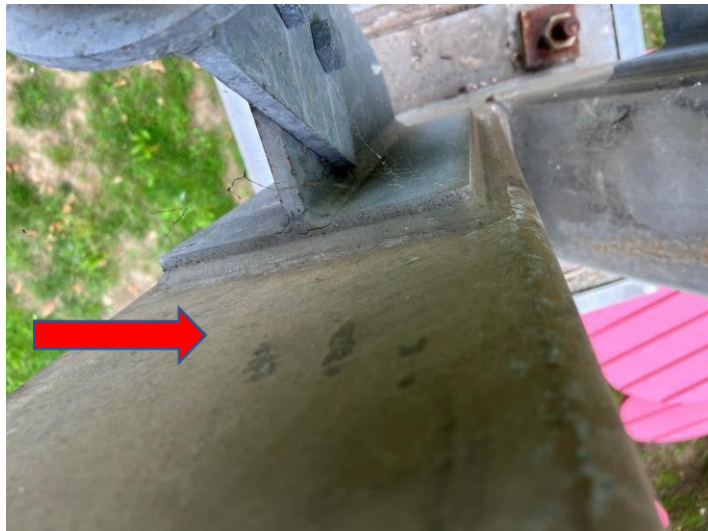
Fig 19: Light corrosion

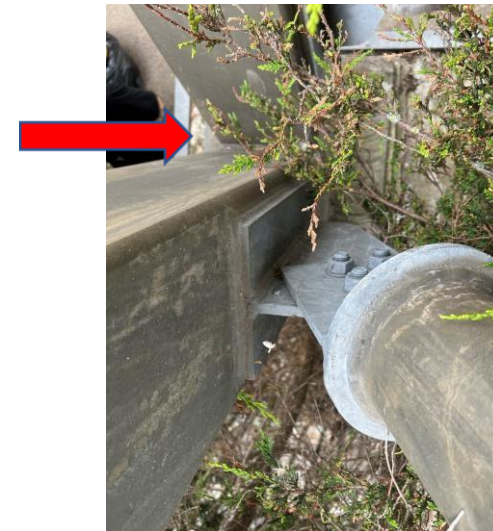
Fig 20: Light corrosion minor displacement

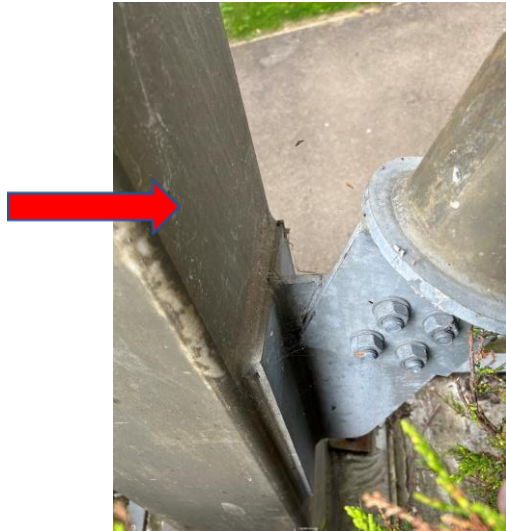
Fig 21: Light corrosion

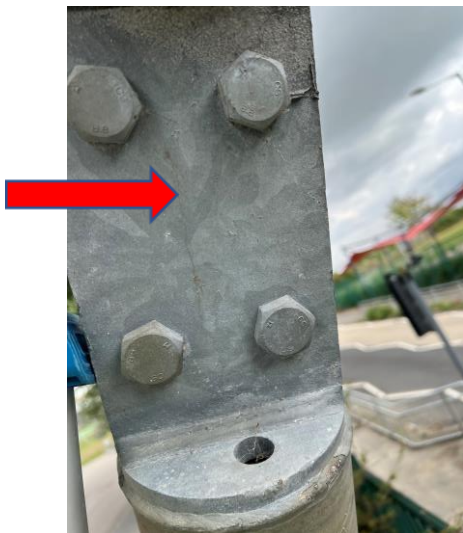
Fig 25: Strut junction light damage

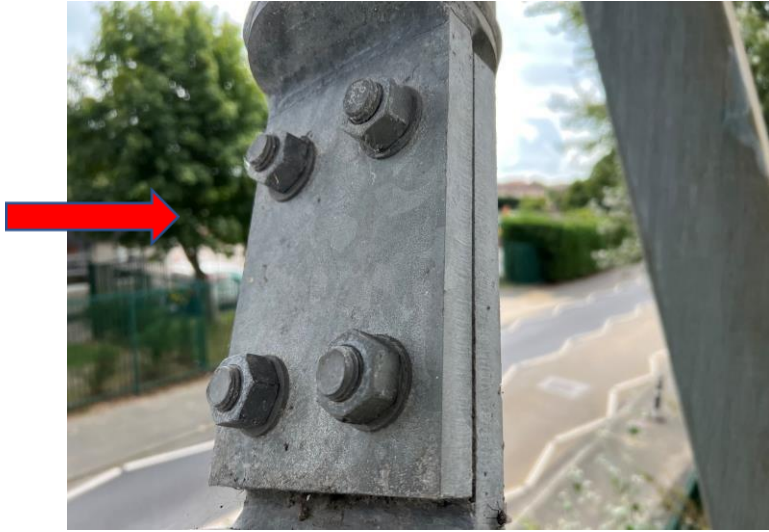
Fig 28: Strut junction light damage

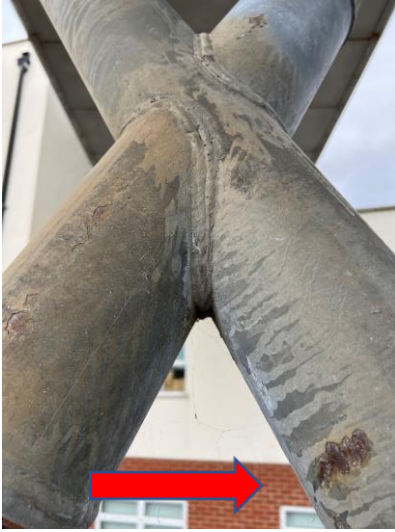
Fig 31: Moderate corrosion & pitting

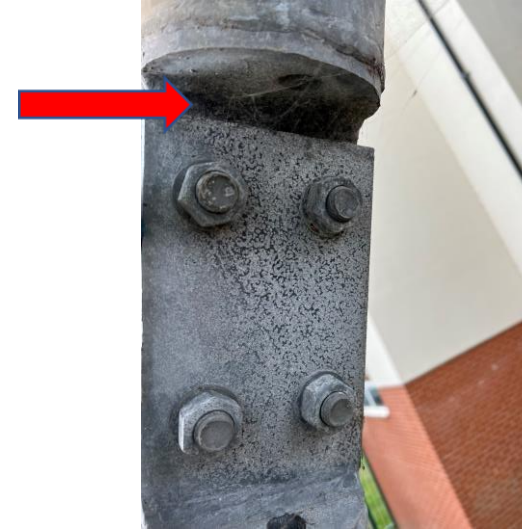
Fig 32 : Moderate corrosion & pitting

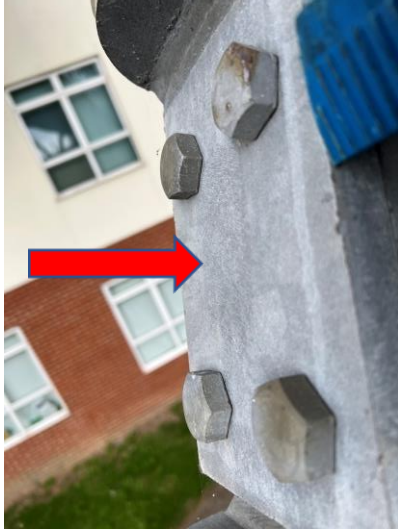
Fig 34: Pitting & corrosion

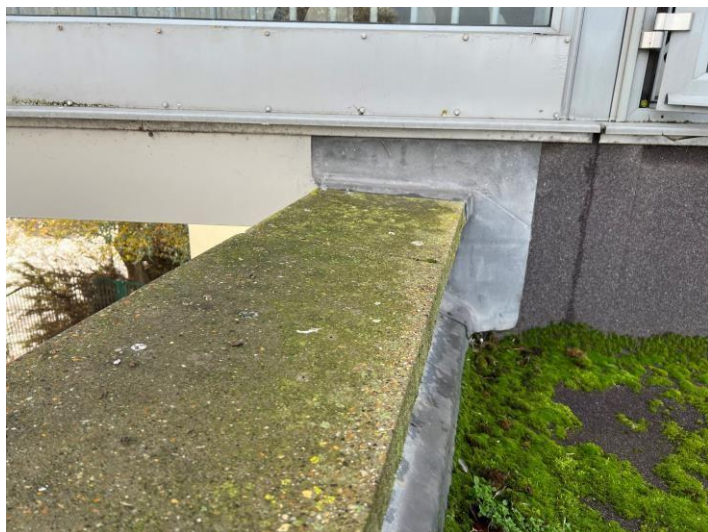
Figure 1: Lack of edge protection

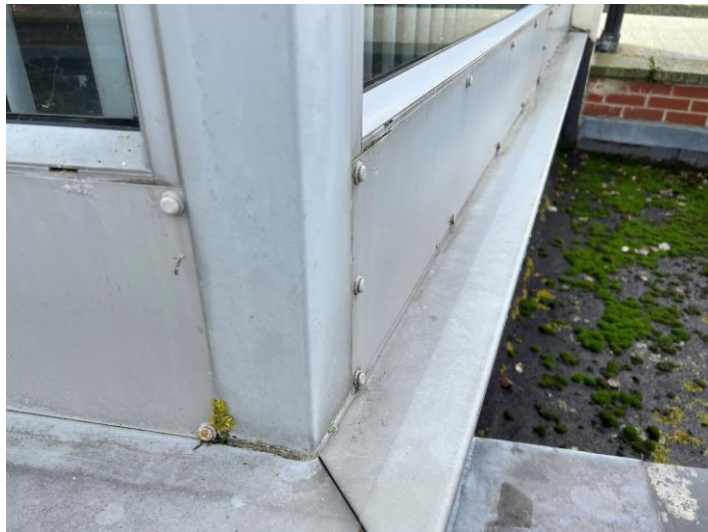
Figure 5: Beam dressing West side aft

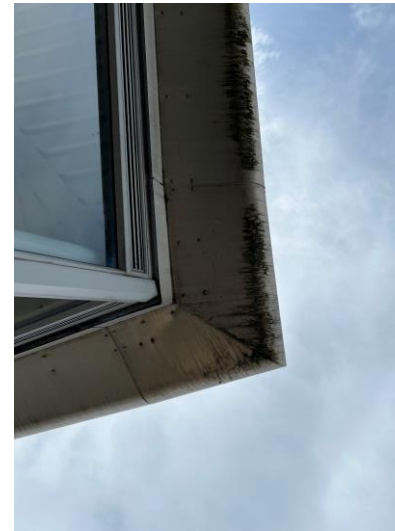
Figure 6: Light wear to sill West

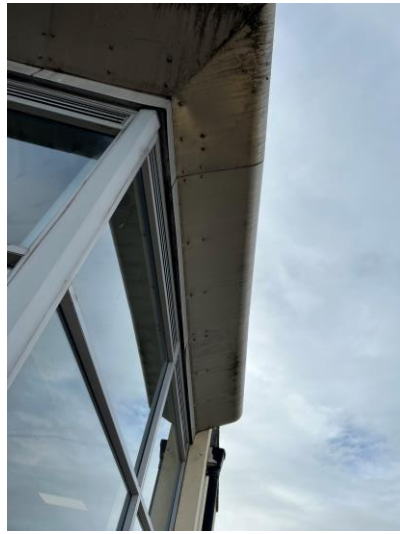
Figure 8: Staining to soffit West

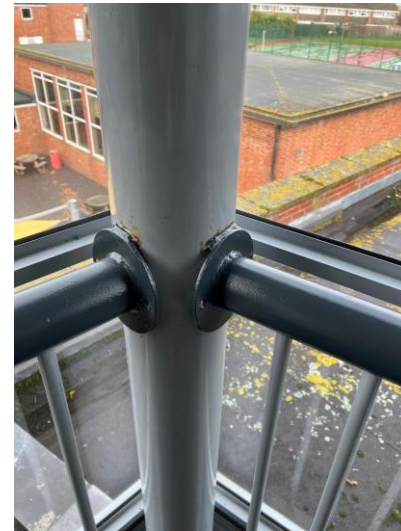
Figure 15: Upright mid section light corrosion

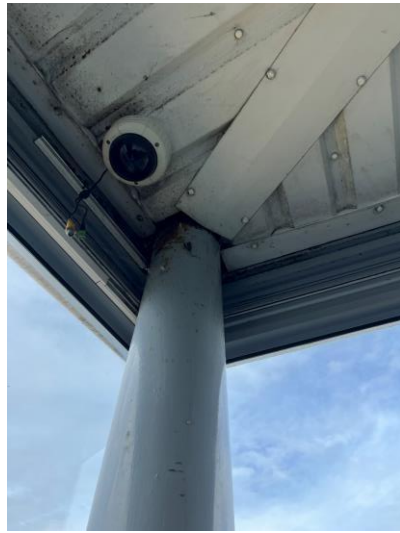
Figure 16: Upright light corrosion roof connection

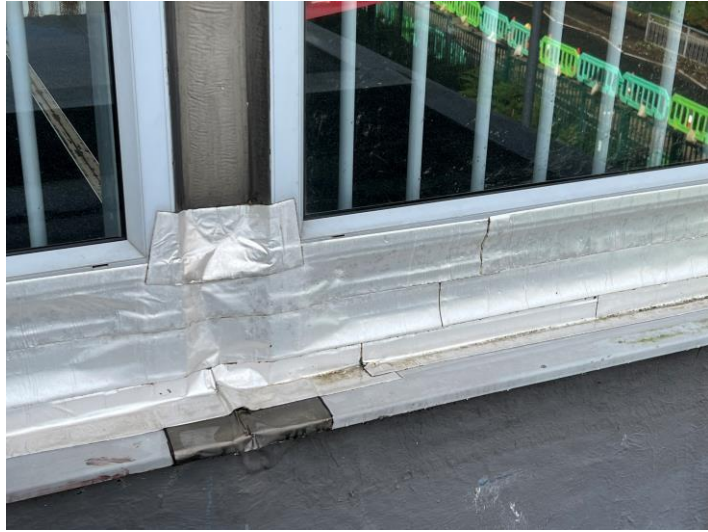
Image 7: Flash band to external cladding

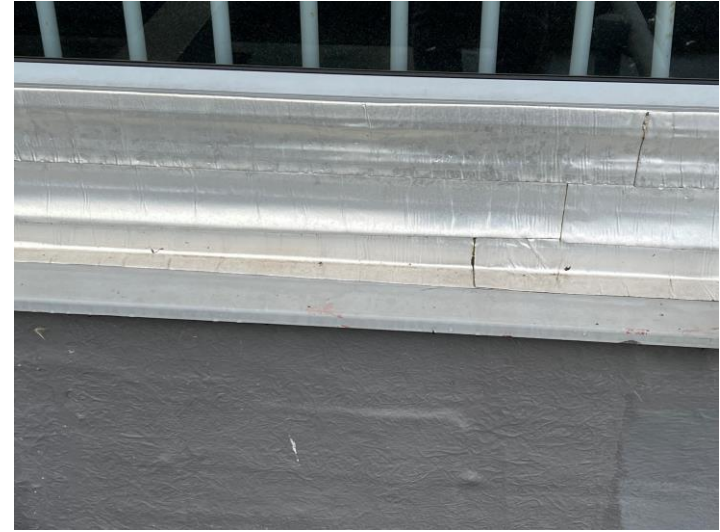
Image 8; Flash band to external cladding

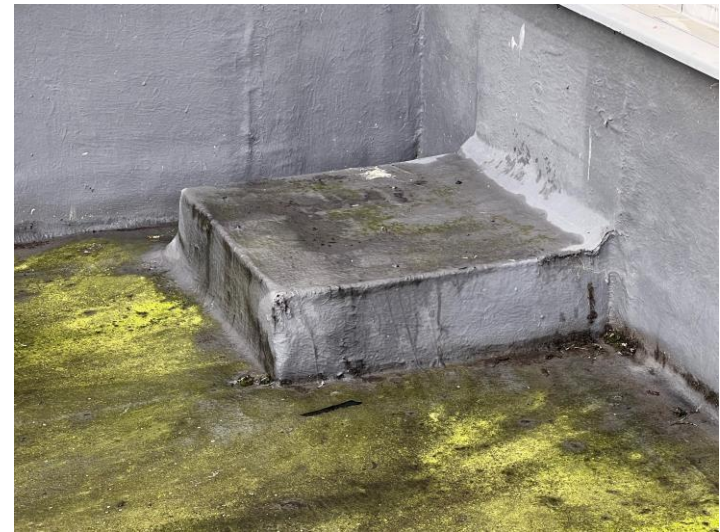
Image 9: Flash band to external cladding

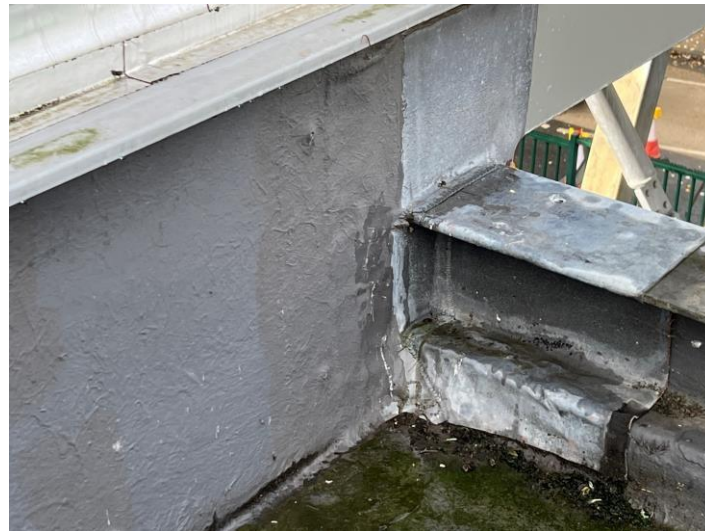
Image 11: Moss to connection

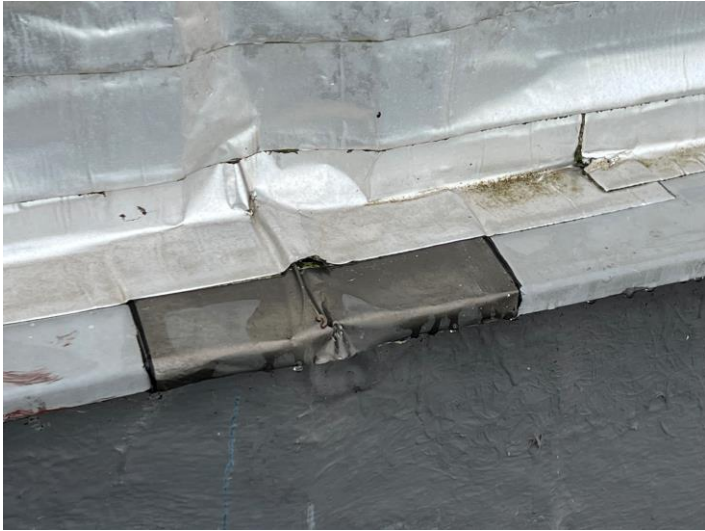
Image 13: Flash band

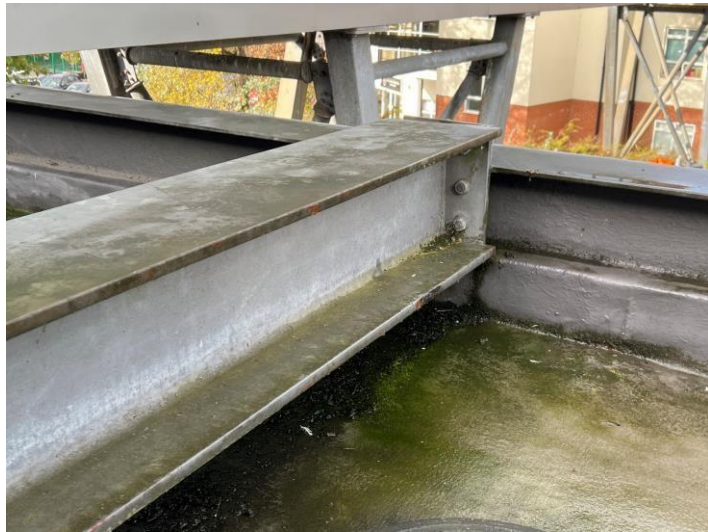
Image 16: Lack of edge protection

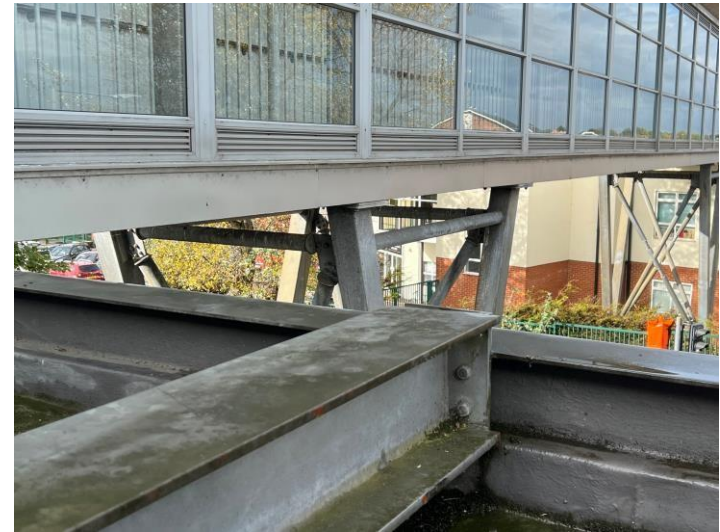
Image 17: Moss to area

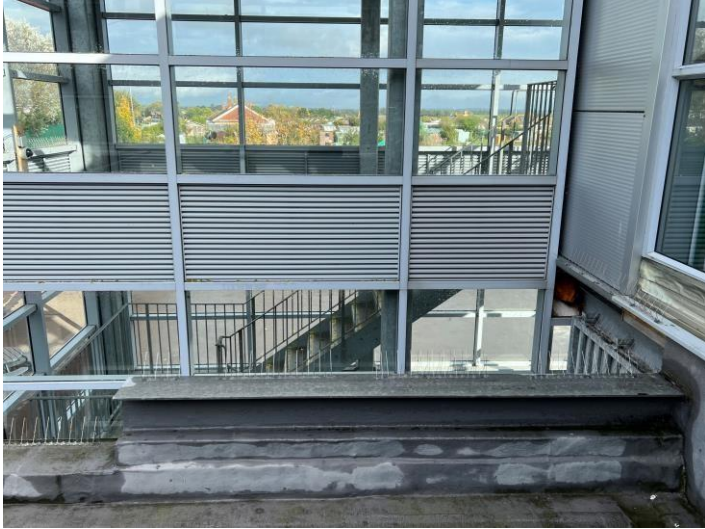
Image 22: Void & missing bird control

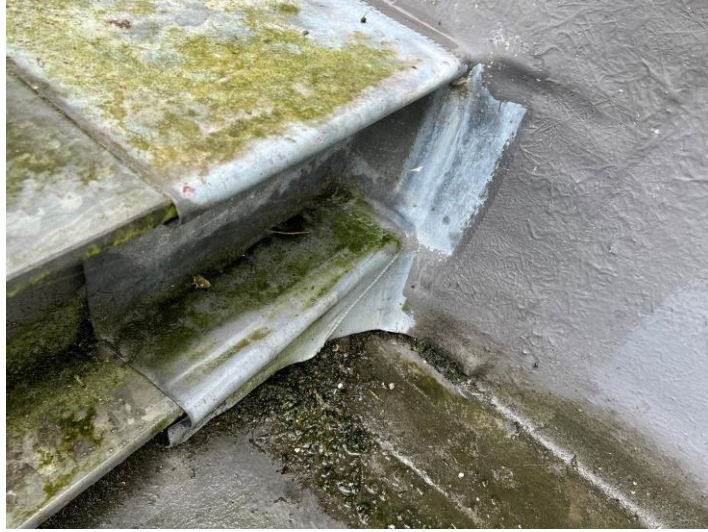
Image 24: Moss to area

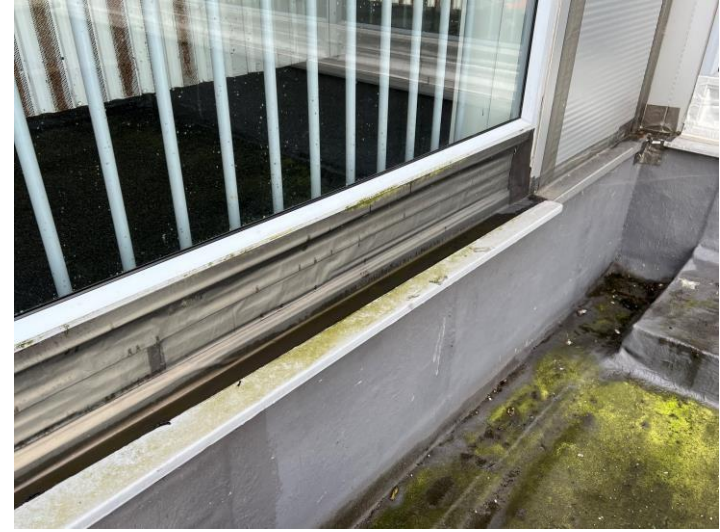
Image 25: Moss to area

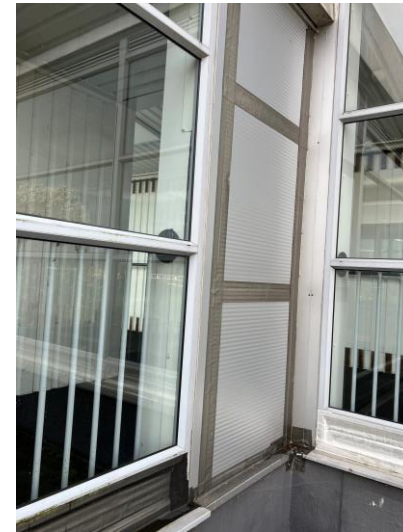
Image 27: Poor repairs

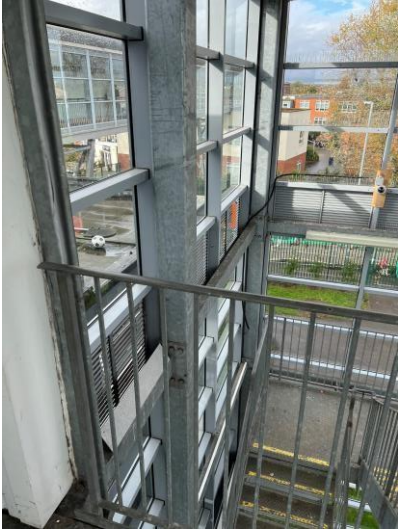
Image 28: Poor repairs

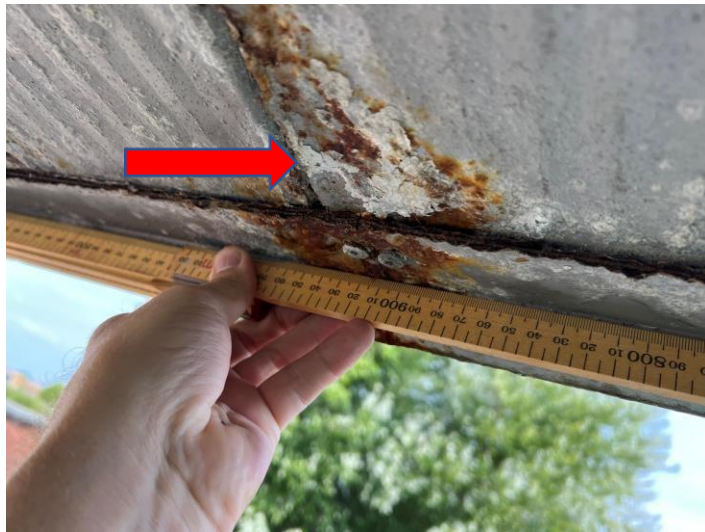
Fig 3 Heavy corrosion at joint

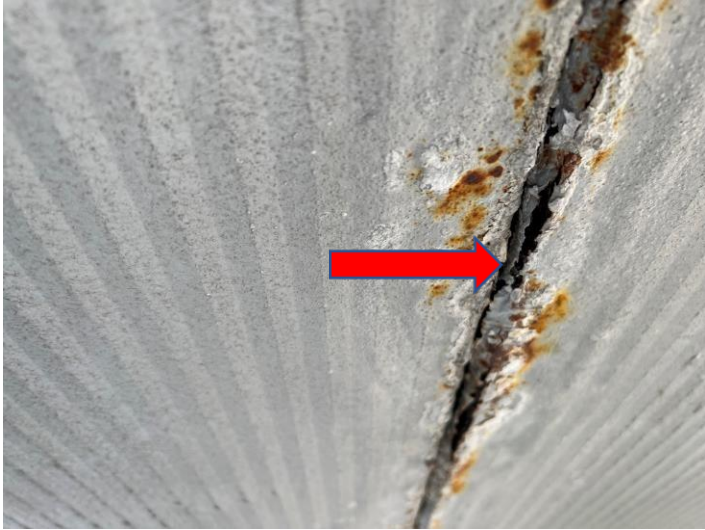
Fig 4 Heavy delamination

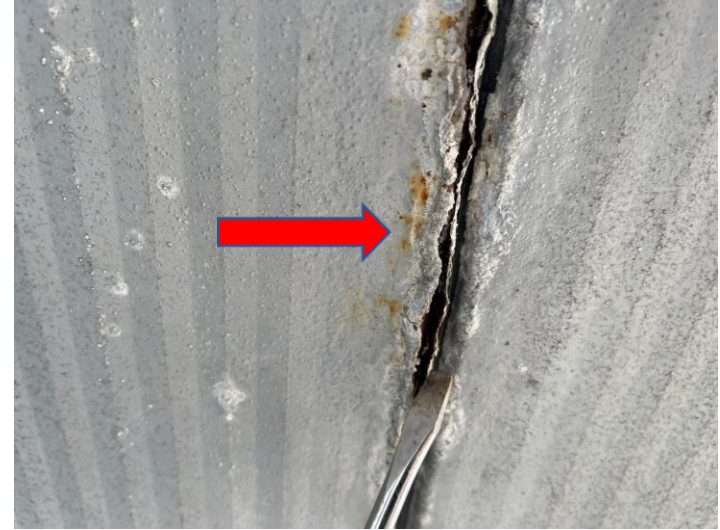
Fig 5 Delamination

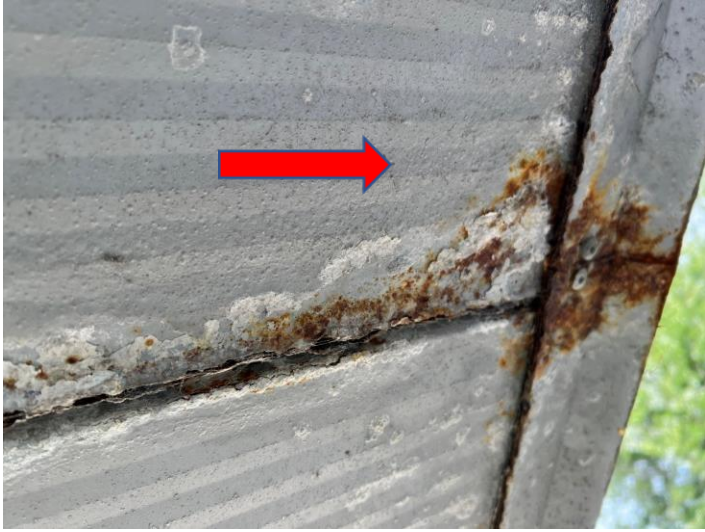
Fig 6 Delamination

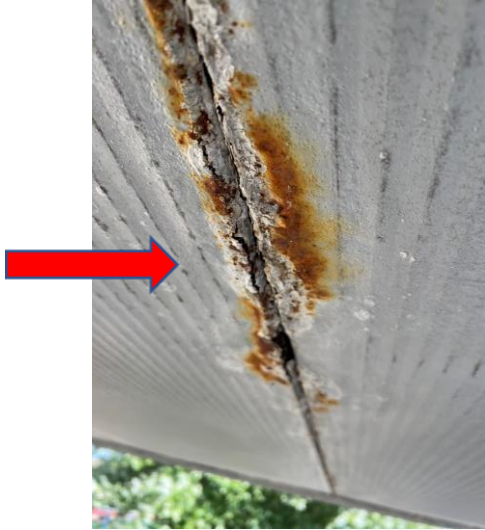
Fig 8 Light corrosion & pitting

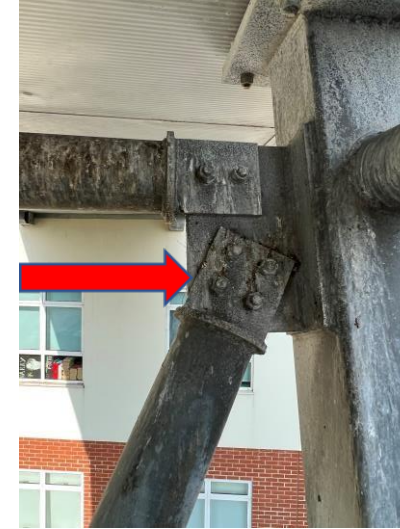
Fig 11 Surface corrosion

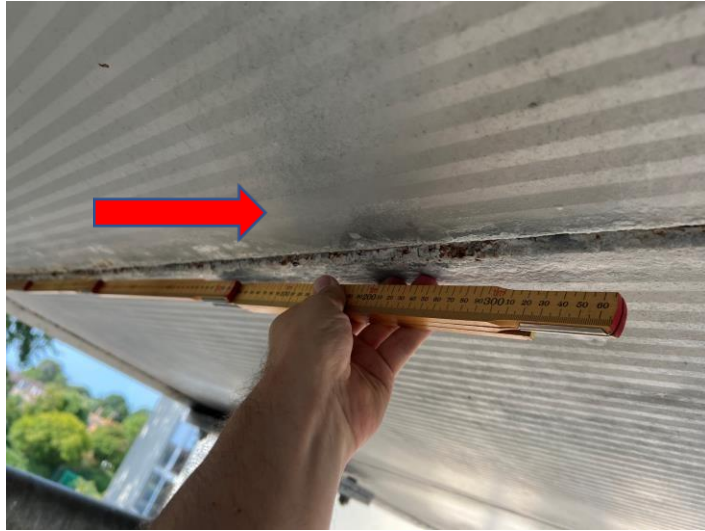
Fig 15 Moderate corrosion

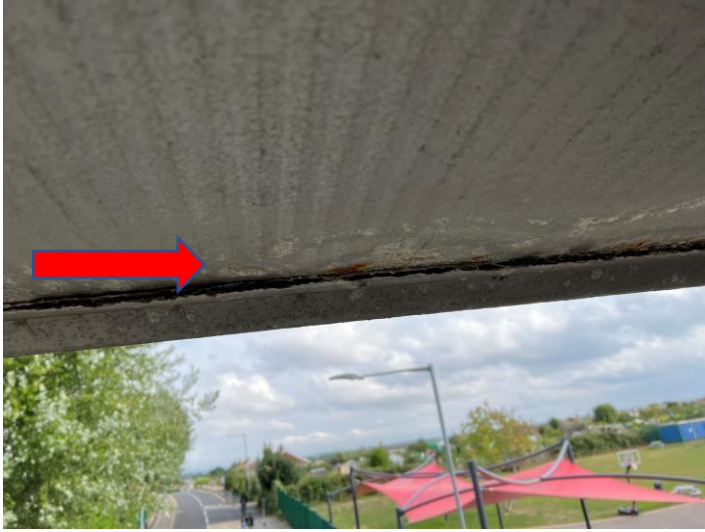
Fig 18 Heavy corrosion

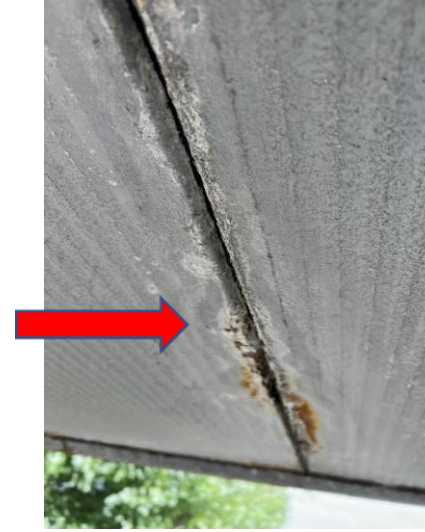
Fig 19 Heavy corrosion

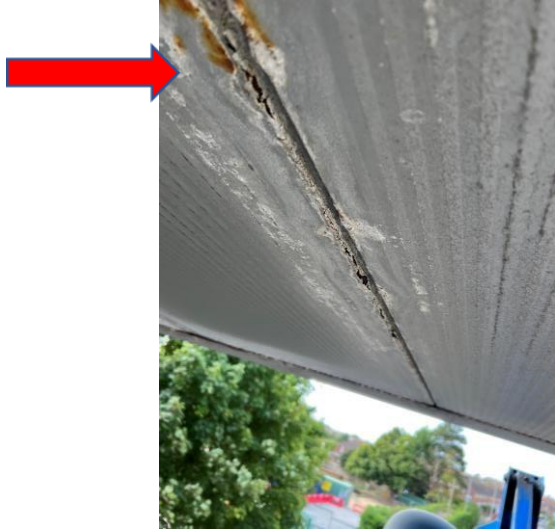
Fig 20 Heavy corrosion

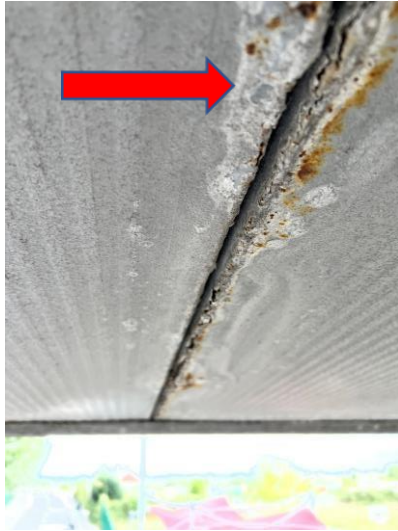
Fig 26 Delamination

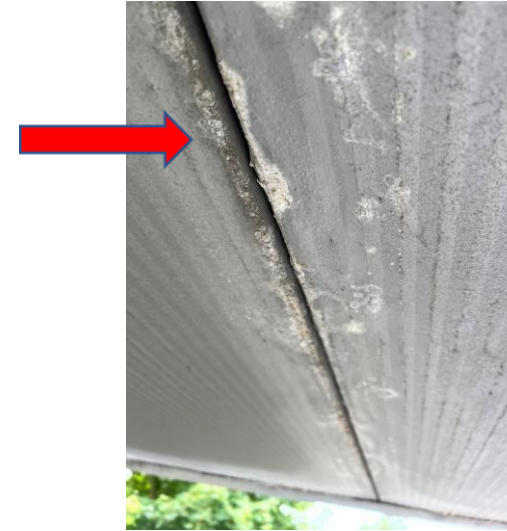
Fig 27 Delamination

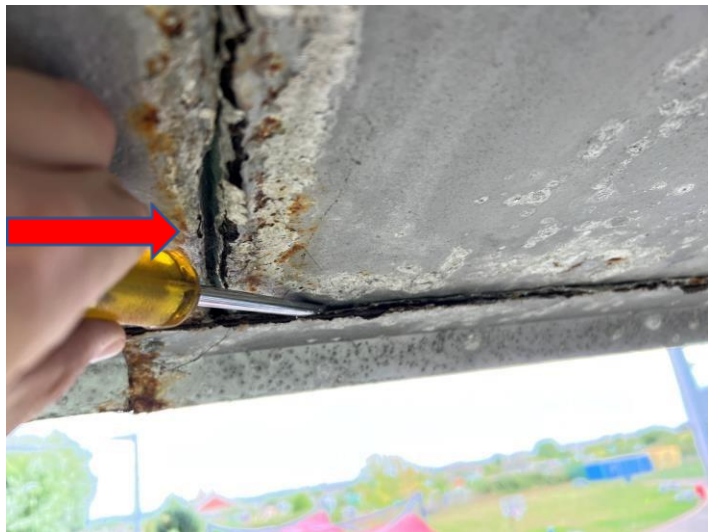
Fig 28 Pitting

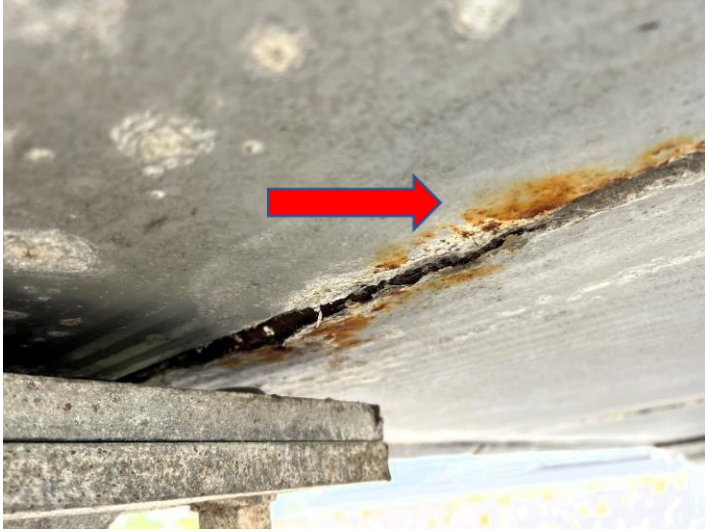
Fig 30 Heavy corrosion

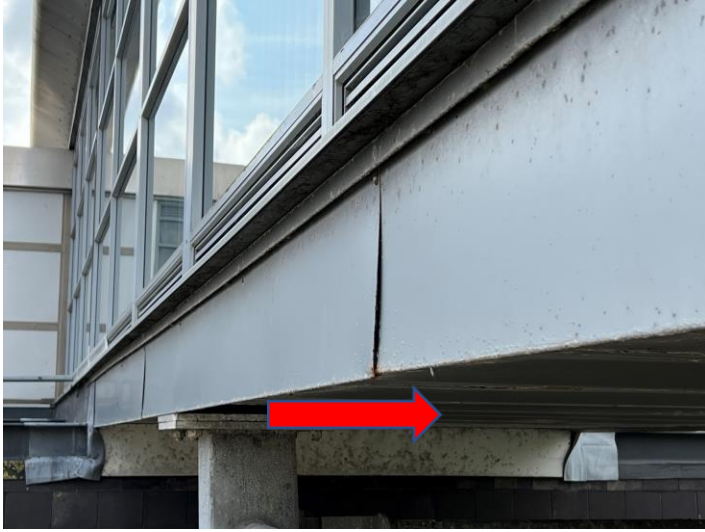
Fig 33 Corrosion at all panel junctions

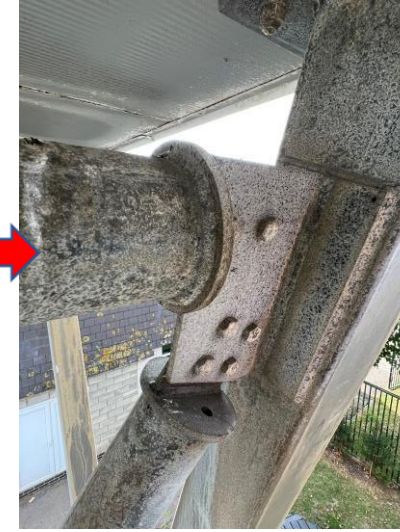
Fig 34 Moderate surface corrosion
