**Inspection of: Link Bridge
St. Catherine's College
Priory Road
Eastbourne
BN23 7BL**

Project No: 778
Document Title: Special Inspection
Document No: CRM060619778
Revision: Rev 4.
Date: Tuesday 30th August 2022

Principal Inspection of Link Bridge – St Catherine’s College

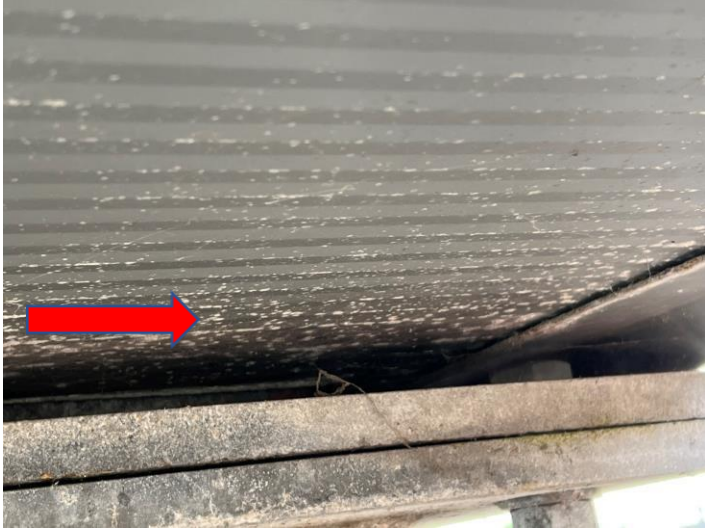
Fig 35 Surface pitting

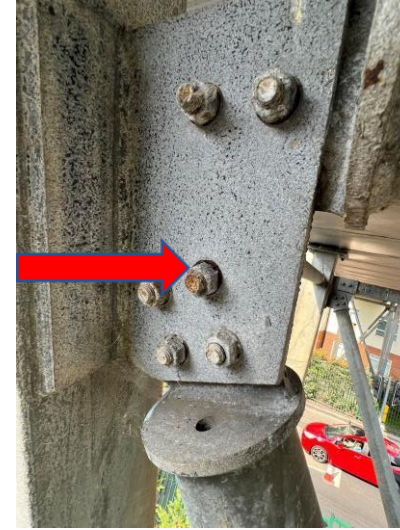
Fig 36 Moderate corrosion & washer corrosion

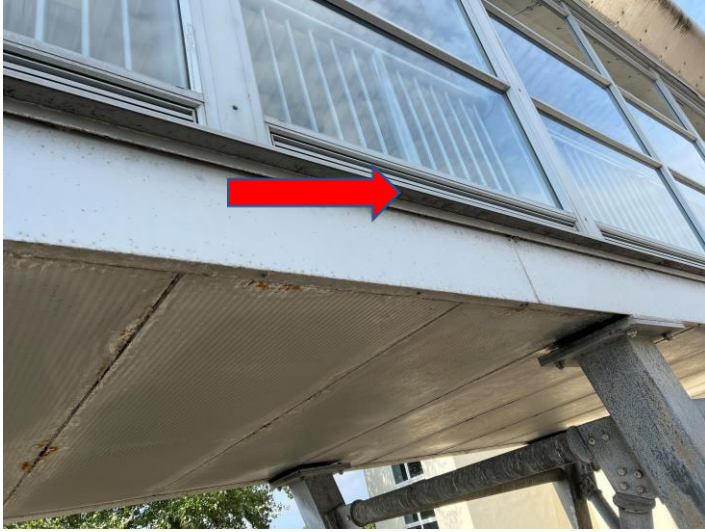
Fig 7 Moderate pitting

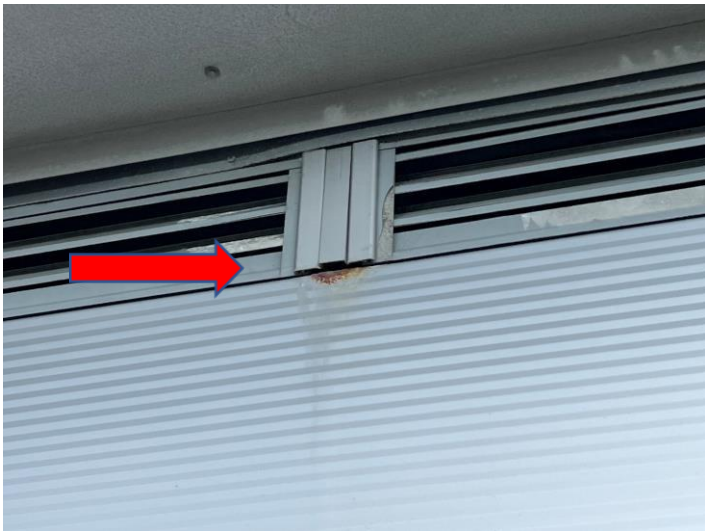
Fig 13 Light corrosion

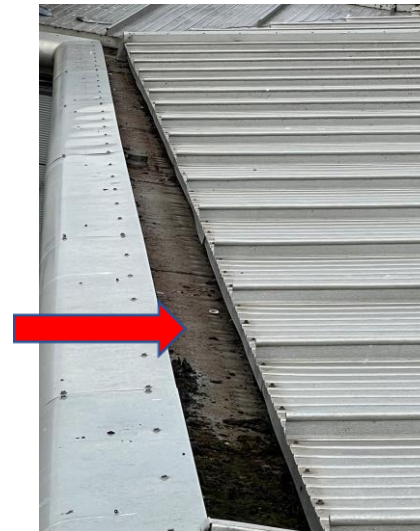
Fig 1 Staining to soffit

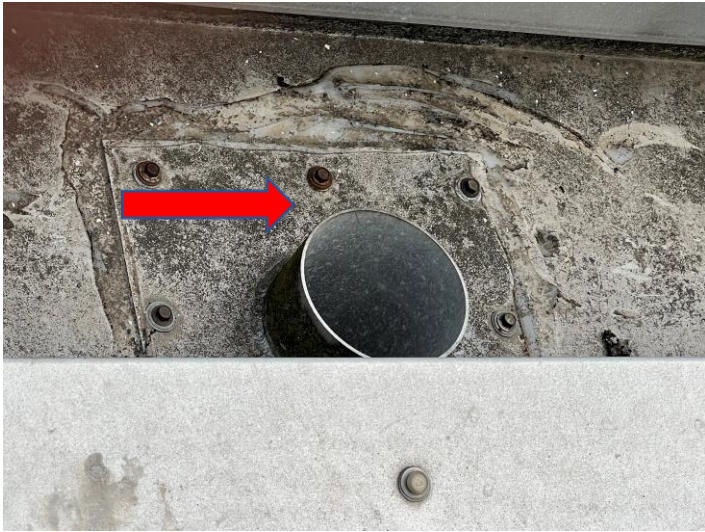
Fig 15 Moderate corrosion

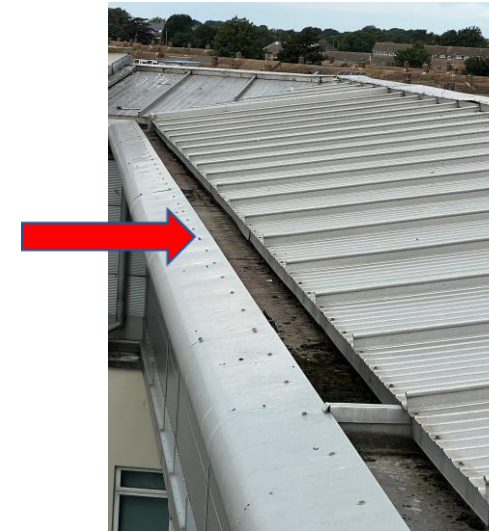
Fig 16 Debris to channel

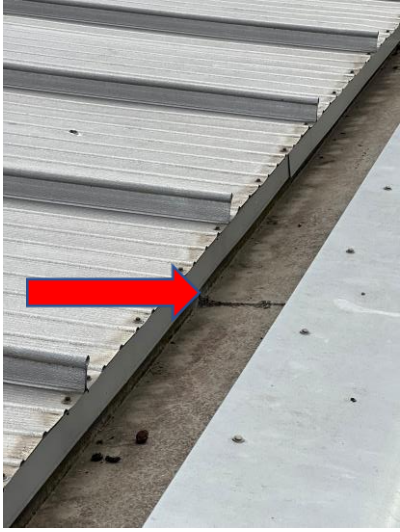
Fig 18 Lack of fall to channel

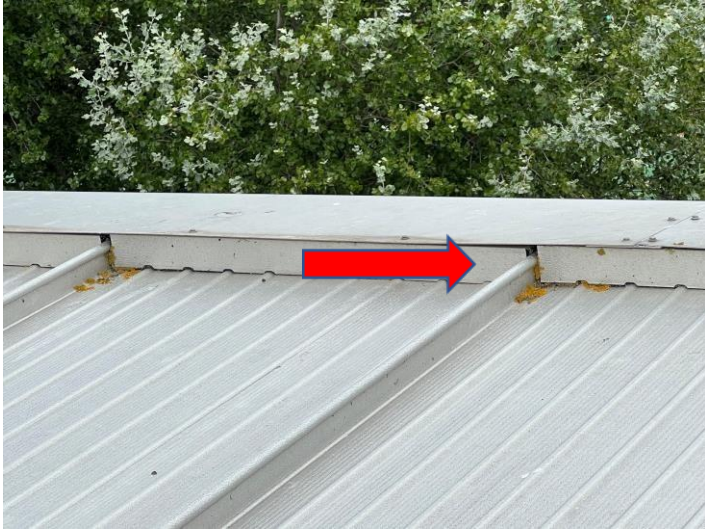
Fig 19 Laps to channel

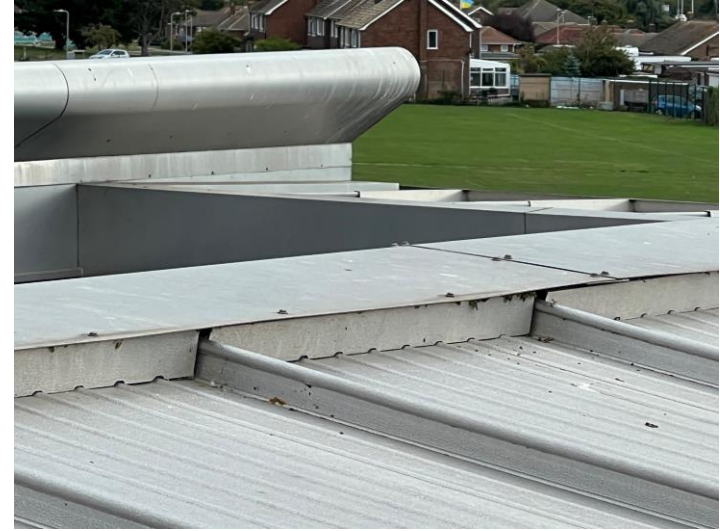
Fig 20 Infill panels poorly fitted

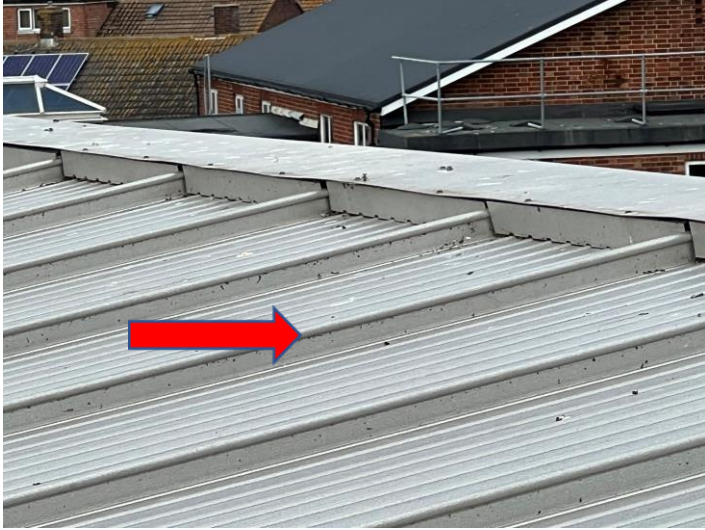
Fig 22 Gaps to infill panels

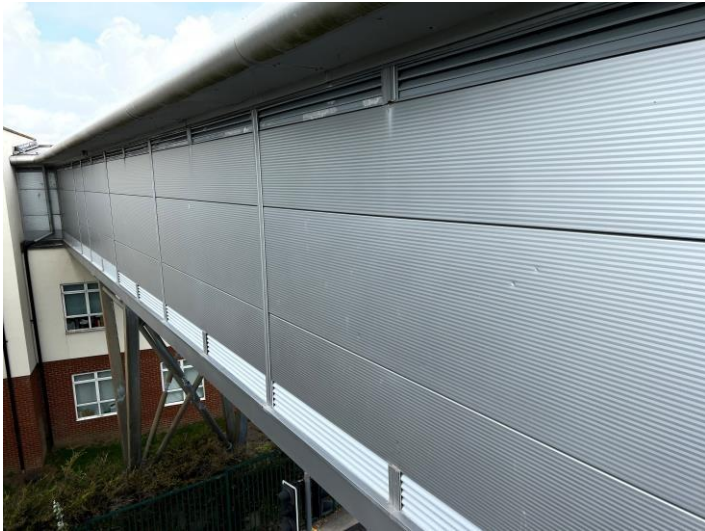
Fig 23 Rolled joints

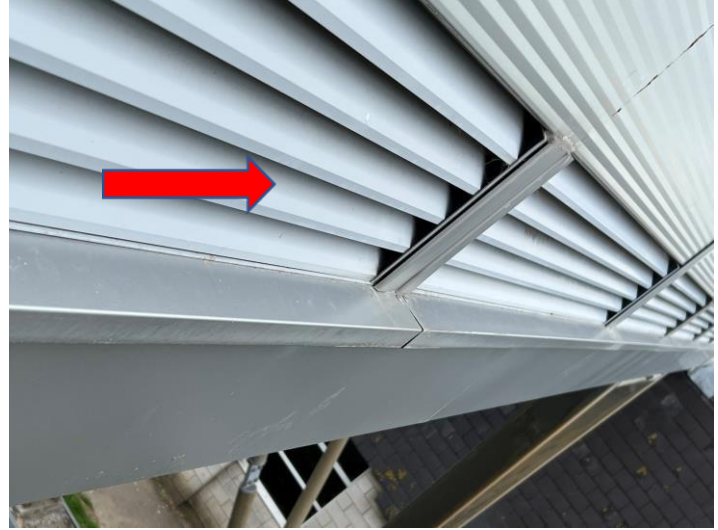
Fig 28 Light pitting to cover fillet
