Beverley Town Council New Town Hall Project Manager

TENDER PACK

Condition Report

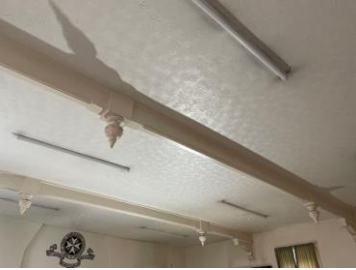
Inspection Date	Surveyor	Survey Type	Floor	Analysis	
	11/11/2022	Robin Walker	Refurbishment	Ground Floor	NAD	
	Building	Room	Description	Extent		
	St Johns Ambulance	Main hall 008	Ceiling	110 m²		
	Sample No / Inspection Ref	Product Type	Surface Treatment	Damage Extent	Material Risk Score	Priority Total
	A-20386 / S001 203527	Textured Coating	N/A	N/A	0	N/A
	Normal Occupant Activity	Likelihood of Disturbance	Human Exposure Potential	Maintenance Activity	Risk Rating	Total Assessment Score
N/A					N/A	N/A
Recommendations / Actions						
No action required						
Surveyor Comments					Review Date	N/A
Textured coating to ceiling of main hall

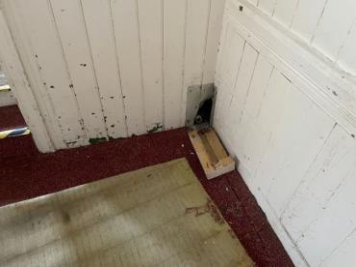
Inspection Date	Surveyor	Survey Type	Floor	Analysis	
	11/11/2022	Robin Walker	Refurbishment	Ground Floor	NAD	
	Building	Room	Description	Extent		
	St Johns Ambulance	Main hall 008	Pipework	Small amounts m ²		
	Sample No / Inspection Ref	Product Type	Surface Treatment	Damage Extent	Material Risk Score	Priority Total
	A-20386 / S003 203502	Pipe Lagging (Fibrous)	N/A	N/A	0	N/A
	Normal Occupant Activity	Likelihood of Disturbance	Human Exposure Potential	Maintenance Activity	Risk Rating	Total Assessment Score
	N/A	N/A	N/A	N/A	N/A	N/A
Recommendations / Actions	No action required					
Surveyor Comments	Thermal insulation to metal pipework within corner boxing				Review Date	N/A

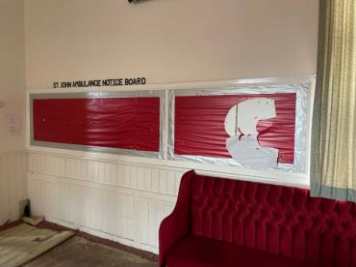
Inspection Date	Surveyor	Survey Type	Floor	Analysis	
	11/11/2022	Robin Walker	Refurbishment	Ground Floor	NAD	
	Building	Room	Description	Extent		
	St Johns Ambulance	Main hall 008	Wall	4 m ²		
	Sample No / Inspection Ref	Product Type	Surface Treatment	Damage Extent	Material Risk Score	Priority Total
	A-20386 / S004 203504	Insulating Board	N/A	N/A	0	N/A
	Normal Occupant Activity	Likelihood of Disturbance	Human Exposure Potential	Maintenance Activity	Risk Rating	Total Assessment Score
	N/A	N/A	N/A	N/A	N/A	N/A
Recommendations / Actions	No action required					
Surveyor Comments	Insulation board notice board				Review Date	N/A

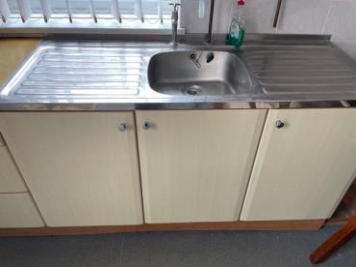
Inspection Date	Surveyor	Survey Type	Floor	Analysis	
	11/11/2022	Robin Walker	Refurbishment	Ground Floor	NAD	
	Building	Room	Description	Extent		
	St Johns Ambulance	Kitchen 009	Sink unit	3 no		
	Sample No / Inspection Ref	Product Type	Surface Treatment	Damage Extent	Material Risk Score	Priority Total
	A-20386 / S005 203510	Bituminous pad to underside of sink	N/A	N/A	0	N/A
	Normal Occupant Activity	Likelihood of Disturbance	Human Exposure Potential	Maintenance Activity	Risk Rating	Total Assessment Score
	N/A	N/A	N/A	N/A	N/A	N/A
Recommendations / Actions	No action required					
Surveyor Comments	Bitumen acoustic sink pads beneath metal sink unit				Review Date	N/A

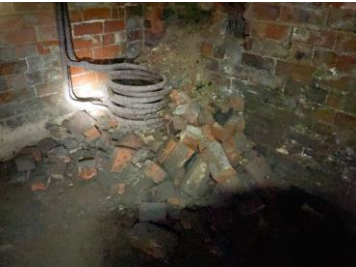
Inspection Date	Surveyor	Survey Type	Floor	Analysis	
	11/11/2022	Robin Walker	Refurbishment	Basement	NAD	
	Building	Room	Description	Extent		
	St Johns Ambulance	Store 016	Pipework	3 lin m		
	Sample No / Inspection Ref	Product Type	Surface Treatment	Damage Extent	Material Risk Score	Priority Total
	A-20386 / S008 203518	Pipe Lagging (Fibrous)	N/A	N/A	0	N/A
	Normal Occupant Activity	Likelihood of Disturbance	Human Exposure Potential	Maintenance Activity	Risk Rating	Total Assessment Score
	N/A	N/A	N/A	N/A	N/A	N/A
Recommendations / Actions	No action required					
Surveyor Comments	Thermal insulation residue to coil of metal pipework				Review Date	N/A

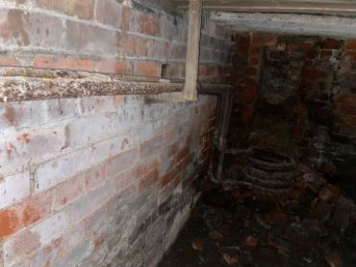
Inspection Date	Surveyor	Survey Type	Floor	Analysis	
	11/11/2022	Robin Walker	Refurbishment	Basement	NAD	
	Building	Room	Description	Extent		
	St Johns Ambulance	Store 016	Pipework	3 lin m		
	Sample No / Inspection Ref	Product Type	Surface Treatment	Damage Extent	Material Risk Score	Priority Total
	A-20386 / S009 203525	Pipe Lagging (Fibrous)	N/A	N/A	0	N/A
	Normal Occupant Activity	Likelihood of Disturbance	Human Exposure Potential	Maintenance Activity	Risk Rating	Total Assessment Score
	N/A	N/A	N/A	N/A	N/A	N/A
Recommendations / Actions	No action required					
Surveyor Comments	Thermal insulation residue to metal pipework				Review Date	N/A

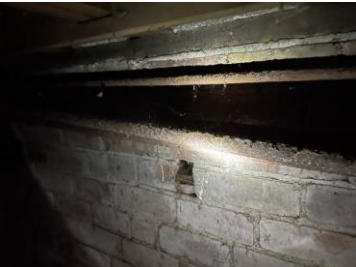
Inspection Date	Surveyor	Survey Type	Floor	Analysis	
	11/11/2022	Robin Walker	Refurbishment	Basement	NAD	
	Building	Room	Description	Extent		
	St Johns Ambulance	Store 016	Pipework	3 lin m		
	Sample No / Inspection Ref	Product Type	Surface Treatment	Damage Extent	Material Risk Score	Priority Total
	A-20386 / S010 203503	Pipe Lagging (Fibrous)	N/A	N/A	0	N/A
	Normal Occupant Activity	Likelihood of Disturbance	Human Exposure Potential	Maintenance Activity	Risk Rating	Total Assessment Score
	N/A	N/A	N/A	N/A	N/A	N/A
Recommendations / Actions	No action required					
Surveyor Comments	Thermal insulation residue to metal pipework				Review Date	N/A

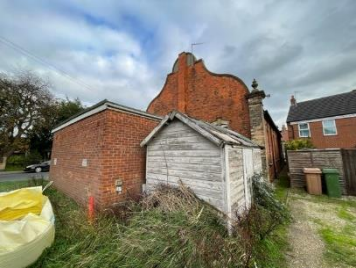
Inspection Date	Surveyor	Survey Type	Floor	Analysis	
	11/11/2022	Robin Walker	Refurbishment	Basement	NAD	
	Building	Room	Description	Extent		
	St Johns Ambulance	Externals 017	Roofs	30 m²		
	Sample No / Inspection Ref	Product Type	Surface Treatment	Damage Extent	Material Risk Score	Priority Total
	A-20386 / S011 203490	Bituminous Product	N/A	N/A	0	N/A
	Normal Occupant Activity	Likelihood of Disturbance	Human Exposure Potential	Maintenance Activity	Risk Rating	Total Assessment Score
	N/A	N/A	N/A	N/A	N/A	N/A
Recommendations / Actions	No action required					
Surveyor Comments	Bitumen felt coverings to external shed and garage roofs				Review Date	N/A

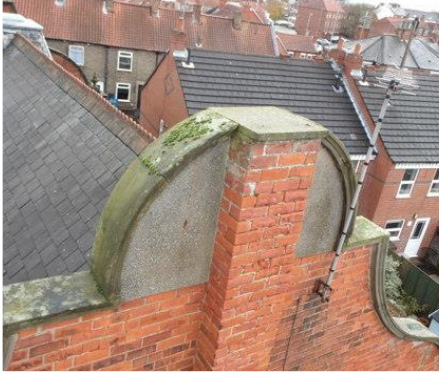
Chimney has been capped.

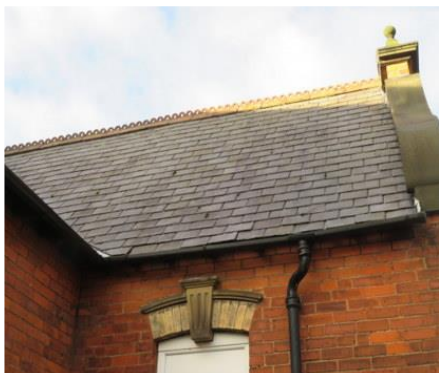
We observed some gaps in the cement pointing to the ridge tiles which require repointing.

Open joints to ridges to entrance roof.

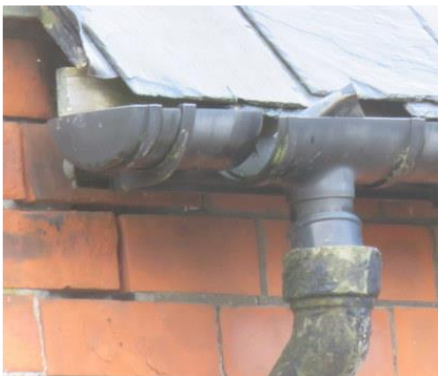
Gutters generally poor.

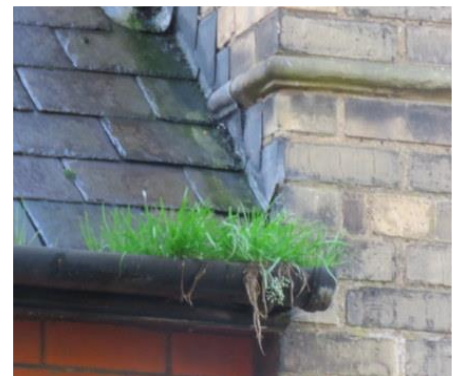
Gutter generally poor.

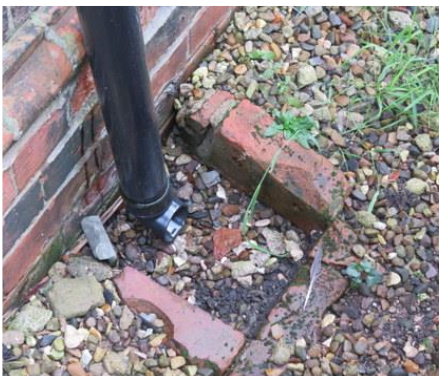
Soak aways to some rainwater
outlets.

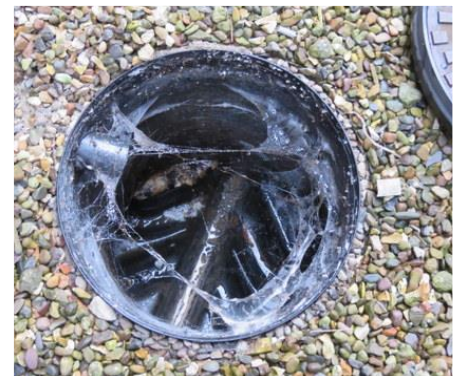
Rainwater outlet into new
development manhole to real.

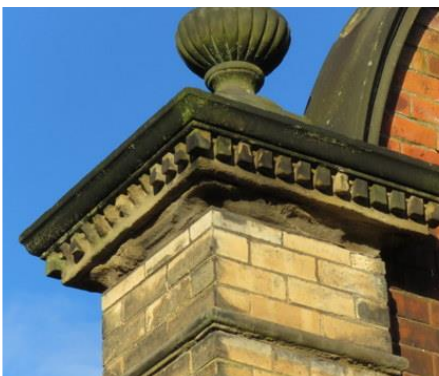
Eroding stone to most stone details.

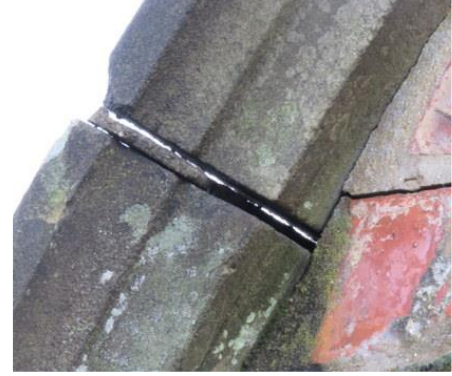
Open joints to gable parapet capping stones.

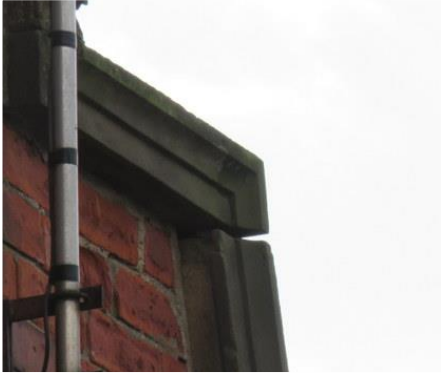
Open joints to gable parapet capping stones.

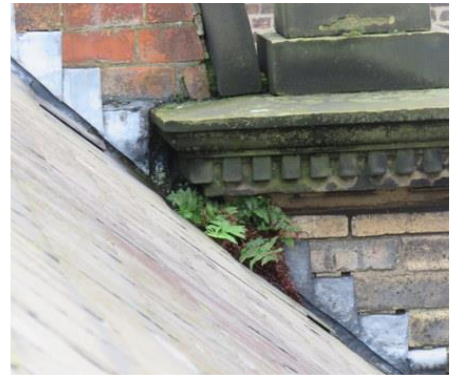
Plant growth in flashings behind gables.

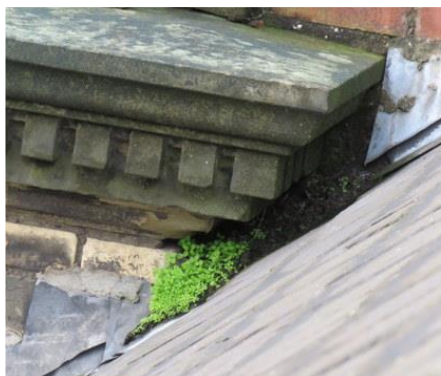
Plant growth in flashings behind gables.

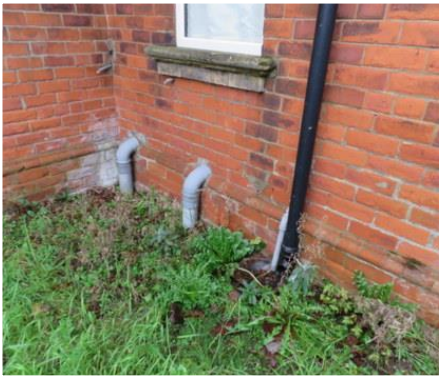
Foul drainage from W.C's.

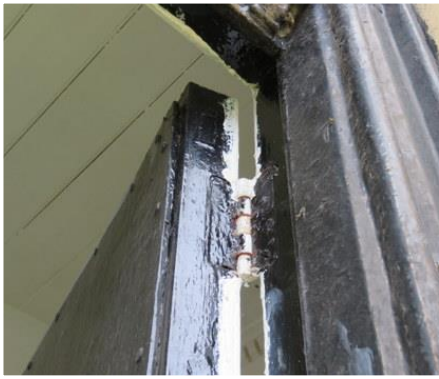
Panels fixed to original entrance doors.

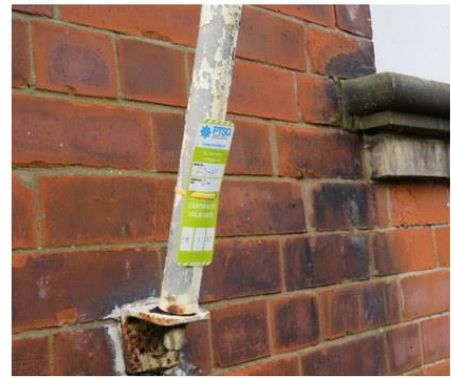
Steel flag pole, inspections carried out by 3rd party.

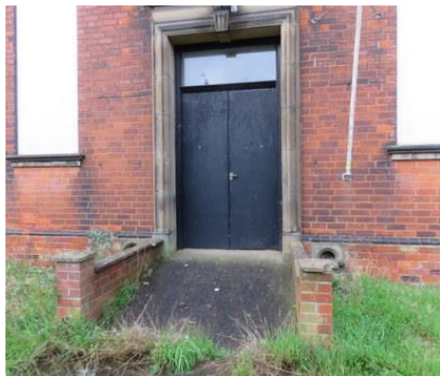
Steep ramp to Wilbert Lane entrance.

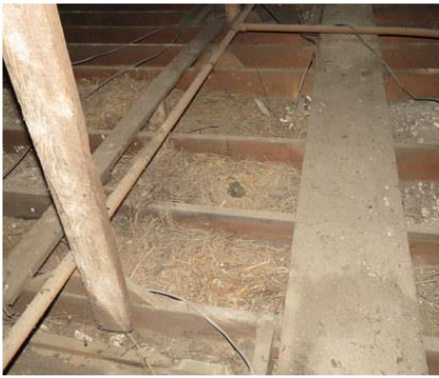
Nesting material evident to a number of areas.

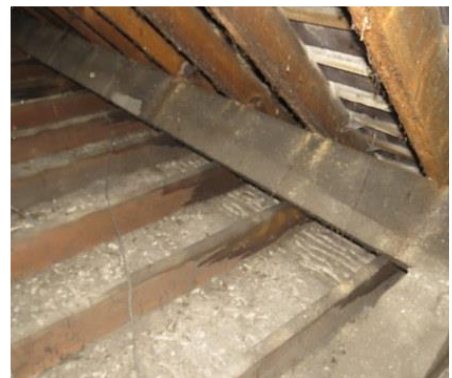
A number of rafters and joist were wet at the time of inspection.

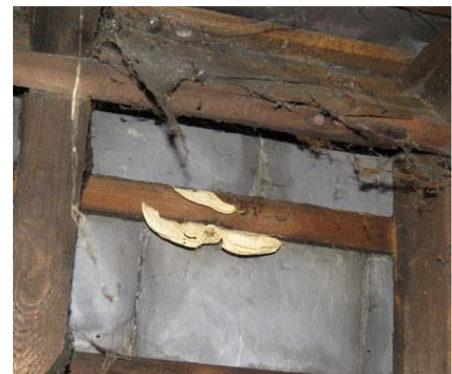
Fruiting body on timber lats beneath cupola.

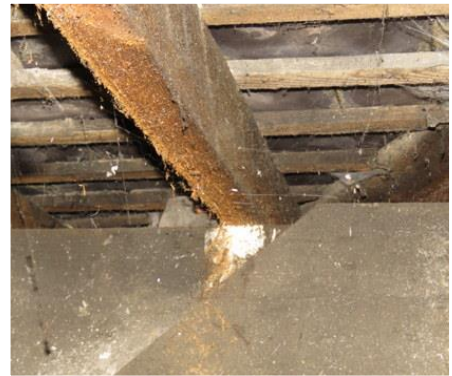
Wet purlin and rafter adjacent to Morton Lane entrance roof.

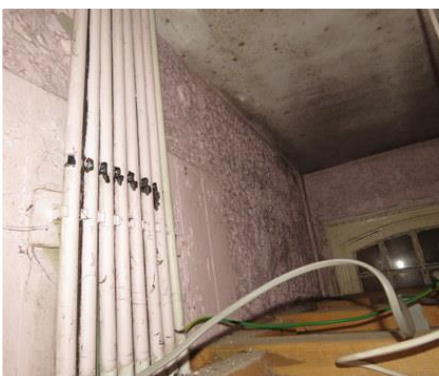
Void between roof and eaves parging loose and missing in various locations.

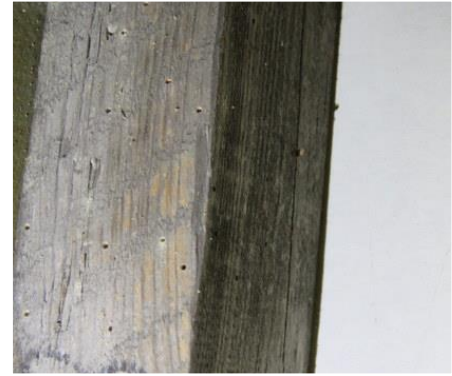
Beetle flight holes in timbers to rear roof slope eaves.

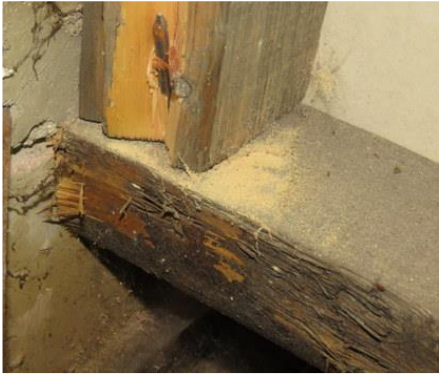
Frass evident to the rear slope eaves construction.

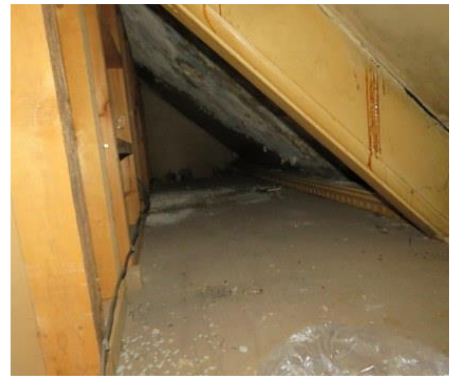
Condensation mold growth to plaster lath in eaves voids.

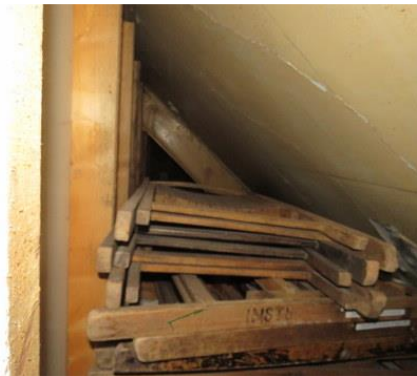
Rubbish stored in the eaves.

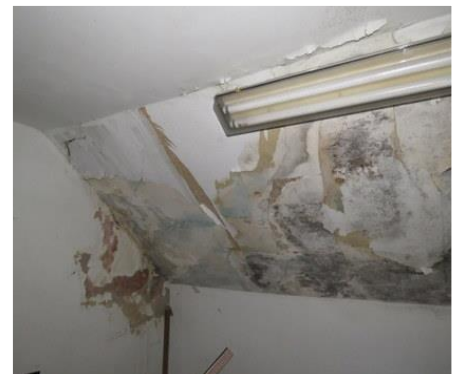
Plaster lath ceilings in top floor blown/effected by condensation.

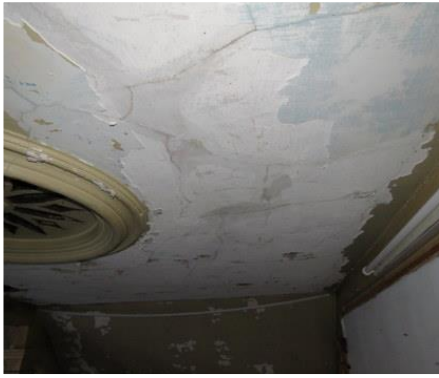
Plaster lath ceilings in top floor
blown/effected by
condensations.

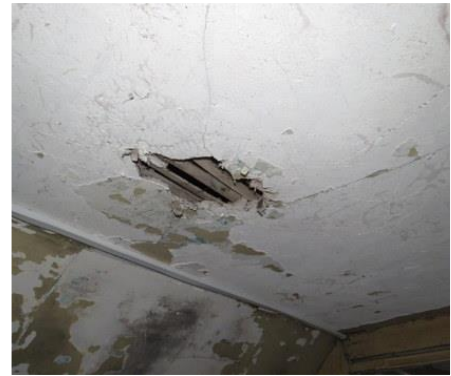
Delaminated sections of plaster
lath throughout first floor areas.

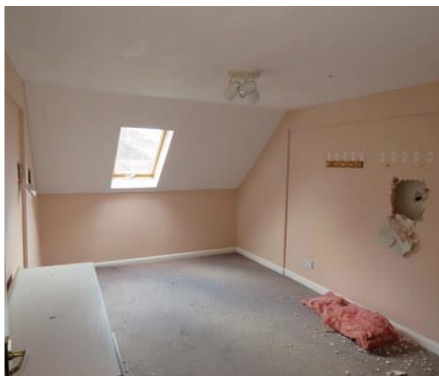
Delaminated sections of plaster
lath throughout first floor areas.

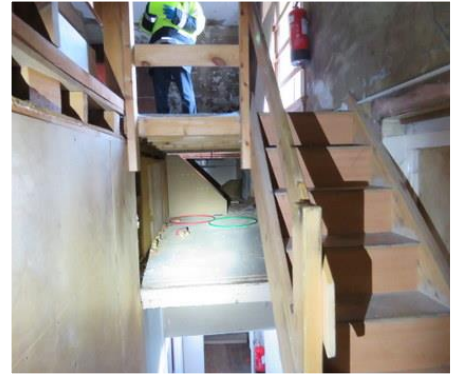
Stair access to first floor.

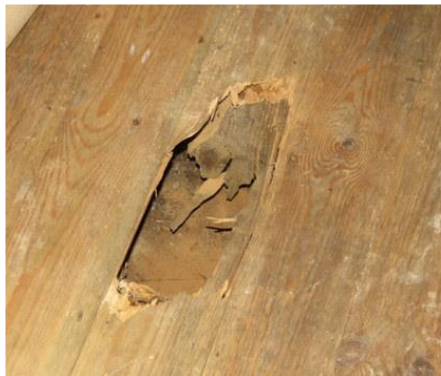
Additional supports fitted beneath damp joists to floor at Wilbert lane entrance.

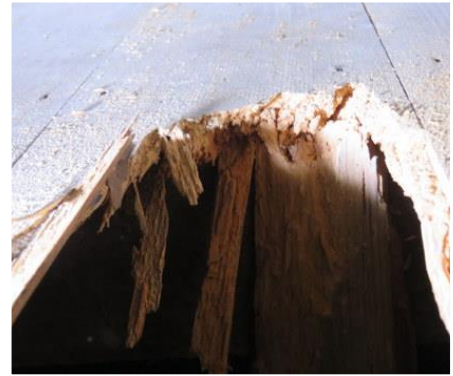
Beetle activity to floor void at corner of Wilbert and Morton lane.

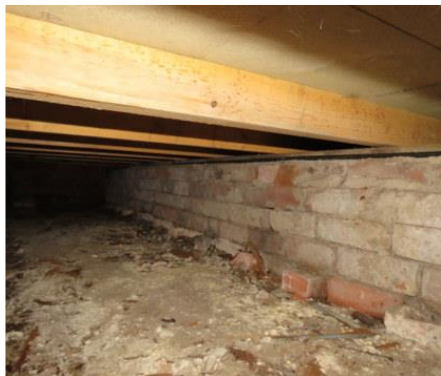
Rot to floor and skirtings in kitchen.

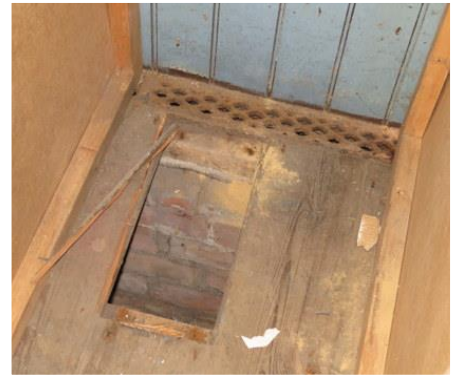
Kitchen floor void.

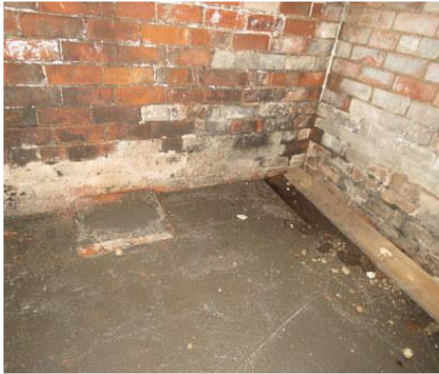
Beetle activity in floor void.

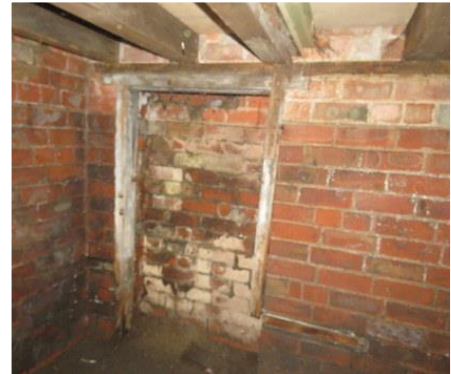
Potential floor detritus in reception room void.

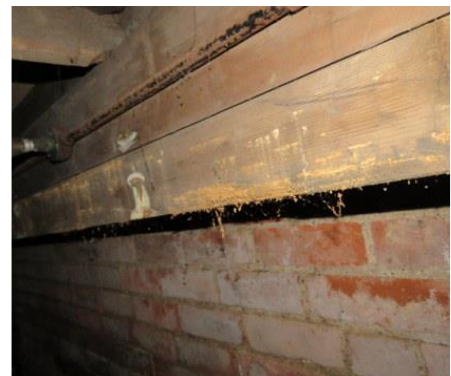
Beetle activity to floor joists beneath main reception room.

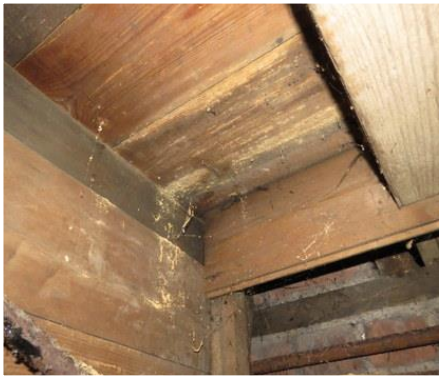
Beetle activity to underside of floor boards.

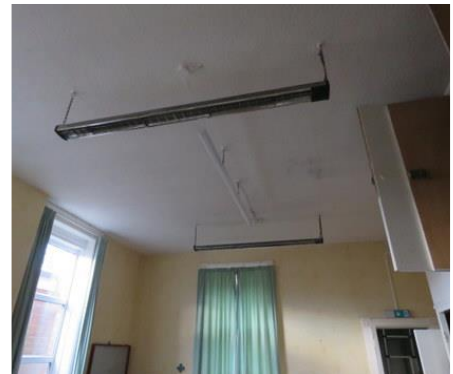
Heating via wall and ceiling mounted electric radiant heaters.

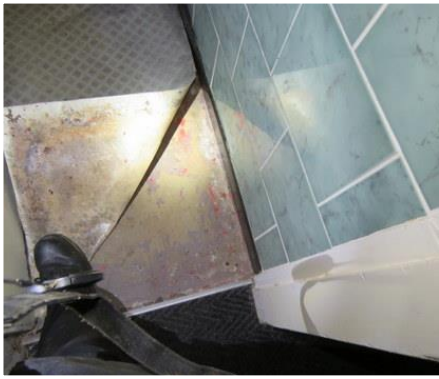
Floor beneath entrance and W.C's concrete.

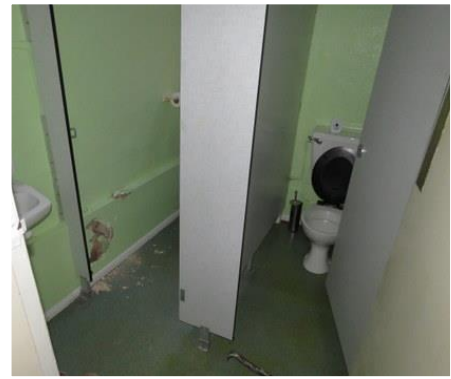
Toilet provision poor.

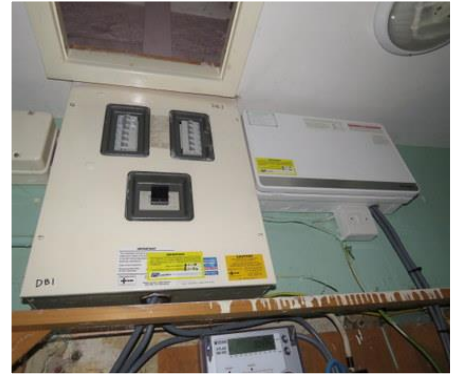
Electrical services.

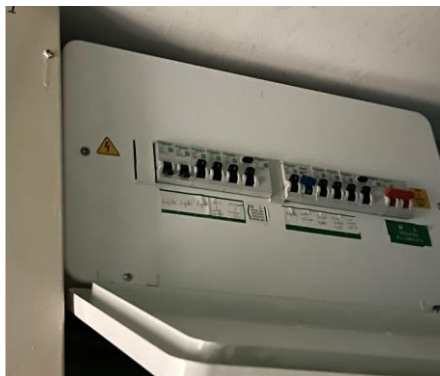
Main electrical board tripped during survey.
