Annual Inspection

Central Swindon North Parish Council

Alanbrooke Close

Inspection Ref: 2248288

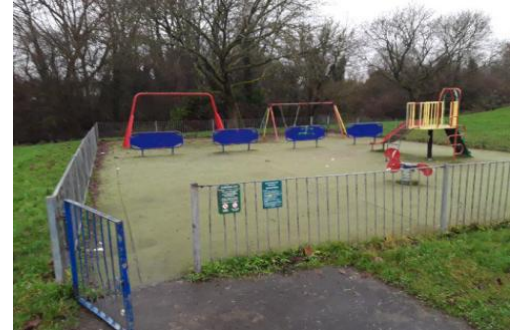
Finding 1

There are gaps opening between the surfacing - Reinstate surface

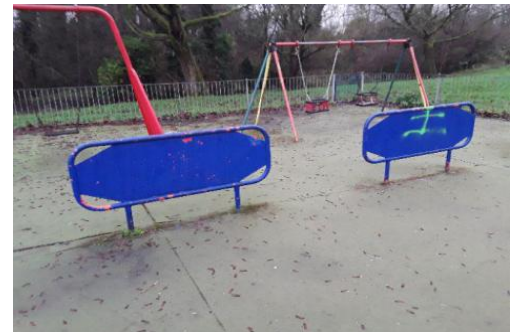
Finding 1

There is some graffiti present - Remove the graffiti
