Jewish and Congregationalist Cemeteries at Ponsharden Falmouth, Cornwall

Conservation Management Plan Volume 2: Appendices

CA Project:880188

CA Report: 17200

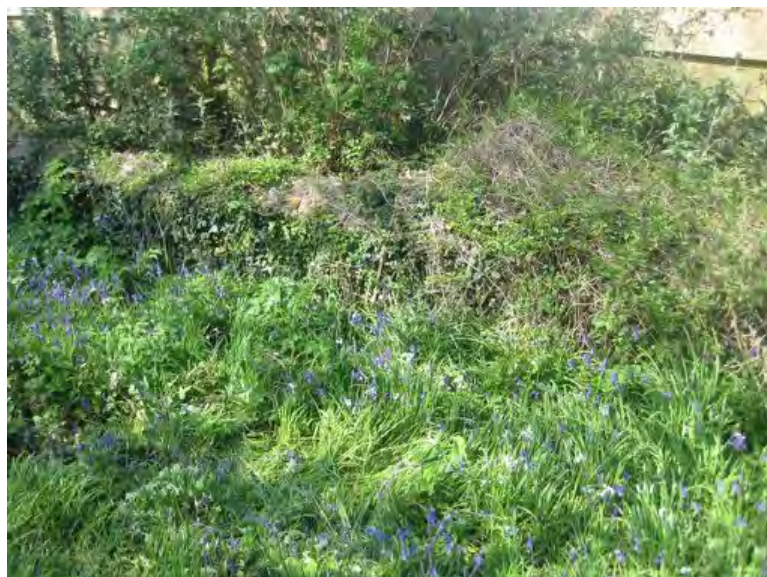
Figure 2 Mid section of wall B1

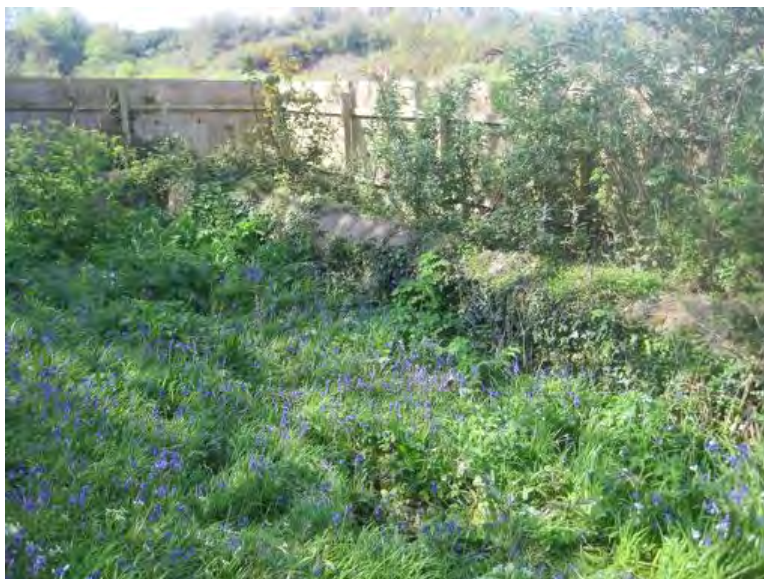
Figure 3 Southwestern end of B1

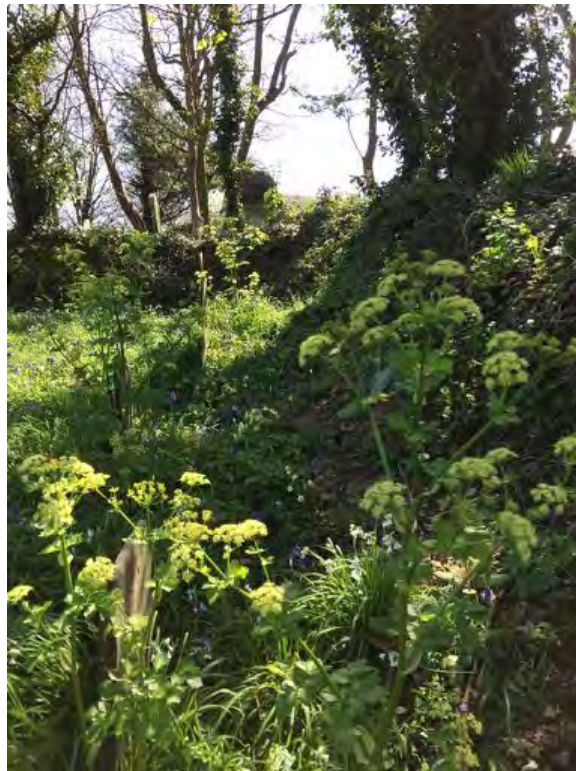
Figure 14 General view of earth bank

Observation: Consider planting a hedge or erect fencing at top of bank to provide physical barrier between the two cemeteries? Depending upon access arrangements a gate or stile over the bank may be required. This will be discussed in more detail within the Conservation Management Plan.

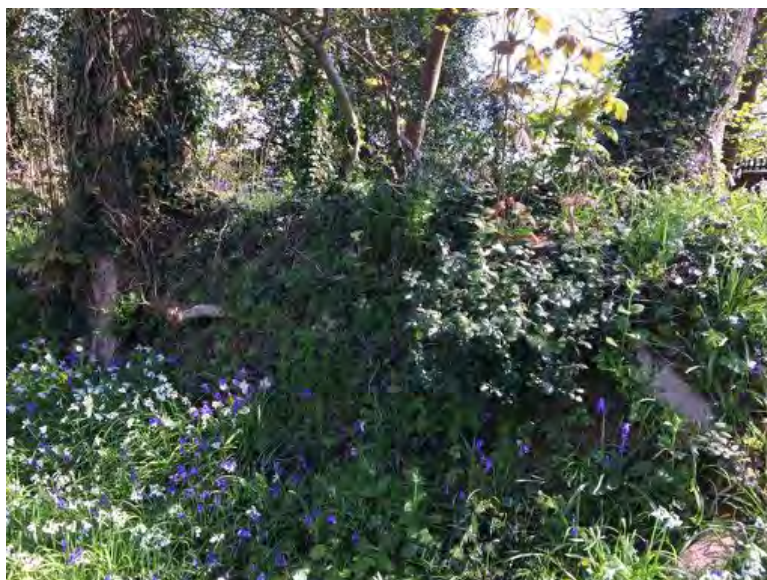
Figure 17 General view of northern end of B3

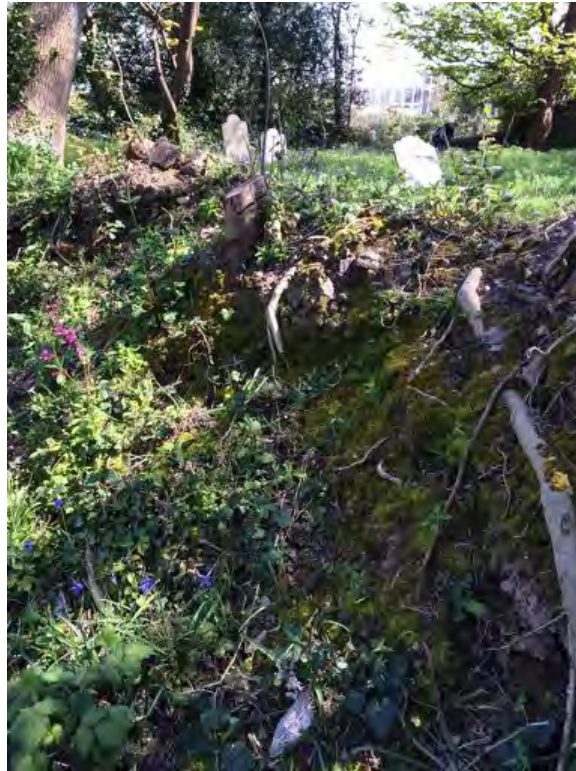
Figure 18 General view of southern end of B3

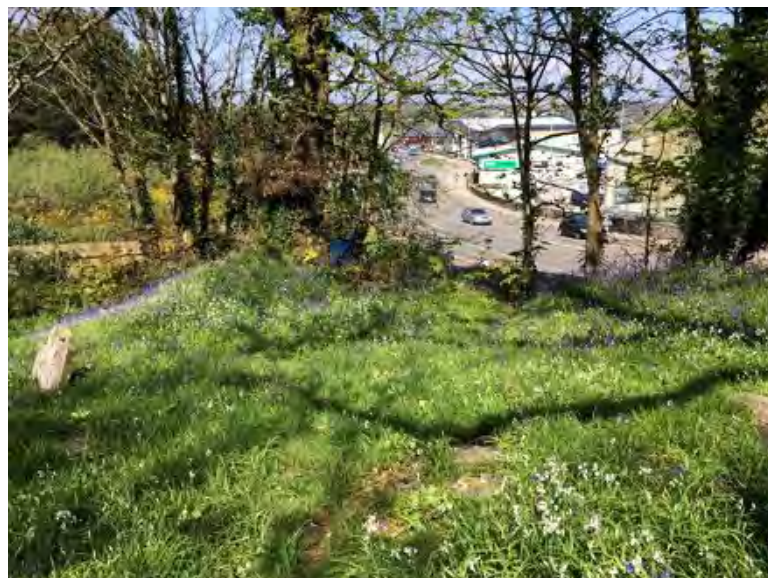
The earth bank is potentially unstable and should be considered to be in an unsound condition. There is evidence of historic slumping of material towards the road with exposed tree roots in several areas of the bank. (see figure 24). In particular, the area immediately below the boundary between the two cemeteries has areas of exposed earth and visible voids in the bank when viewed from road level. The bank requires stabilising in the medium to long term.

Figure 20 B4 bank from top

During these works a bund will be formed at the top of the slope to form some edge protection to users of the cemetery while maintaining a natural profile to the bank.

A timber post and rail fence to be constructed along the top edge of the bank to provide security and discourage climbing of the bank. Alternatively a stone faced bank, in a Cornish Hedge style could be formed to provide an edge without the need for fencing.

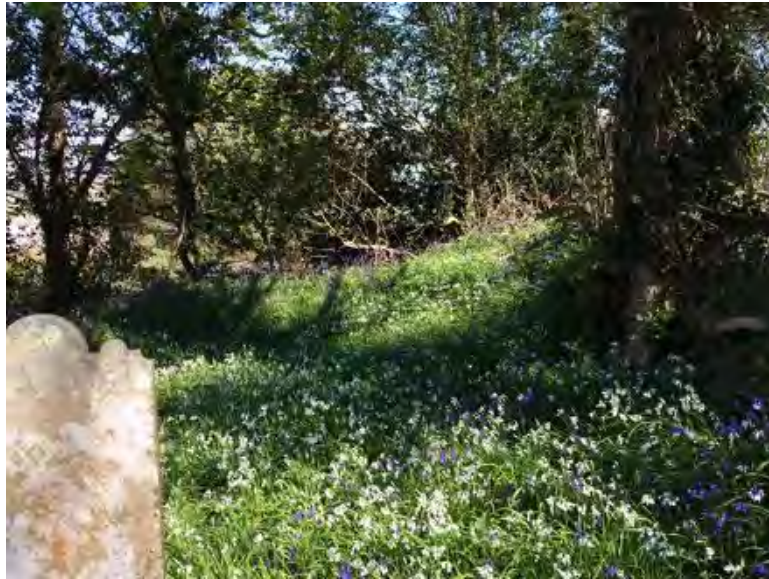
Figure 21 B4 bank from top

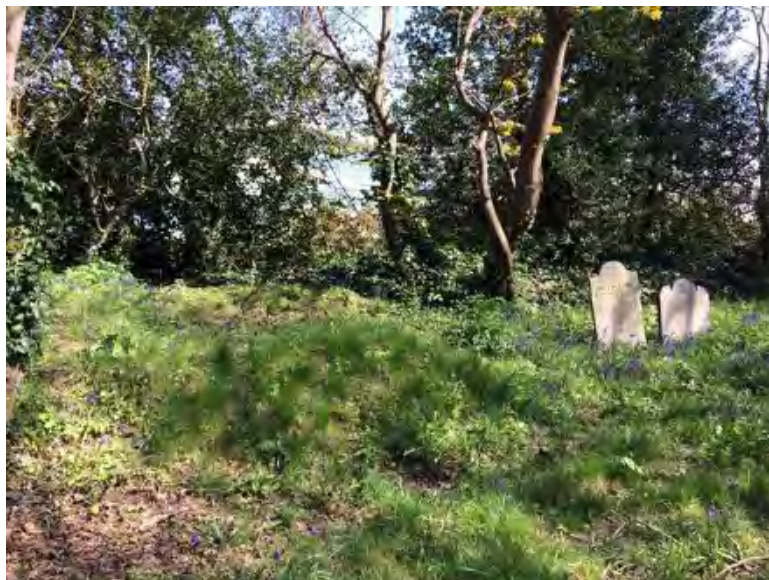
Figure 22 B4 bank from top

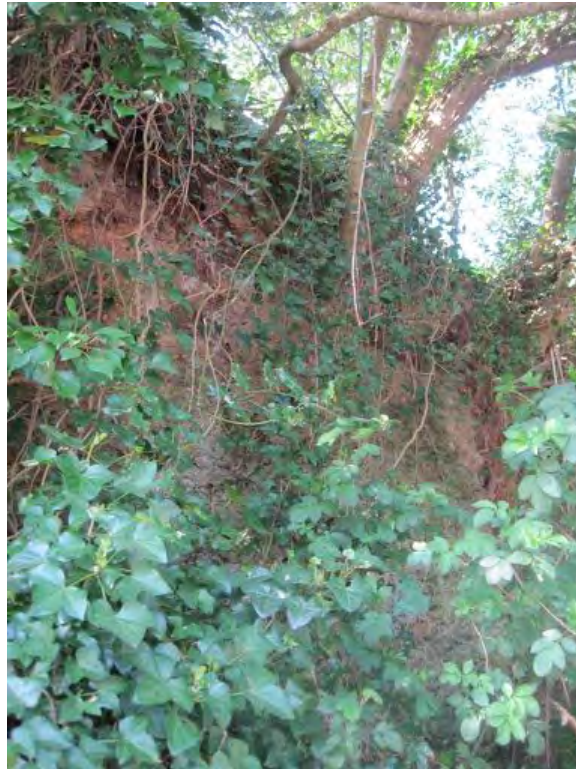
Figure 23 View from bottom of bank

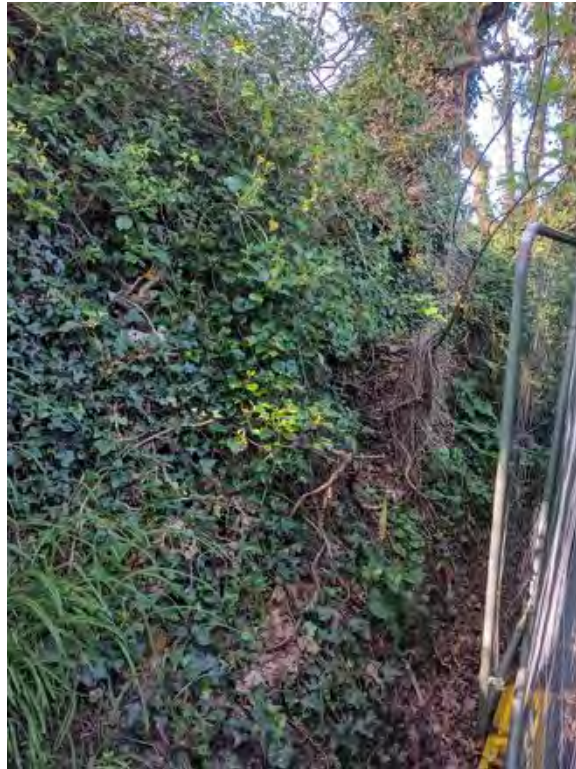
Figure 25 General view of bank towards north west behind gas governor building

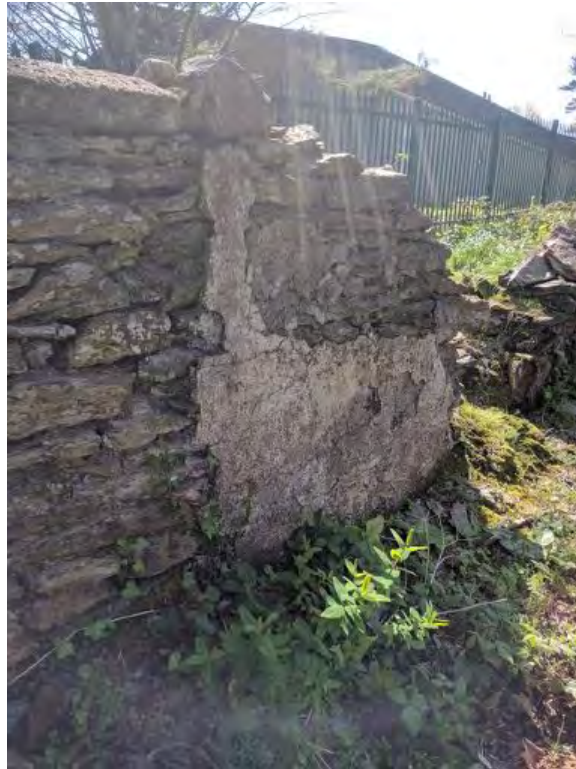
Figure 32 Detail of render remains at approx. 8m-9m length

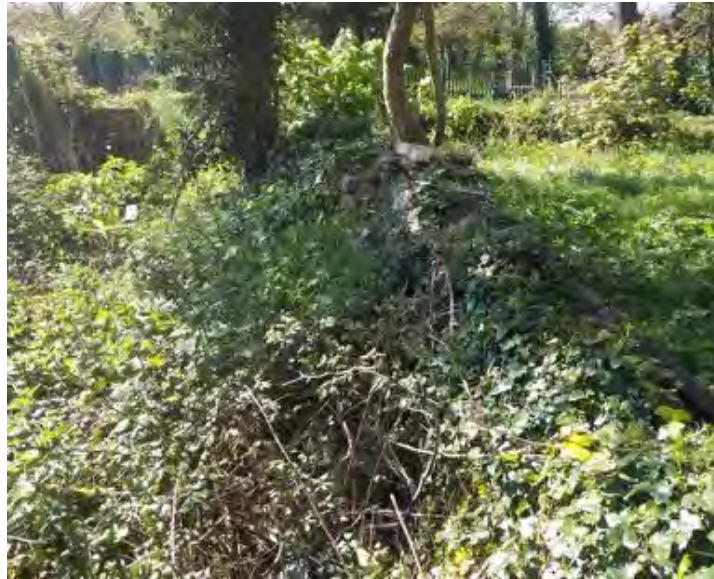
Figure 34 (30m-end) General view of partial collapse and extensively overgrown section

- Rebuild collapsed sections in traditional Cornish hedge construction.
- Define more clearly the original access point and undertake exploratory work to see if original extents can be determined.
- Rebuilt to approx. height of 800mm.

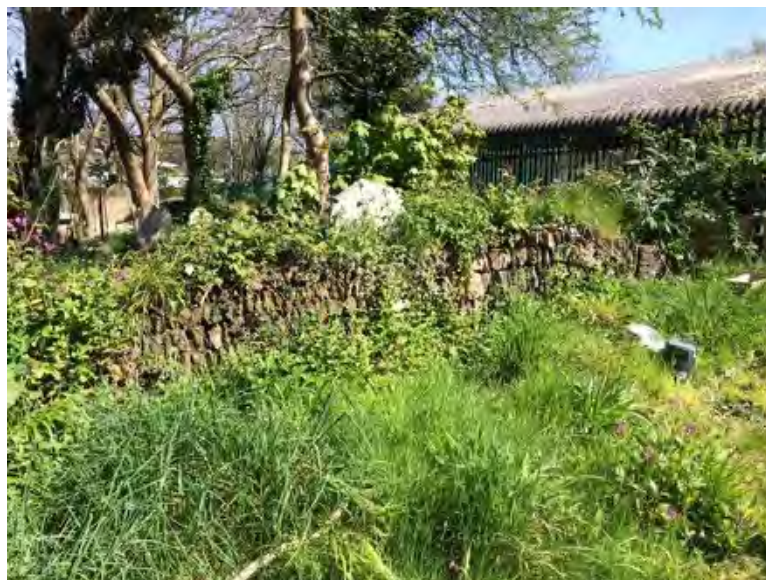
Figure 35 General view of eastern end of Cornish hedge

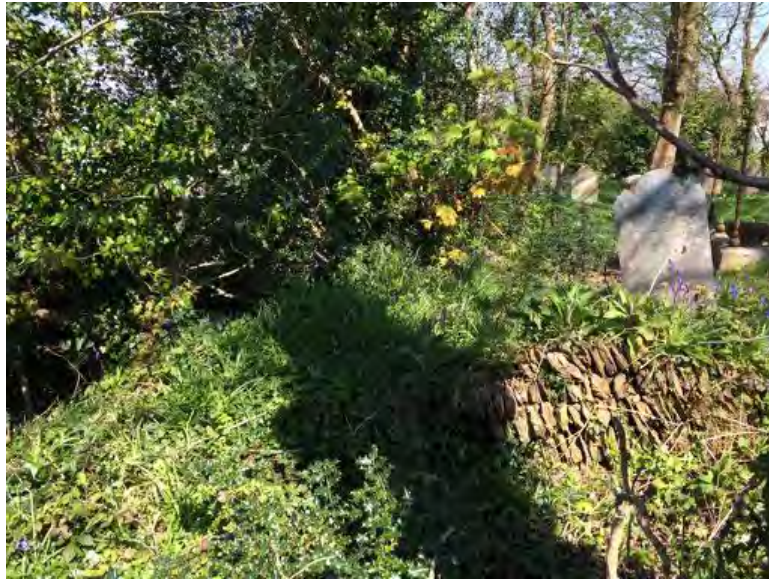
Figure 38 Detail view of western end of B7.

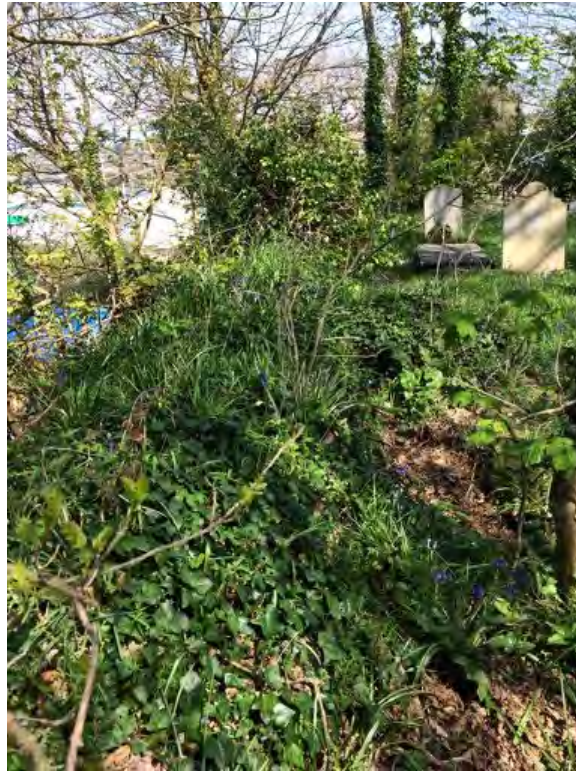
Figure 39 General view of B8 bank from the Congregationalist cemetery

It has been noted that there is scattered bramble scrub located on the western and eastern boundary to the site. It is recommended that this is not allowed to encroach further within the site. The aim should not be to eradicate the bramble scrub from site as it does have ecological benefits, providing a food source, shelter and if it were to become denser, potentially bird nesting habitat. Therefore, it is recommended that it is contained outside of the walled area of the cemetery, i.e. to the west of the wall which forms the western boundary to the Jewish cemetery and between the eastern wall of the Congregationalist cemetery and the perimeter fence. Bramble should be cut back using hand tools (e.g. loppers and billhooks or brushcutter) between October and February (outside of the bird nesting season), to maintain the current extent of habitat and prevent further encroachment.²

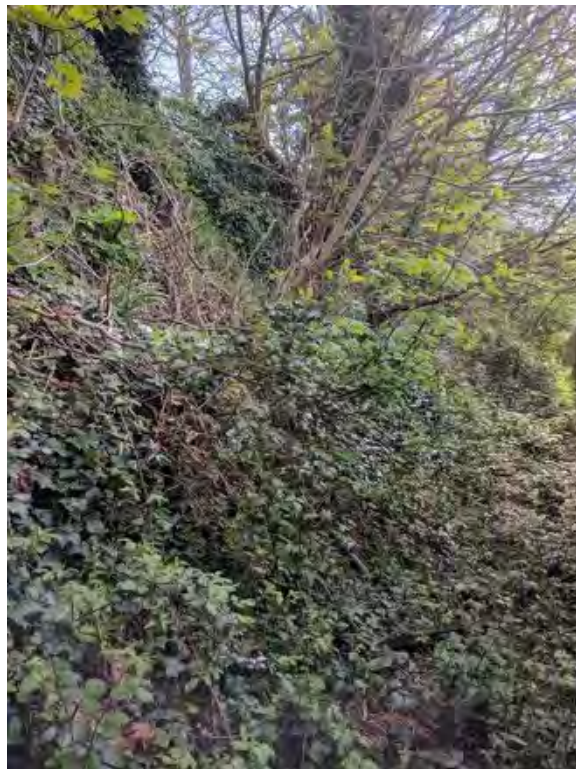
Figure 42 General view of B8 earth bank from below

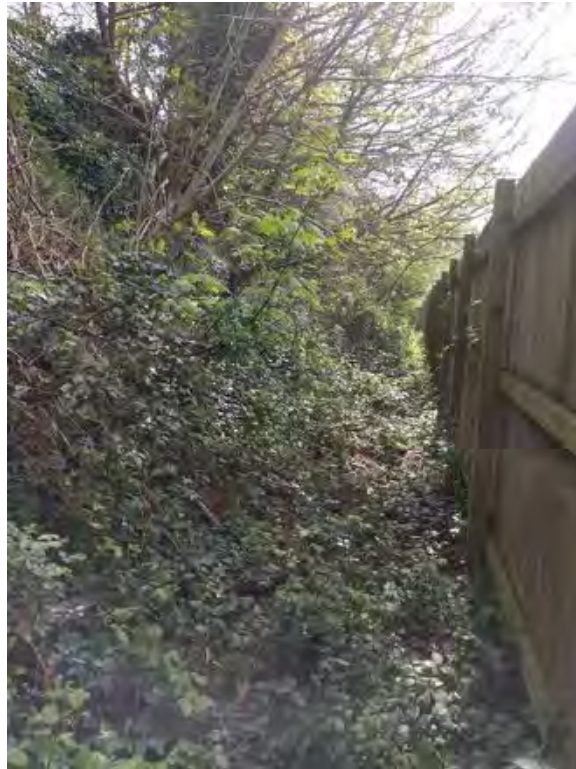
Figure 43 Further general view of earth bank B8

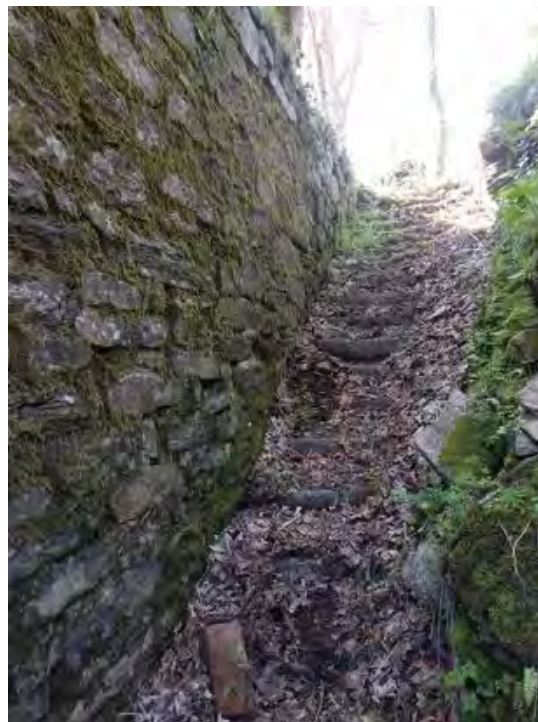
Steps: The granite steps are buried beneath a layer of debris and vegetation (see figures 44 and 45).

Figure 44 General view of steps

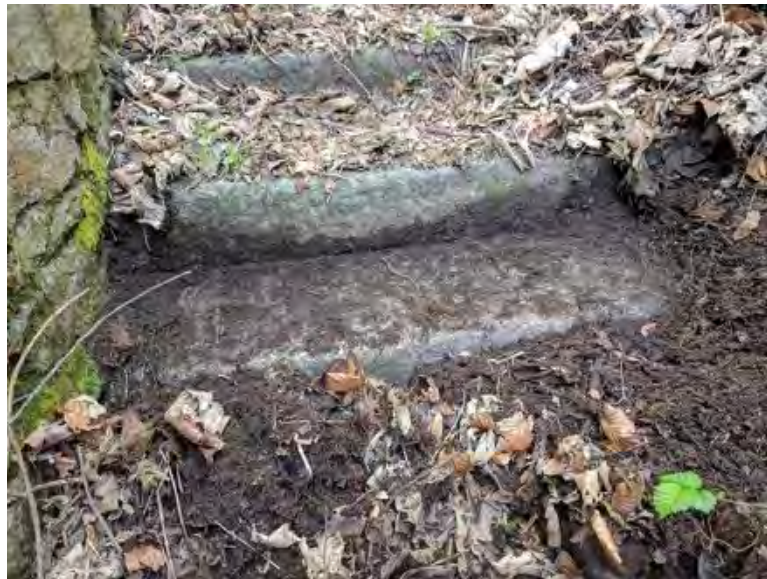
Figure 45 Detail of granite steps

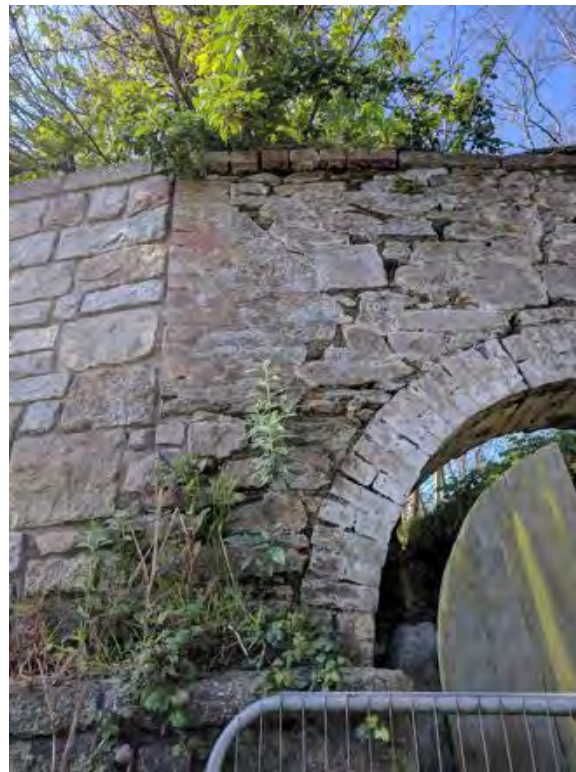
External elevation face of arch (north elevation): This wall is generally sound, with some areas of missing pointing (figures 46 and 47) there was some instability at the head of the wall caused by neighbouring trees (figure 50).

Figure 46 Junction of existing arch with contemporary stone retaining wall

External elevation face of arch (north elevation): Allow for general repointing (100%) and further repairs and some re-bedding to top of wall to consolidate (see figure 50 for example).

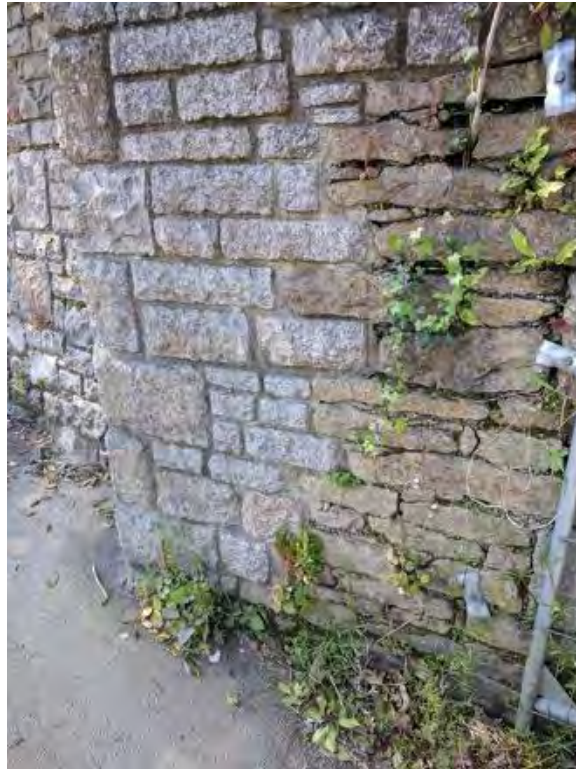
Figure 47 Detail of how contemporary retaining wall was constructed to tie into existing masonry

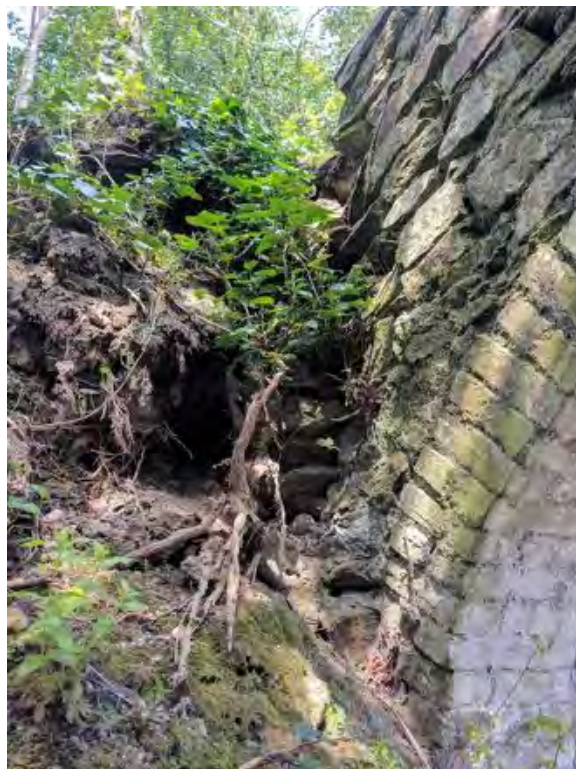
Figure 48 Detail view of rear of Arch intersection with earth bank and collapsed western stairwell wall

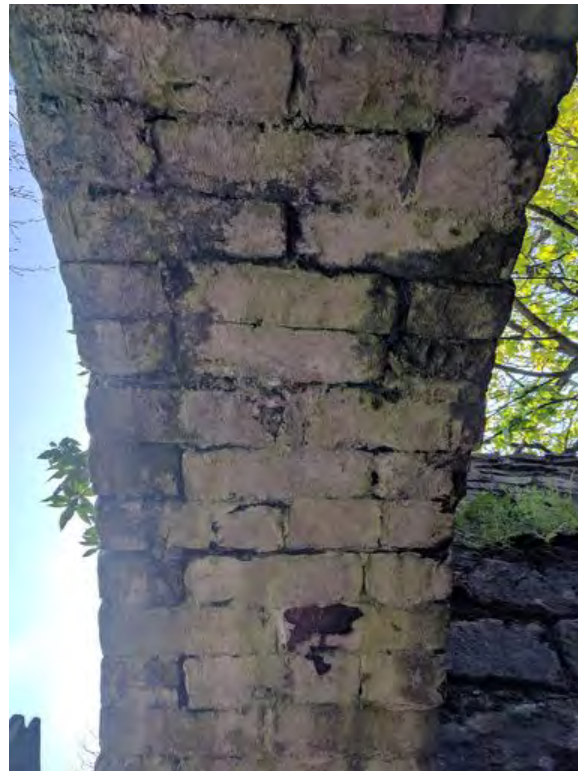
Figure 49 Detail of underside of brick arch

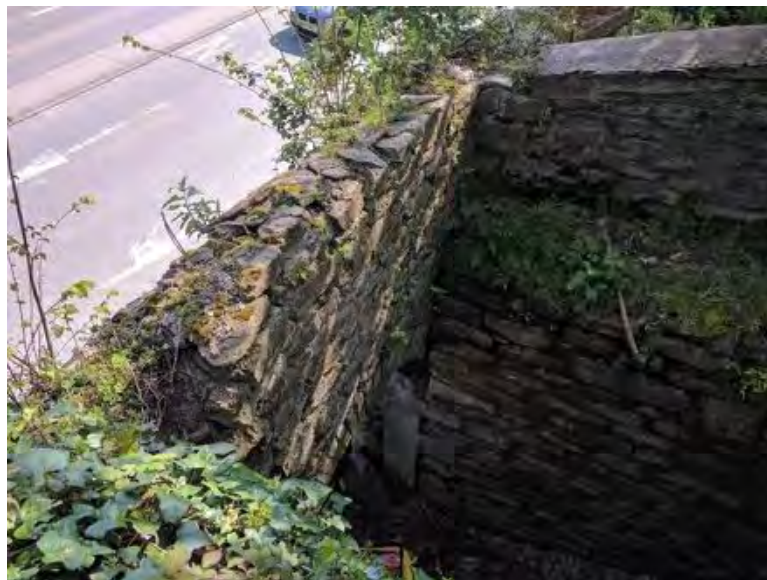
Figure 52 Top view of northern arch wall

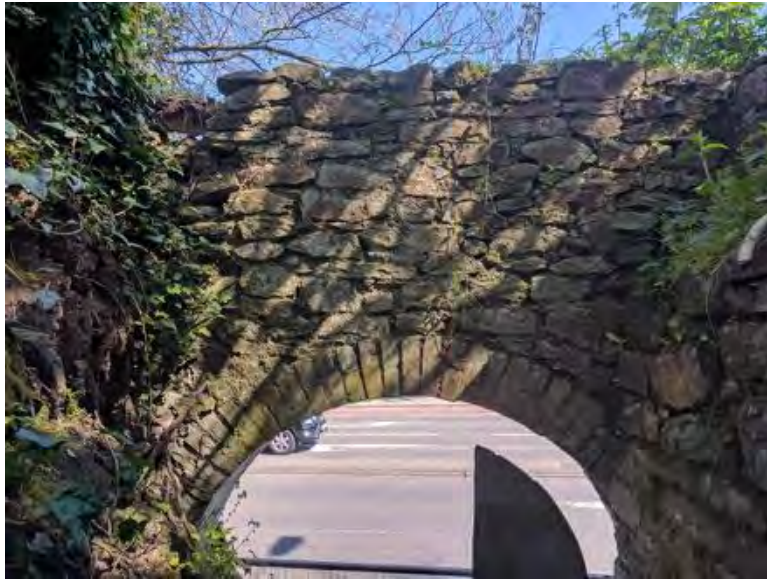
Internal face of arch: Again there is some mortar loss to the stonework (figure 53) to this elevation, generally the brick arch and its abutments appear sound.

Figure 53 Inner face of arch entrance wall

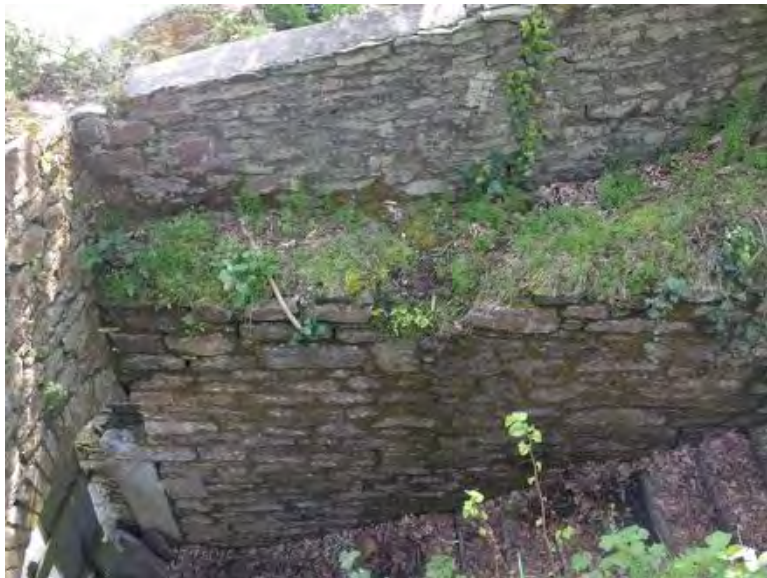
Figure 54 General view of eastern stairwell wall

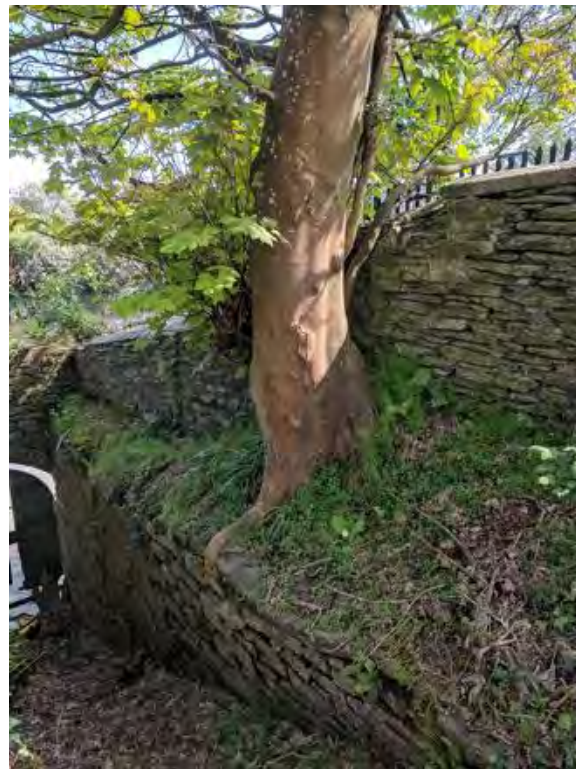
West wall of steps: The west wall of the steps is currently upright, however the large tree CT20 is threatening the stability of this area, it can be seen in figure 55 and 56 that some bowing and movement has already occurred, this needs to be dealt with urgently to avoid further damage. Access to this area should be restricted.

Figure 56 Detail view of CT20

West wall of steps: Remove CT20, locally rebuild stonework as necessary and allow for 100% repointing to whole of wall.

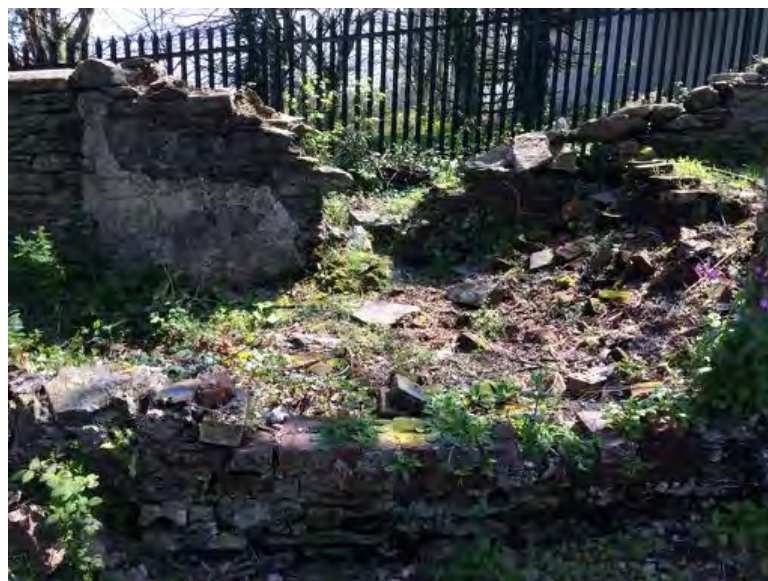
Figure 57 General view of possible mortuary chapel.

- Clear out brick and earth debris to inner area of structure, if possible expose to original floor level (It may be possible to use volunteer labour for some of this work).
- Salvage and store loose bricks.
- Consolidate wall tops, and re-bed loose bricks.
- No proposal to rebuild structure.
- If possible establish reveals of door opening to help make clearer original extent of building.
- Rebuild boundary wall – refer to B6 for detail.

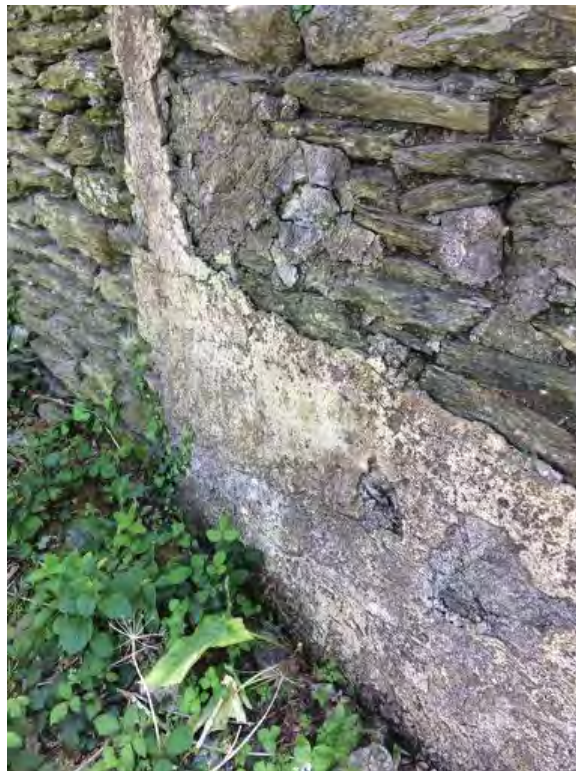
Figure 59 Detail of render/plaster remains to boundary wall

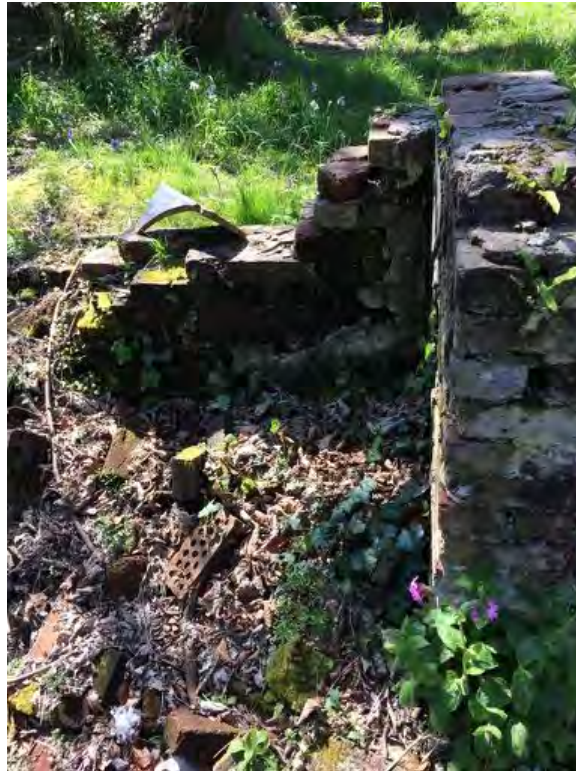
Figure 60 Detail of internal corner to building

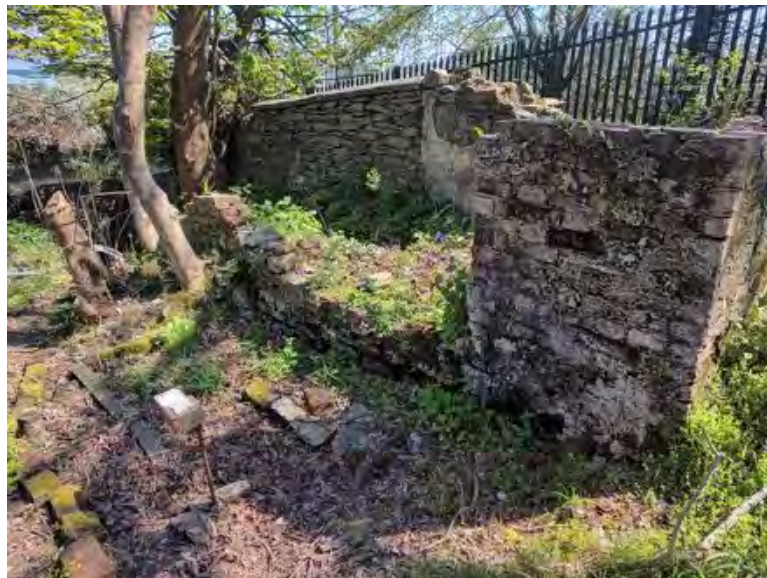
Figure 61 General view of Mortuary building remains

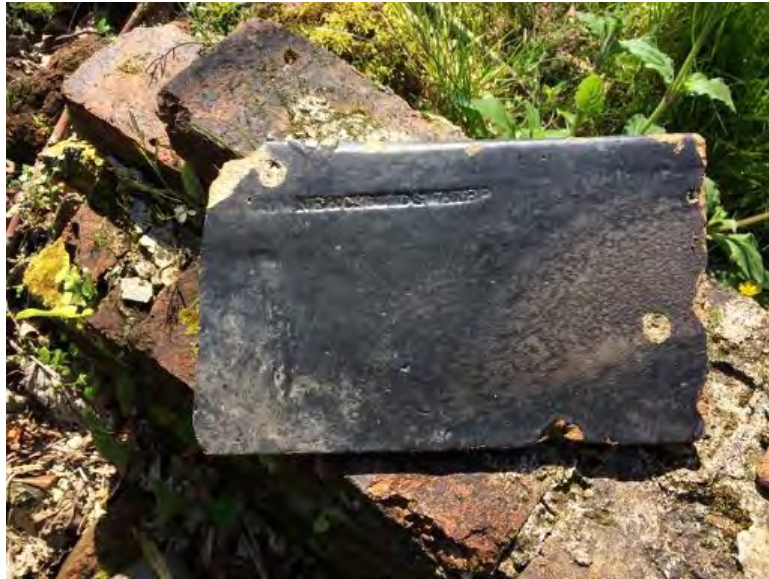
Figure 62 Remains of glazed ridge tile found on site

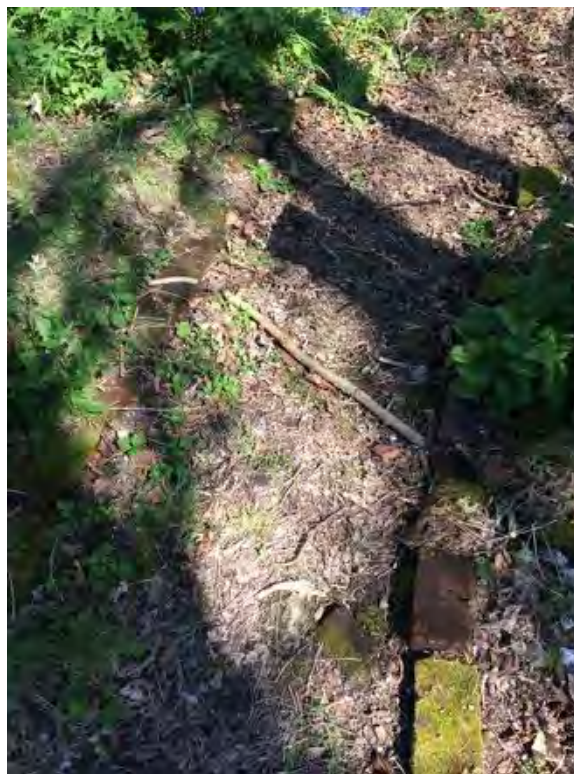
Figure 63 Detail of pathway to northern end of site

- Excavate to establish whether any original path base exists.
- Clear vegetation and expose brick and stone edges. Re-bed brickwork
- Clear vegetation, re-bed and repoint low level (400mm max) stone wall edge.

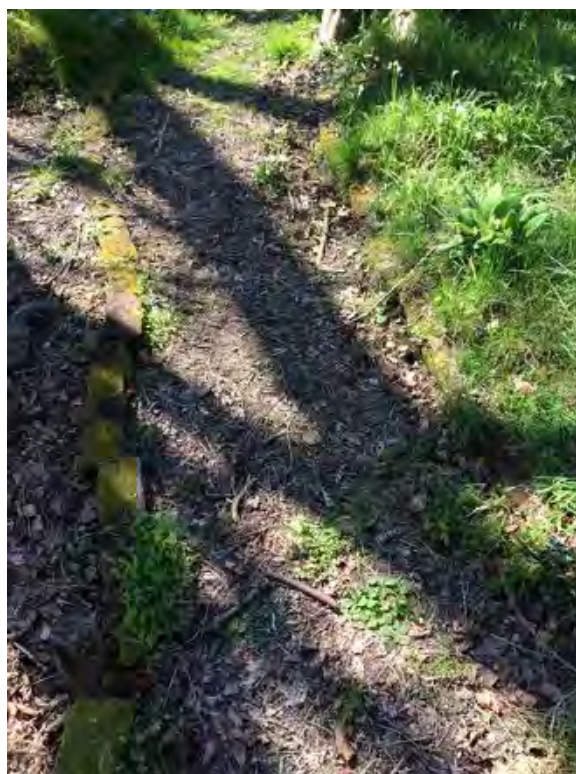
Figure 64 Further detailed view of pathway with brick edging

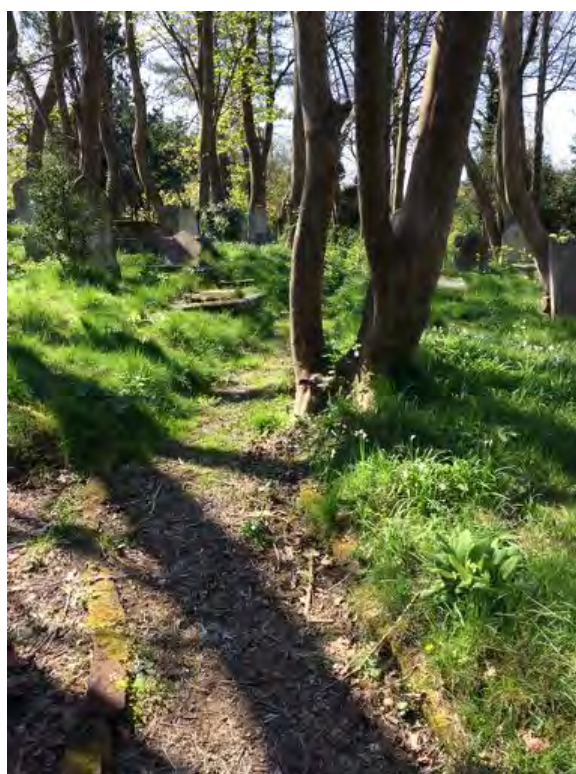
Figure 65 General view of pathway, tree to foreground is not near any monuments and provides an interesting focal point and frame for the setting.

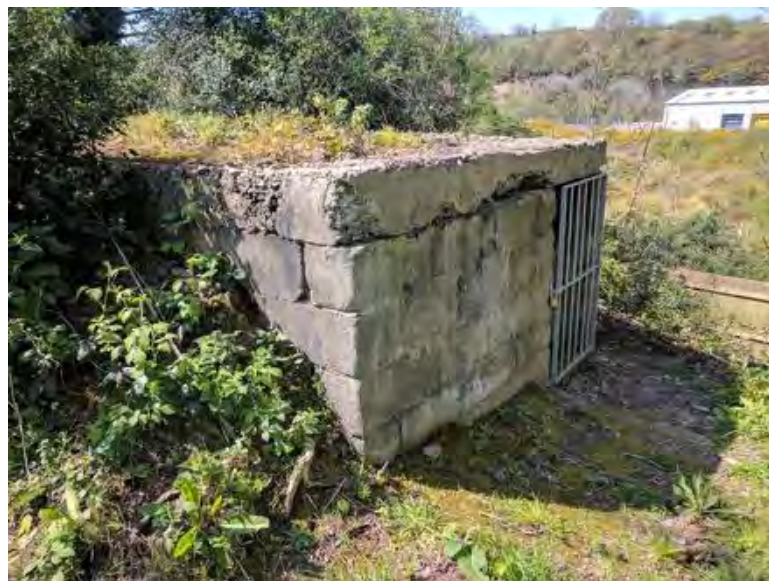
Figure 67 General view of concrete structure to southwest of Congregationalist cemetery

No works proposed. Potential use as maintenance store subject to any health and safety issues as limited head height internally. Not recommended to allow public access due to potential trip hazards and confined dark space with limited head height.

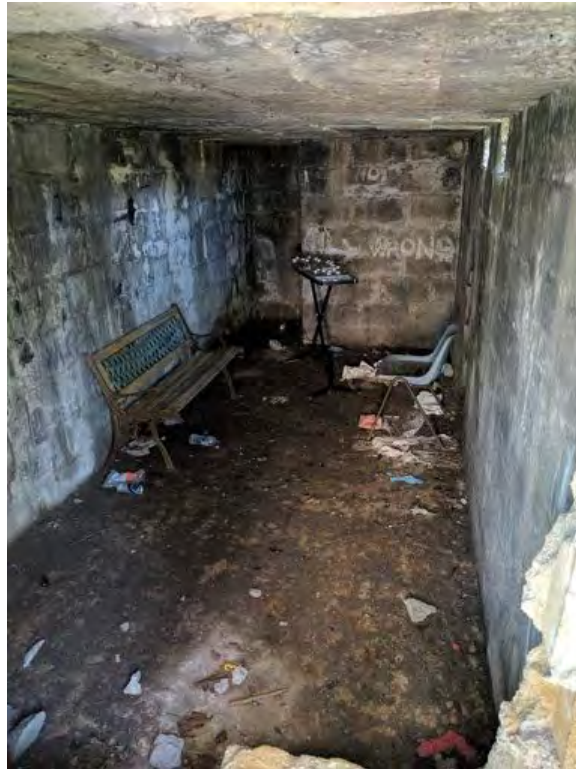
Figure 68 Internal view of concrete structure, previously been used as rough sleeping site.

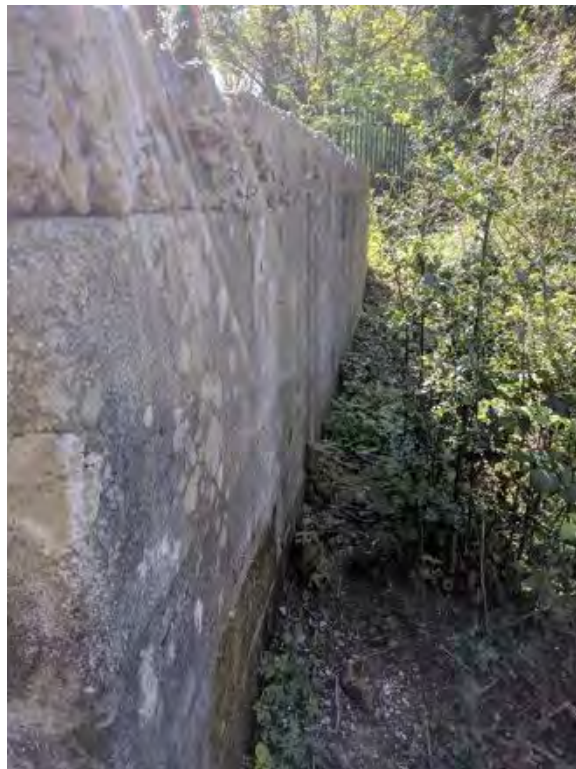
Figure 69 Western elevation of concrete structure
