Congregationalist Cemetery, Ponsharden

Proforma Condition and Repairs Schedule

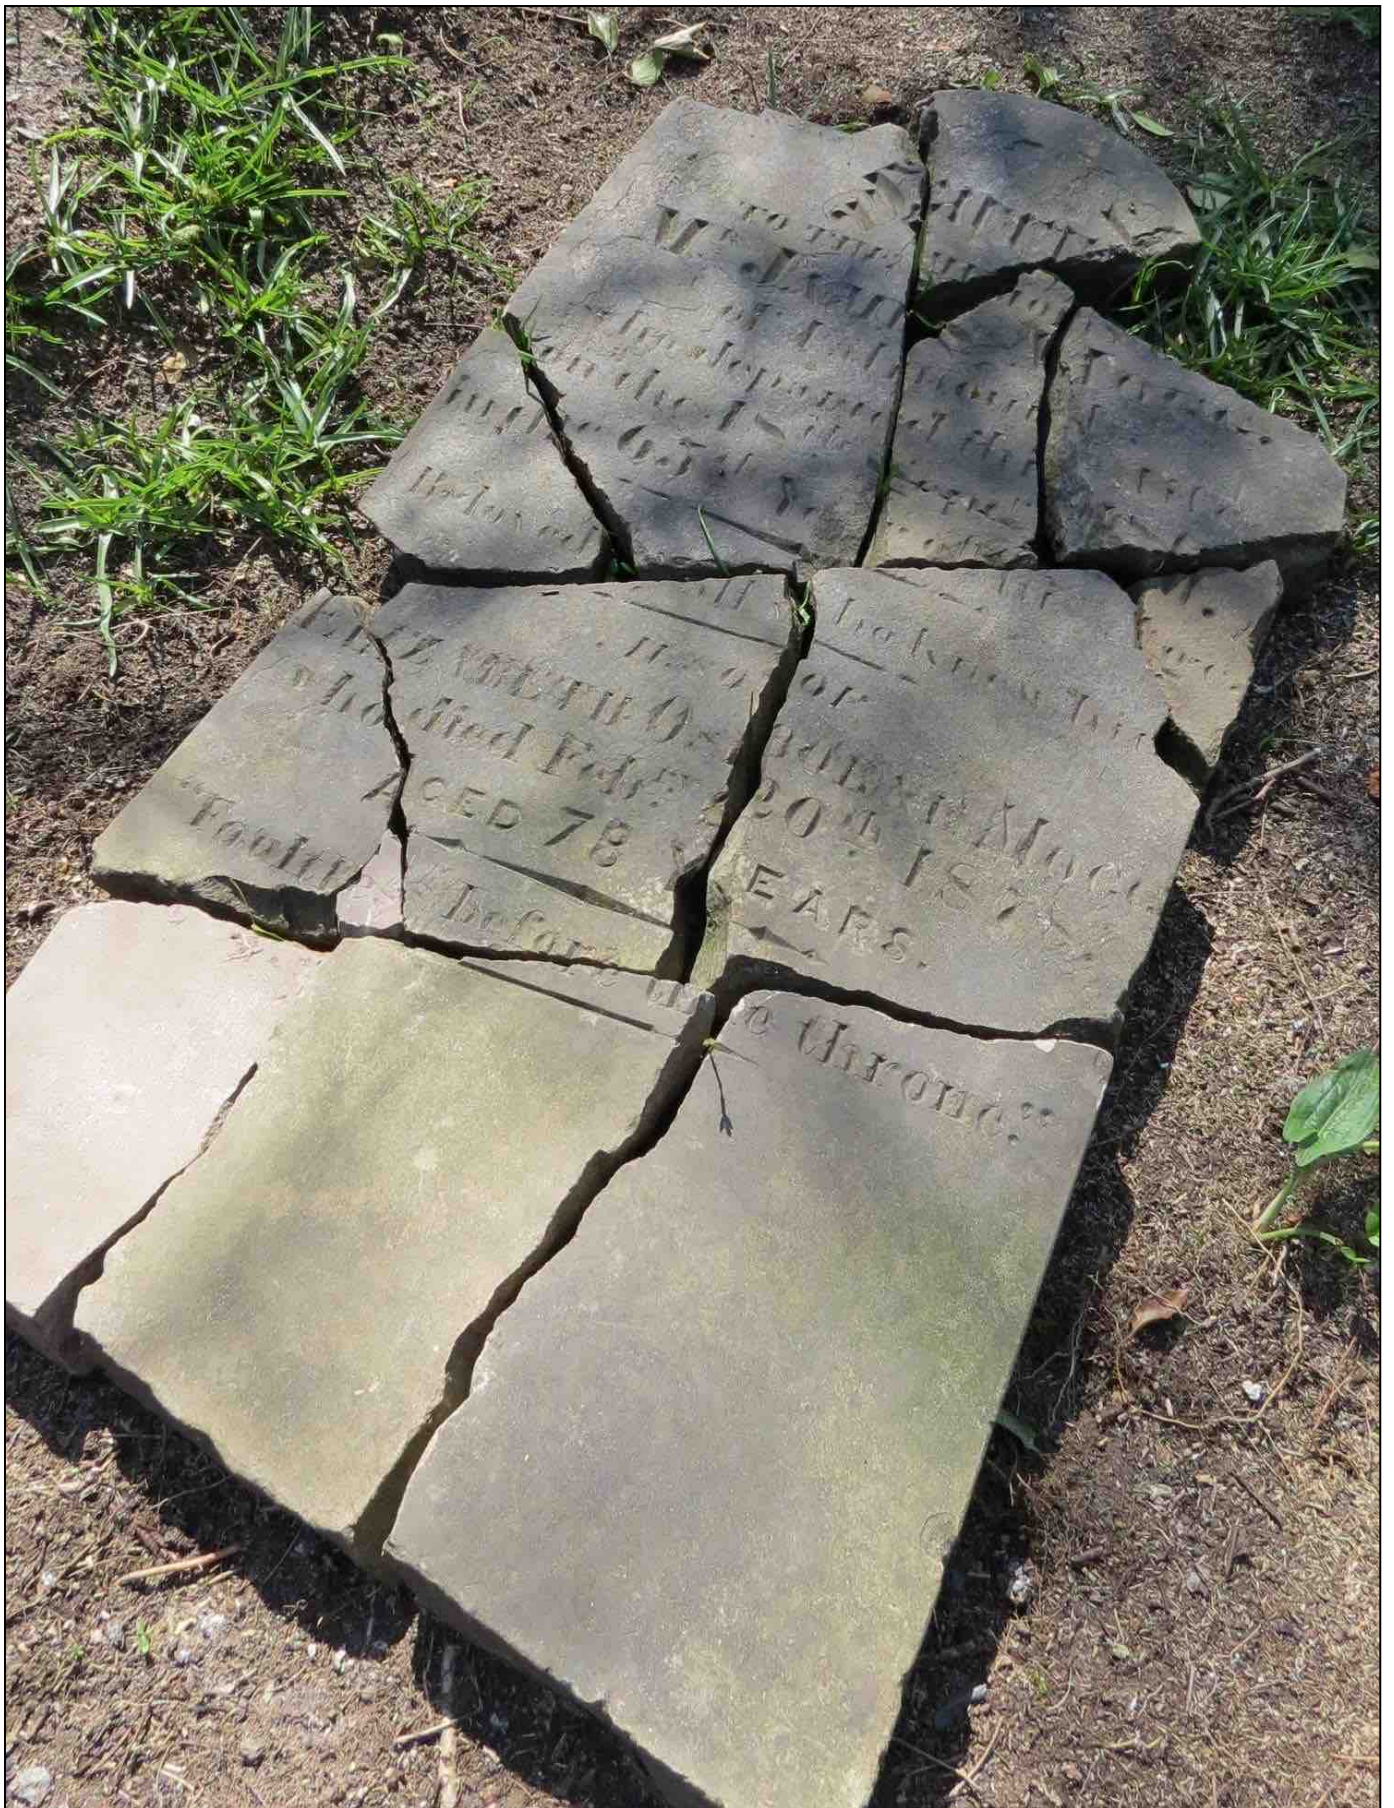
Monument 26

Broken

Vertical split caused by tree root

High risk of further damage/loss. Kelland report states current upright section is over a tree root and cannot be reassembled upright due to this

Trees CT2 and CT3 to be monolithed under separate enabling contract. Remove upright section and remove section of tree root to allow for re-erection. Pin 3 pieces together with stainless steel dowels and pin to 25mm thick slate backing. Make good joints with mortar. Clean off organic growth and dirt, and re-erect at the location of the existing base.

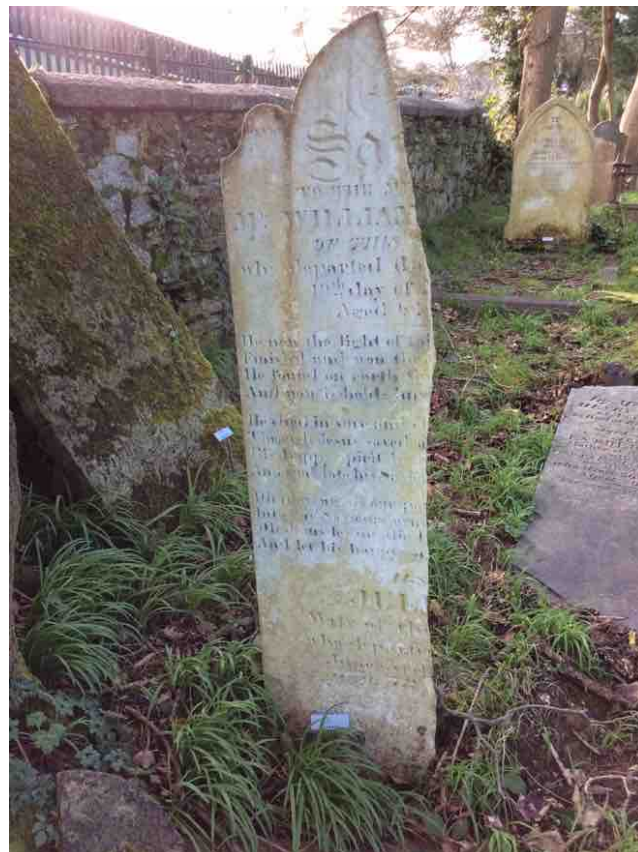
Monument 31

Overall structural condition:	Disrupted/separated	West side panel split, some elements stored inside, granite kerbs badly disrupted by tree growth
Ground condition :	Good/level	Slight slope
Impact of vegetation:	Disruption by roots	Granite surrounds disrupted by tree damage
Condition of foundation:	Not visible

Side panel fixings corroding, most of main balusters missing or broken, all railings missing

Tomb vandalised and extensively damaged, further damage since 2012 survey (broken side to chest tomb) ongoing damage by tree. High risk of further damage

Tree CT18 to be felled under separate enabling contract. Remove roots disrupting monument. Salvage parts of probable second monument stored within tomb and enclosed by tree roots, and set aside for possible re-use. Clean stonework. Remove lid and build up core off base slabs with honeycomb brickwork slightly higher than side panels. Pin or cramp broken side panel (in 5 fragments) together with stainless steel dowels or cramps, and cramp side panels to core with stainless steel fixings. Point joints. Rebed lid. De-rust and decorate surviving ironwork. Re-bed kerbs. Remove organic material within

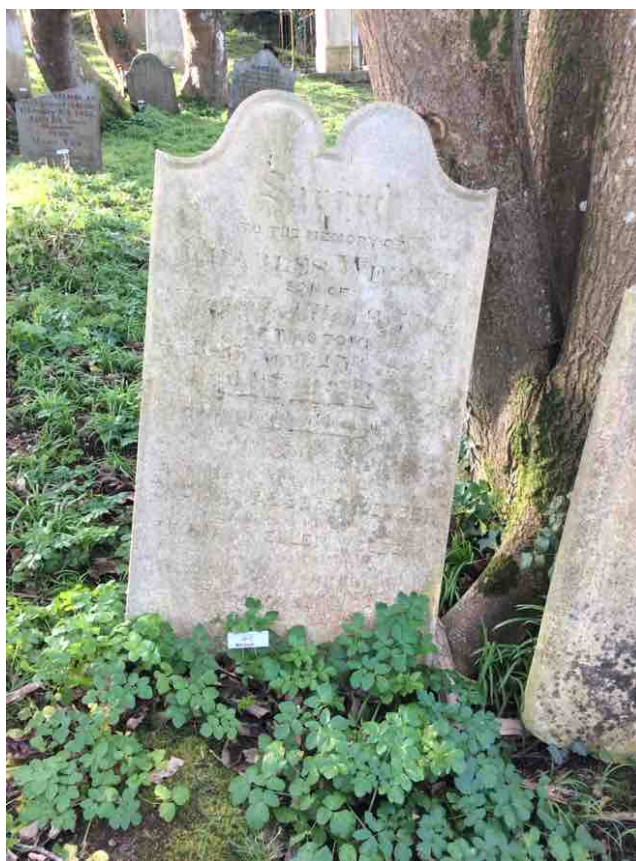
Possibly unstable as leaning against tree

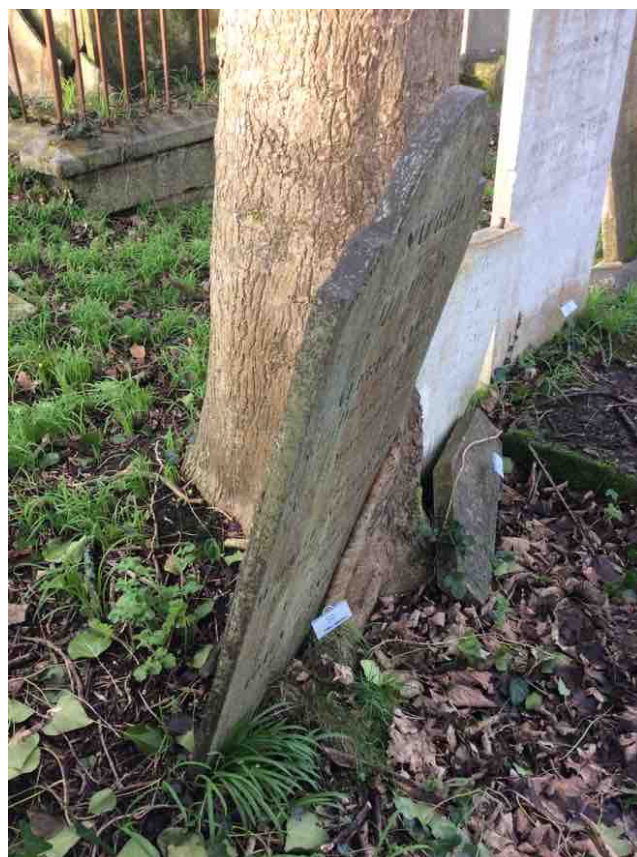
Tree growth / roots. Fallen top section is stable

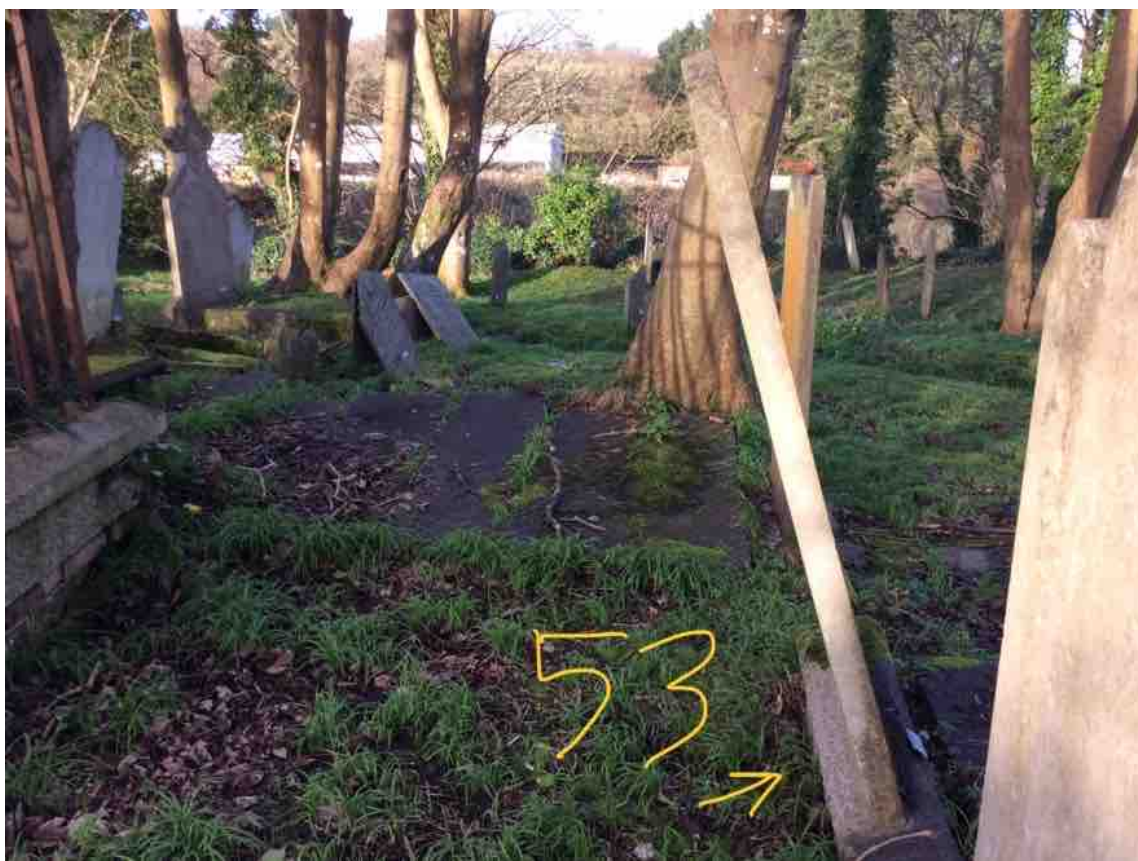
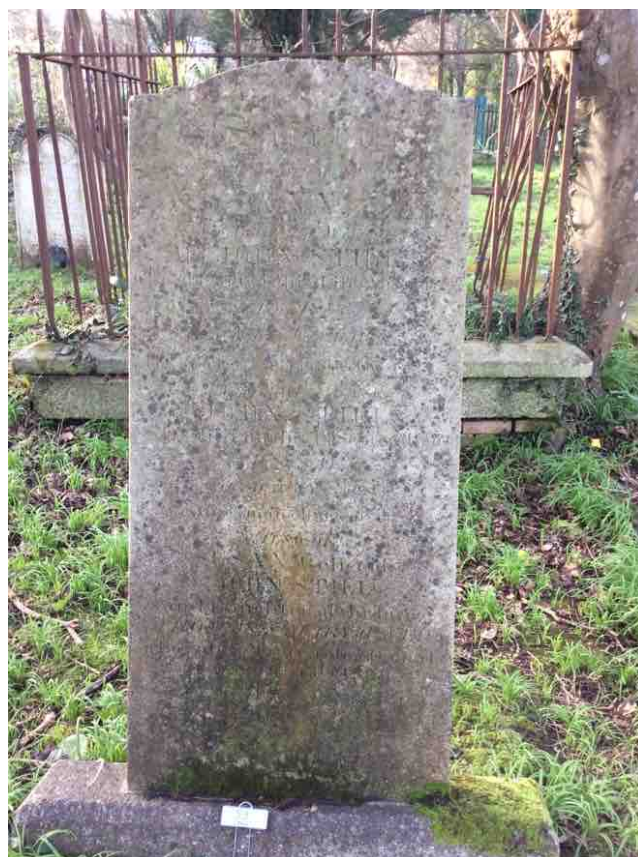
Due to tree roots. Headstone becoming unstable

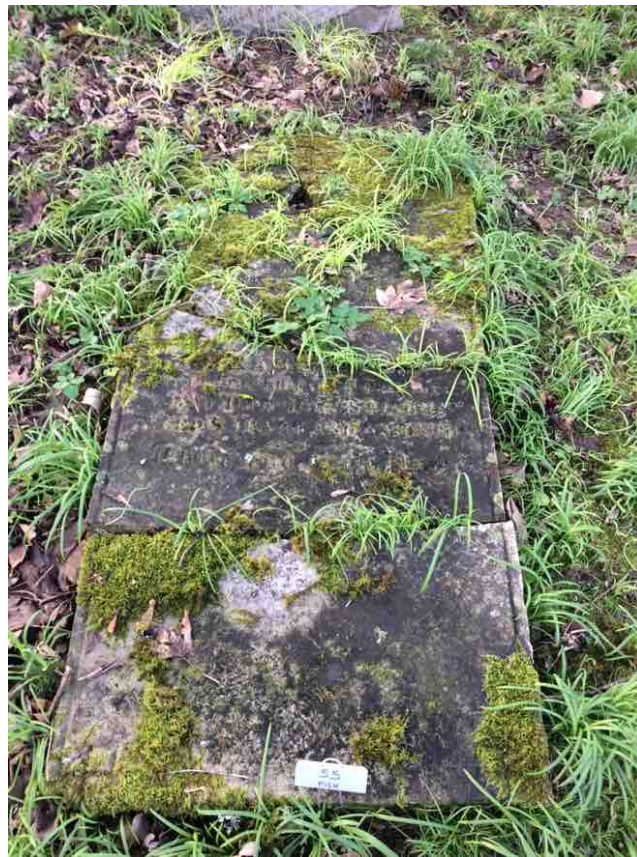
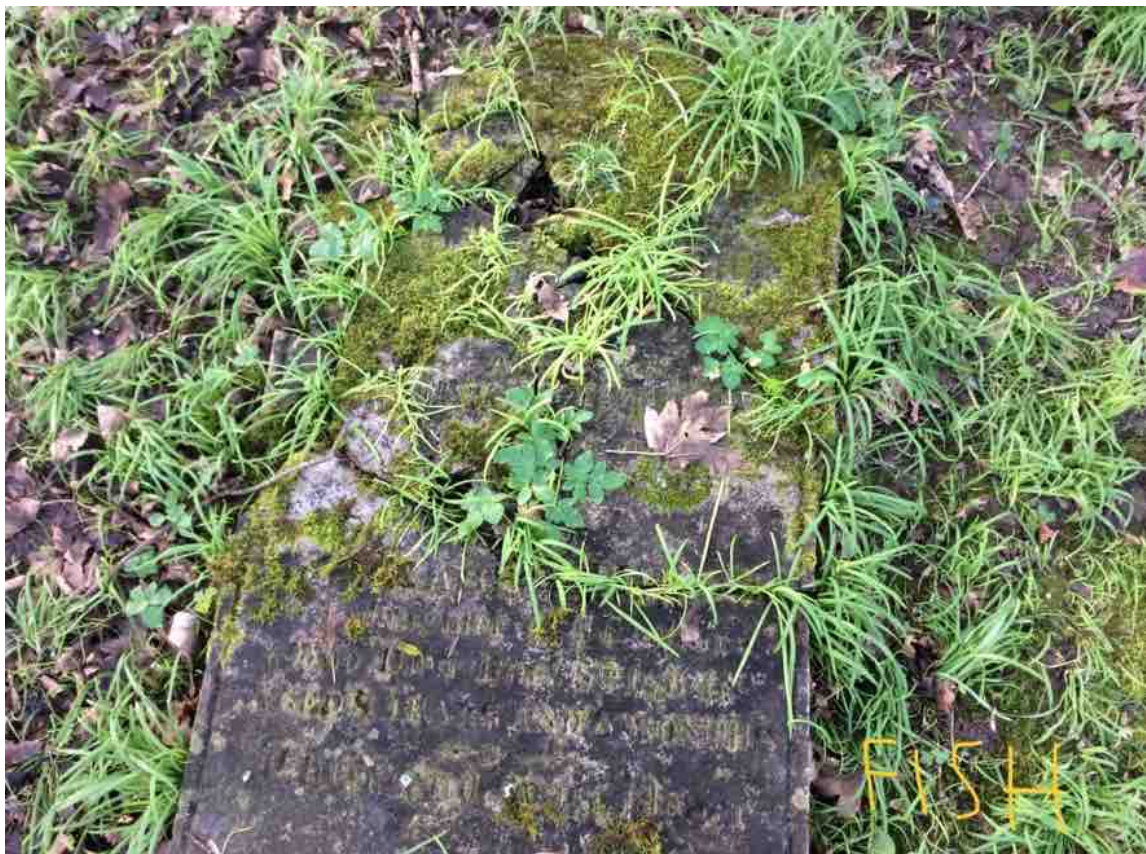
Broken headstone on ground

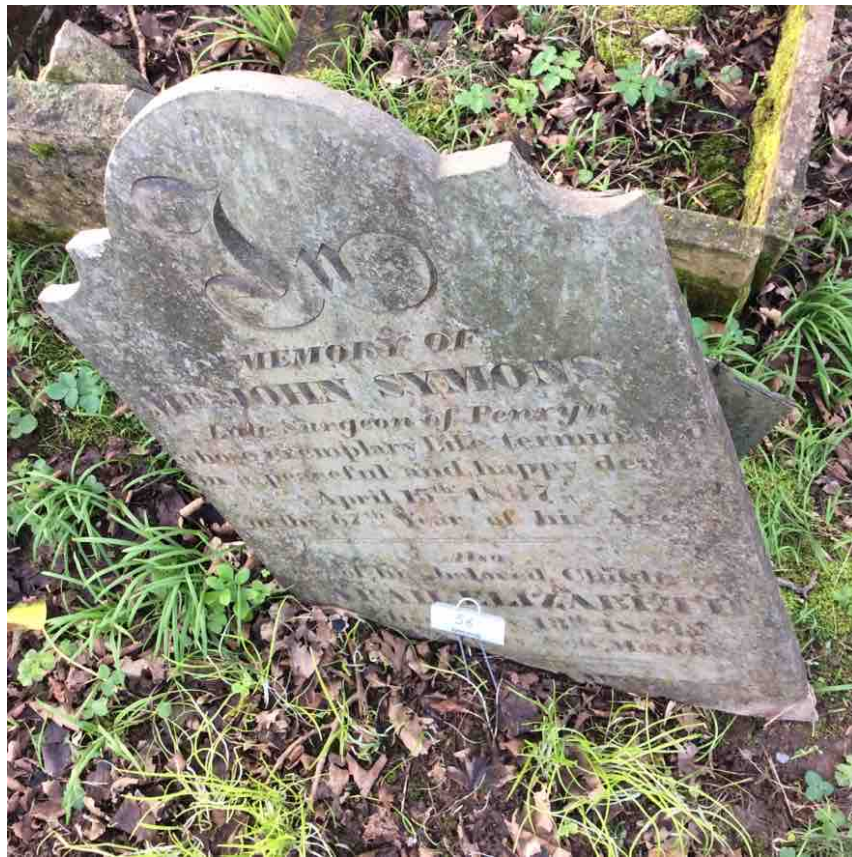
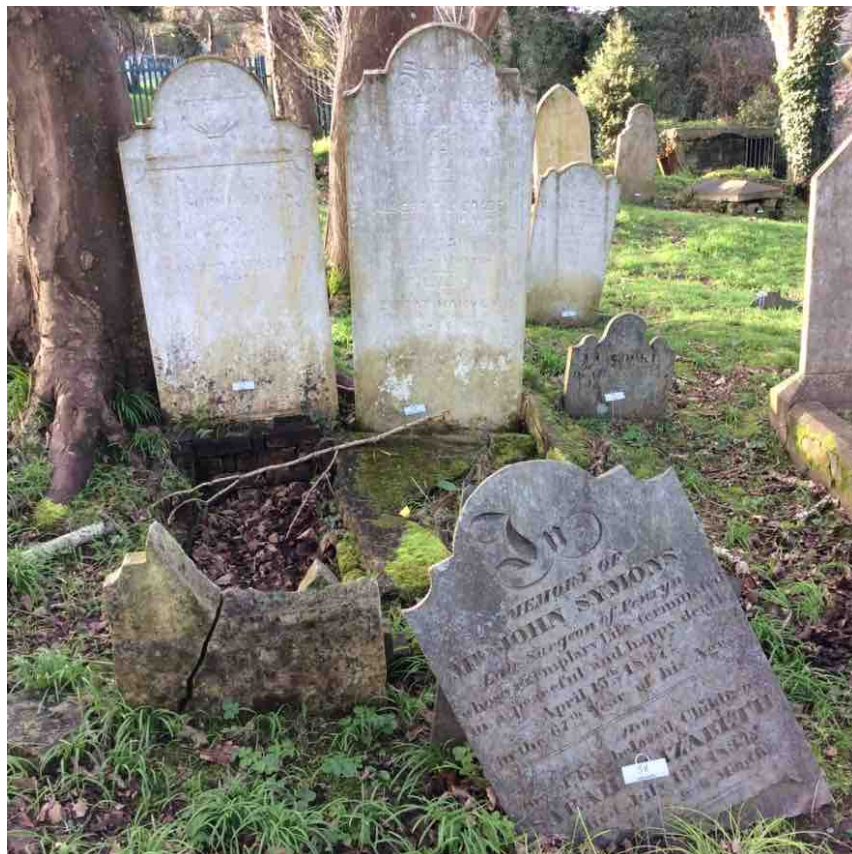
and broken section leaning against headstone, possibly unstable

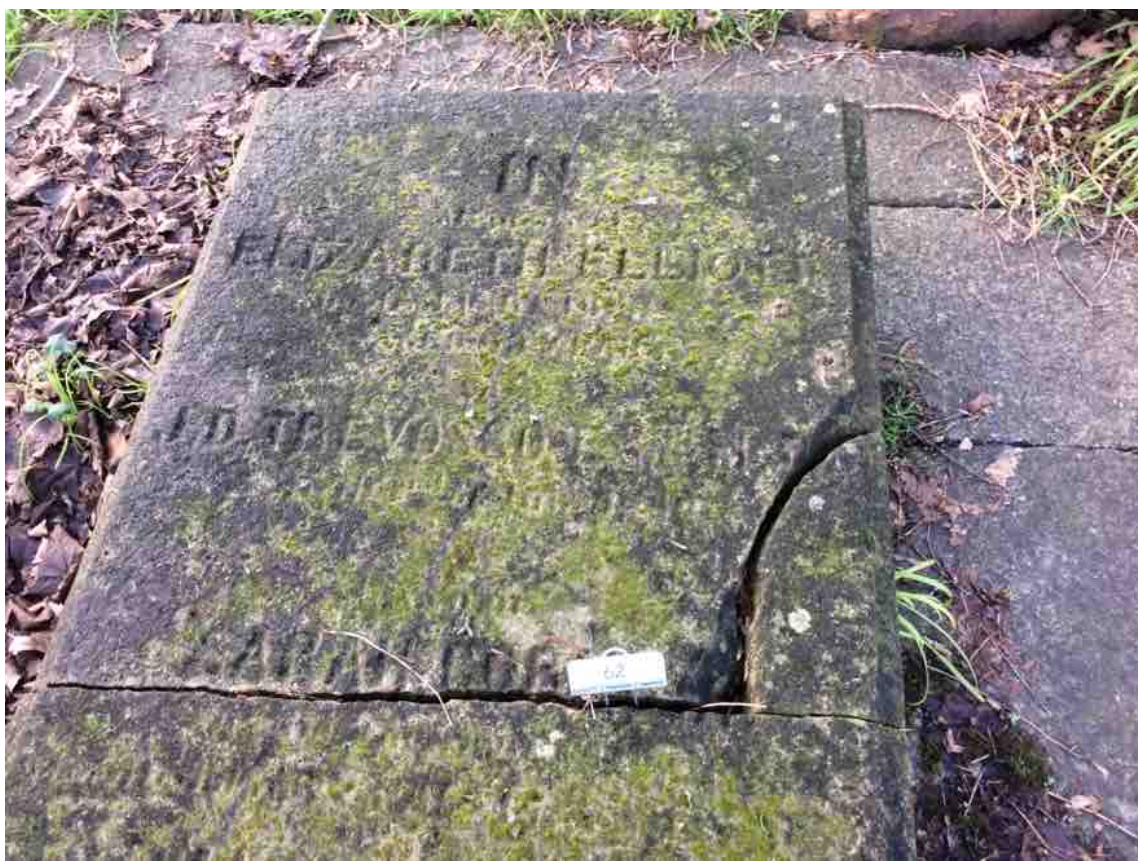
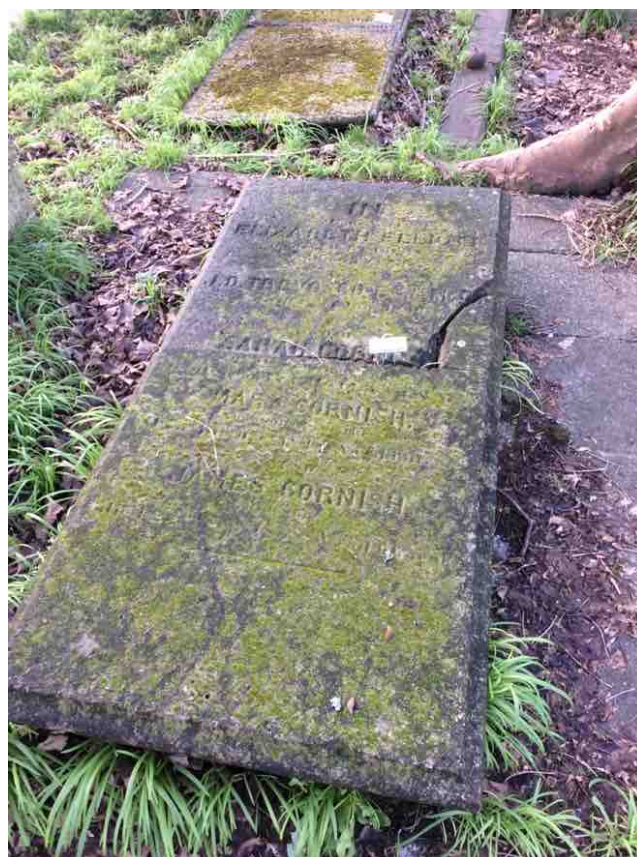
Breaks do not cause a hazard

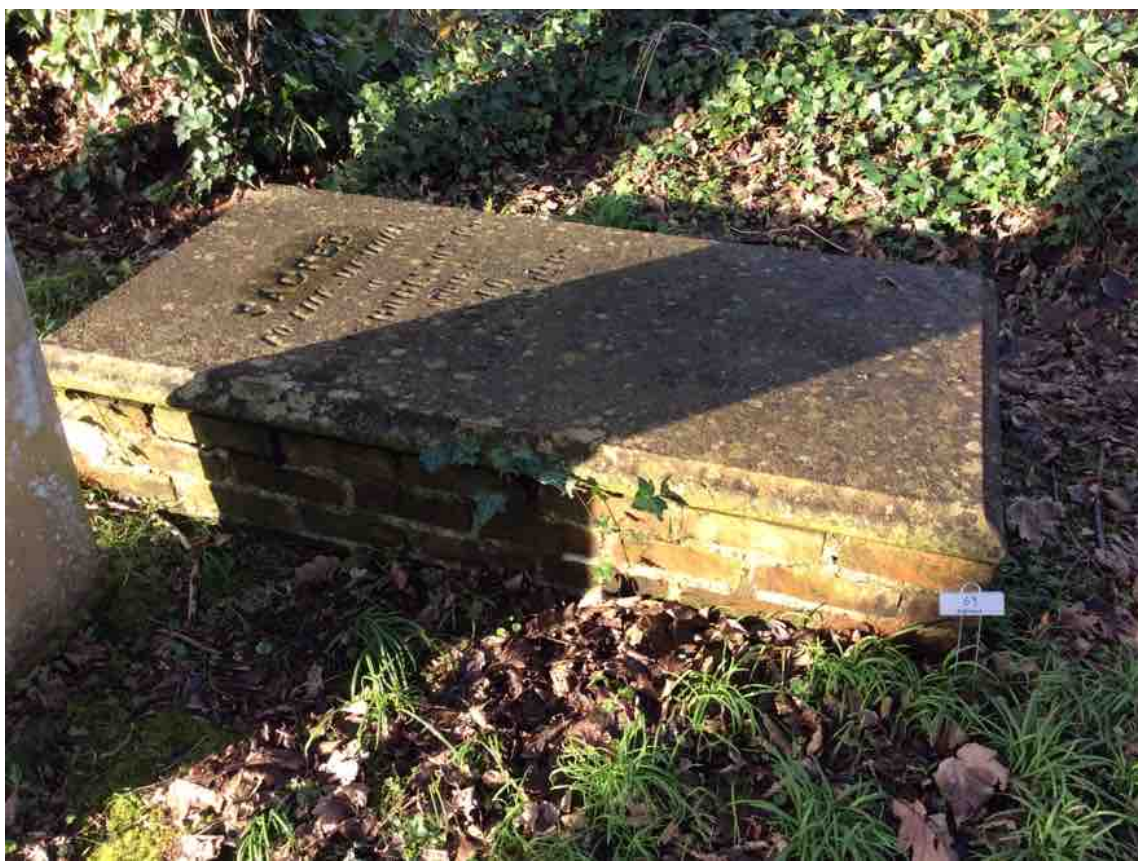
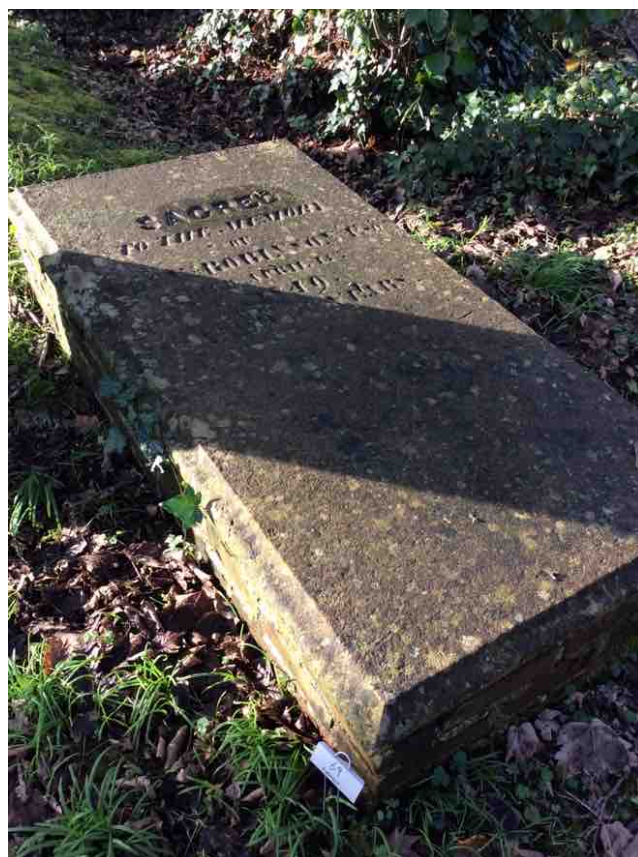
Loose brickwork. No risk

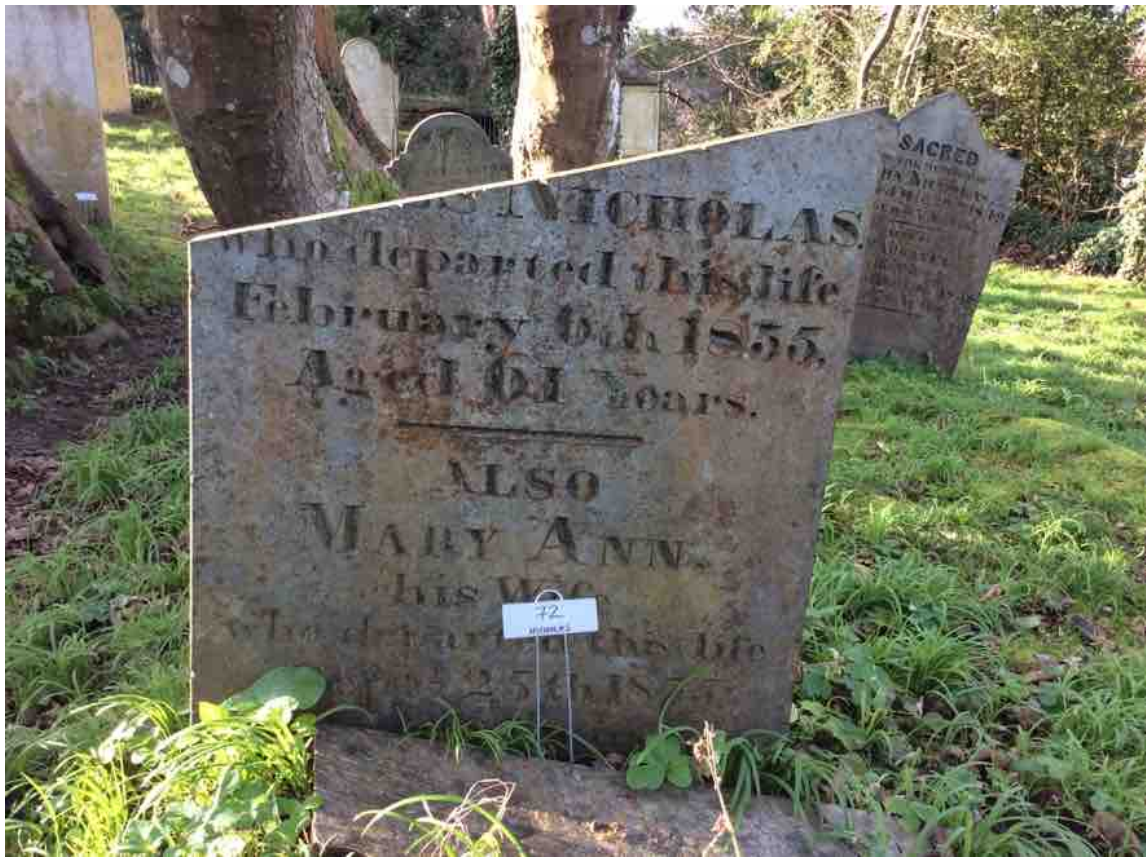
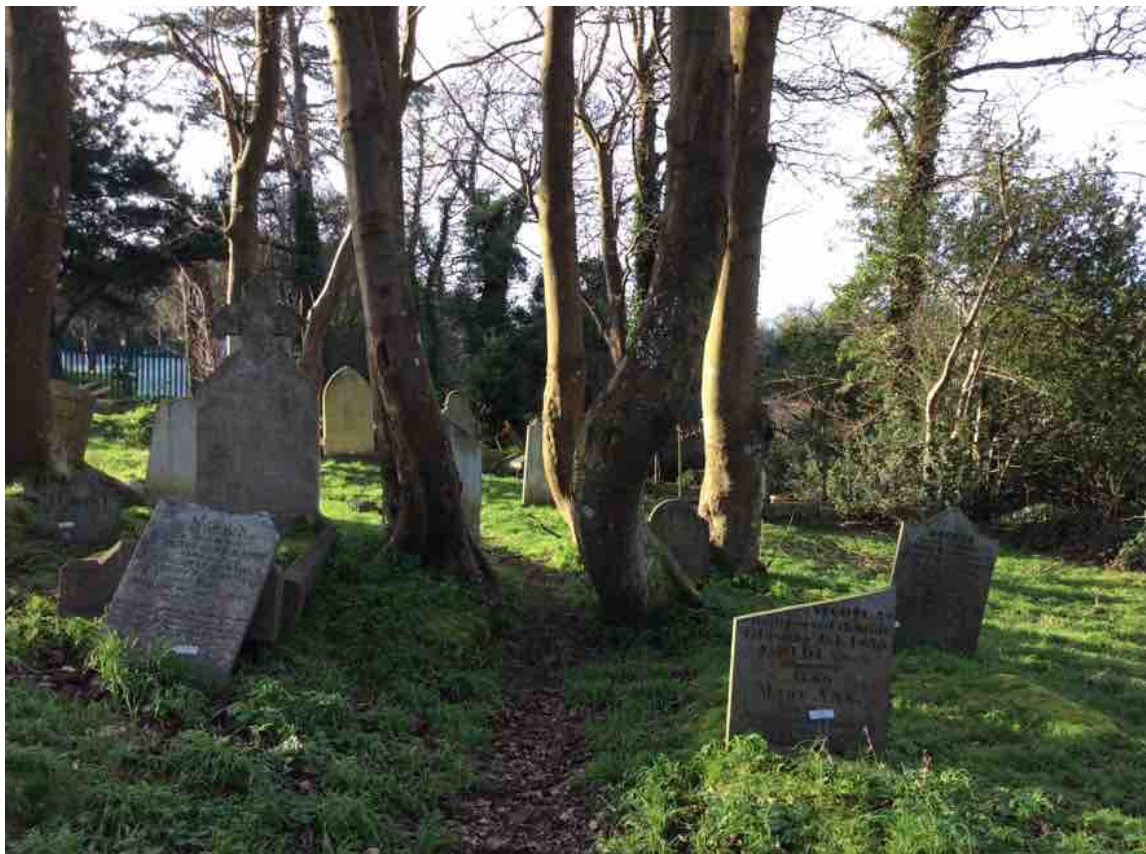
Slight lean, headstone is stable

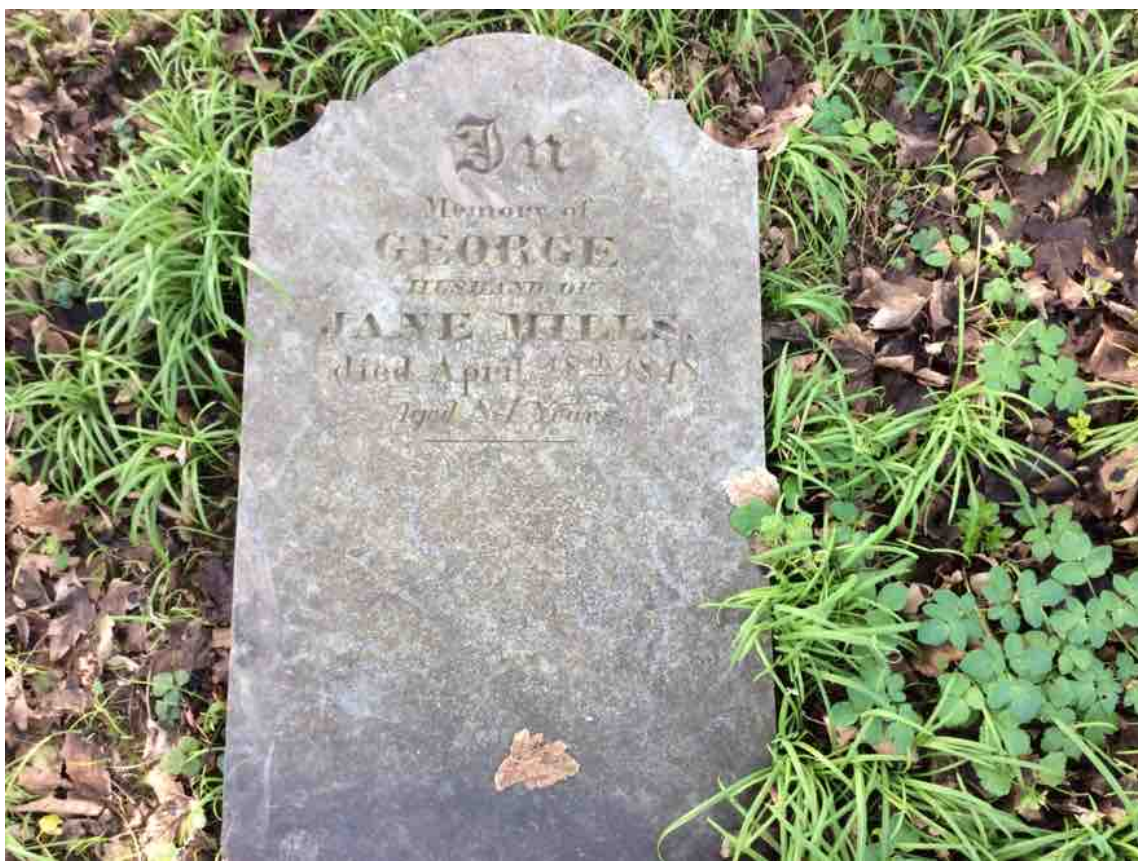
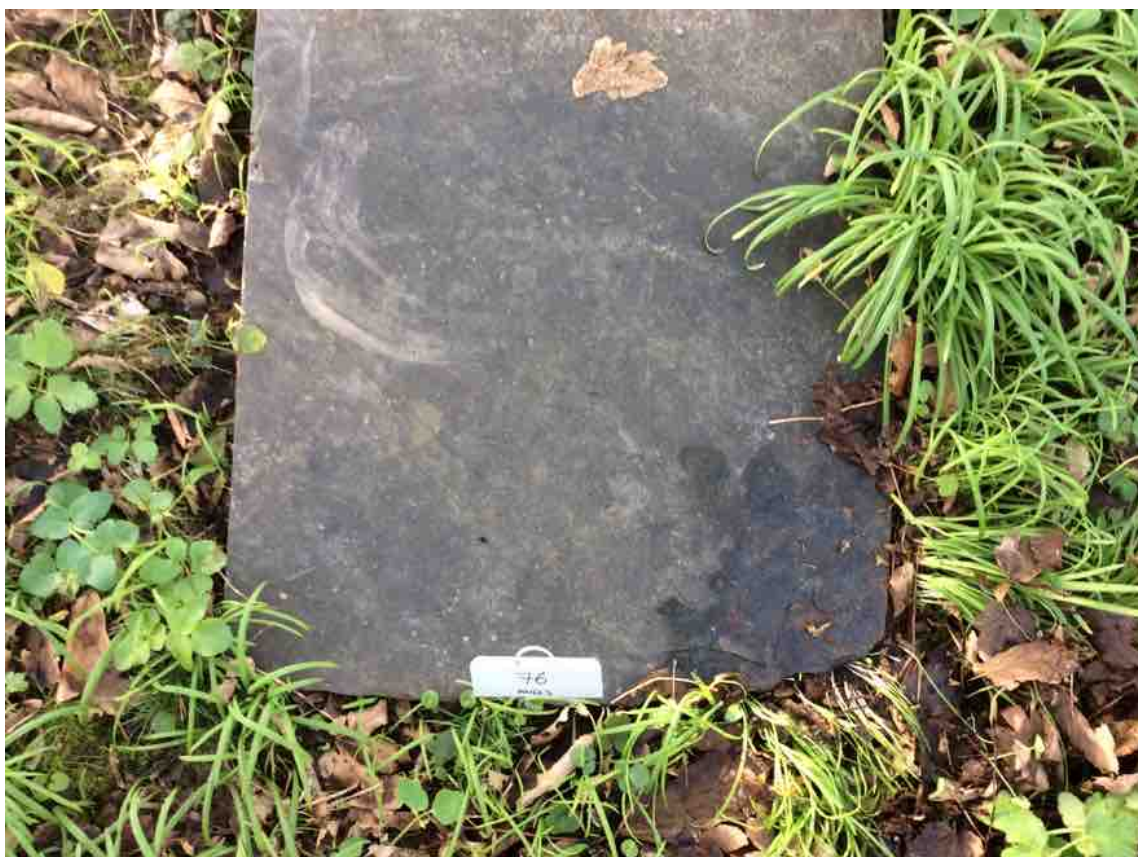
Headstone lying on ground

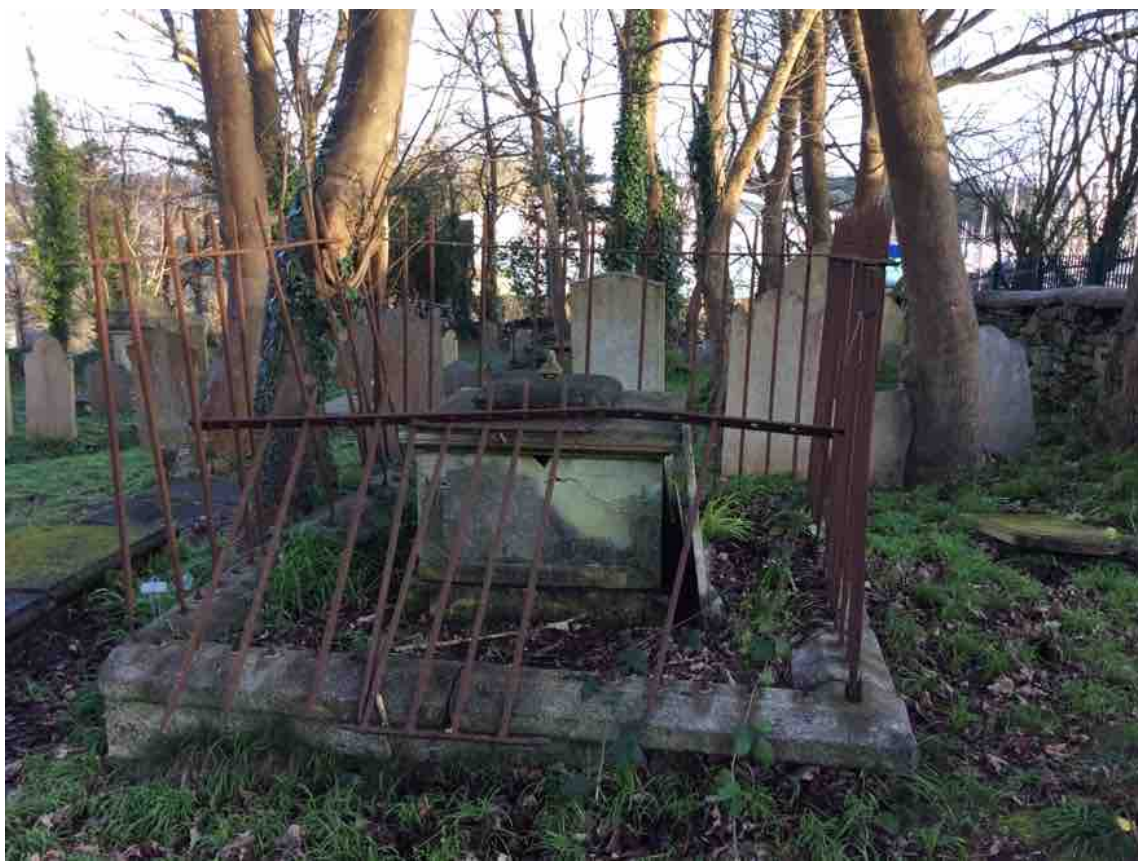
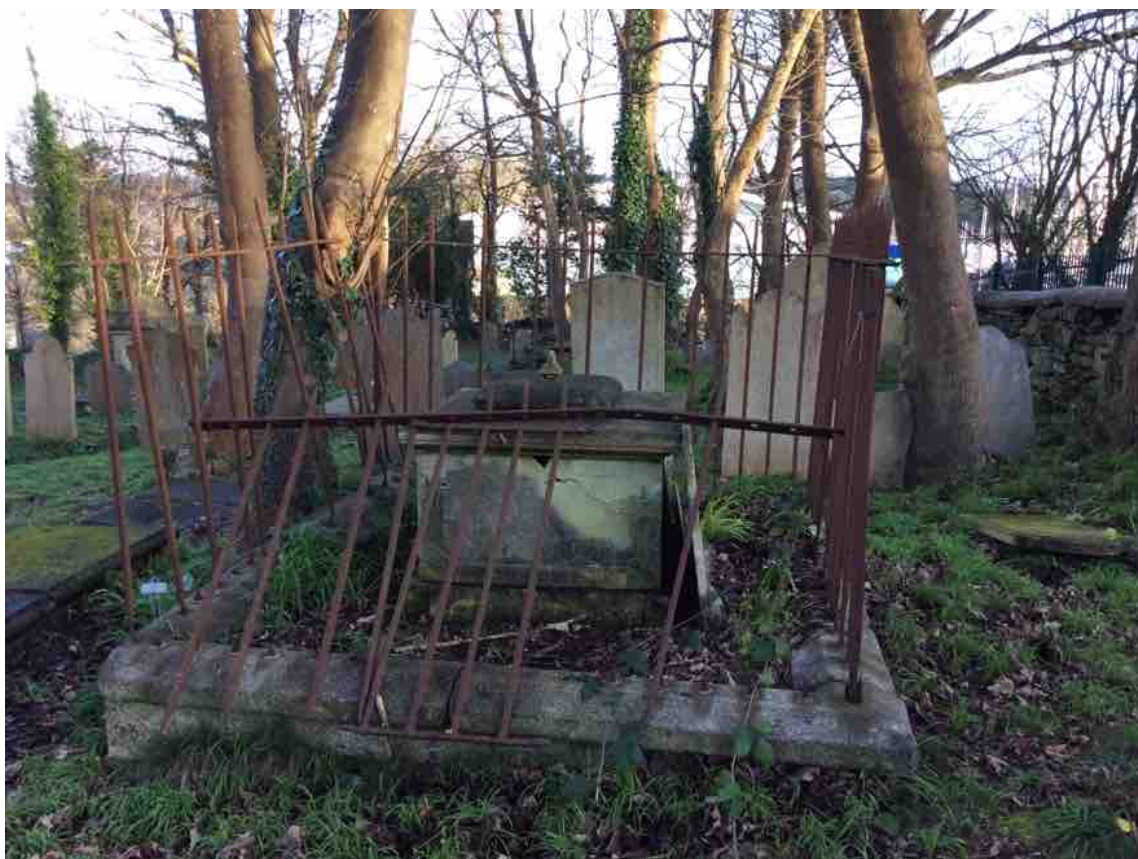
Sharp edges to broken railings

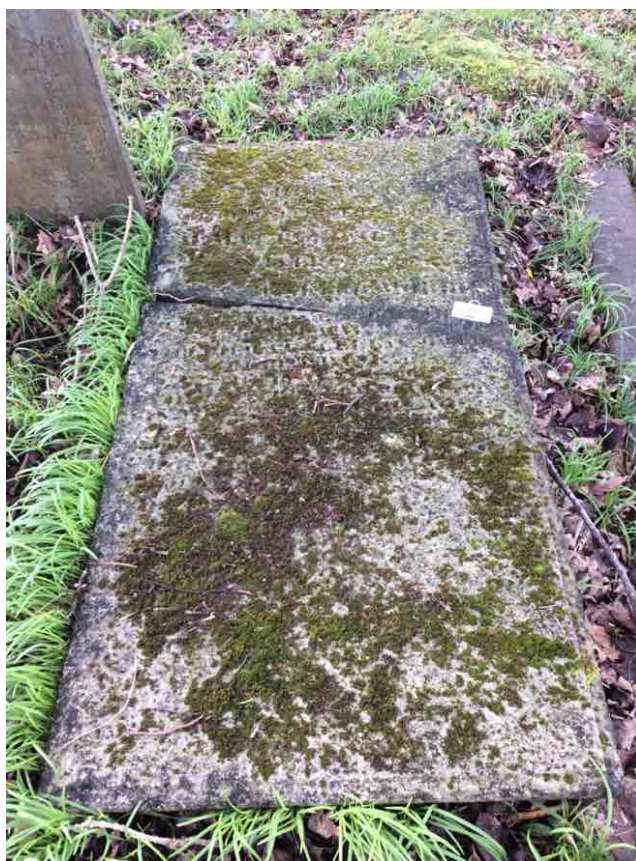
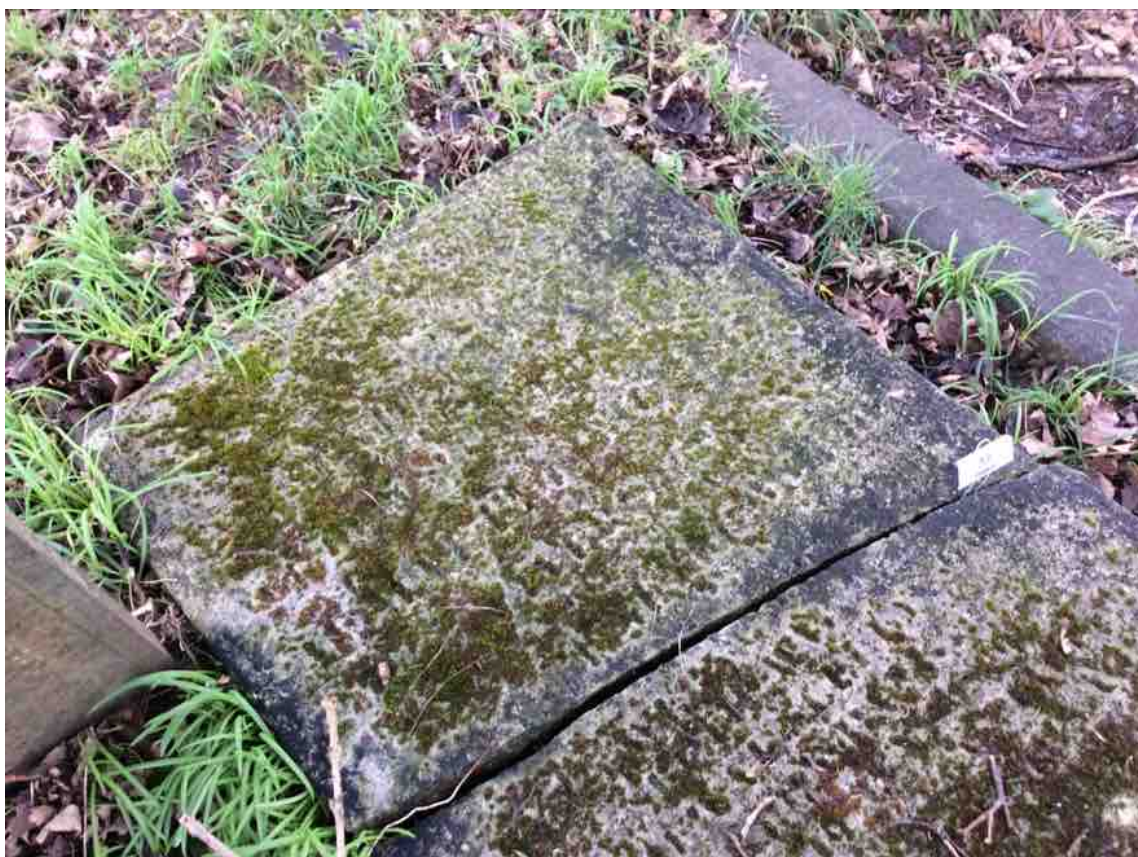
Trip hazard

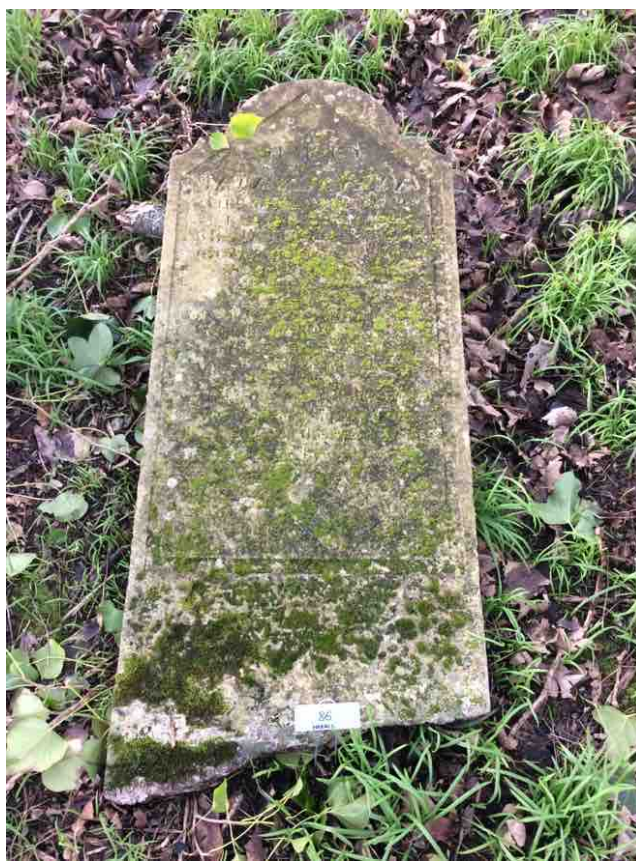
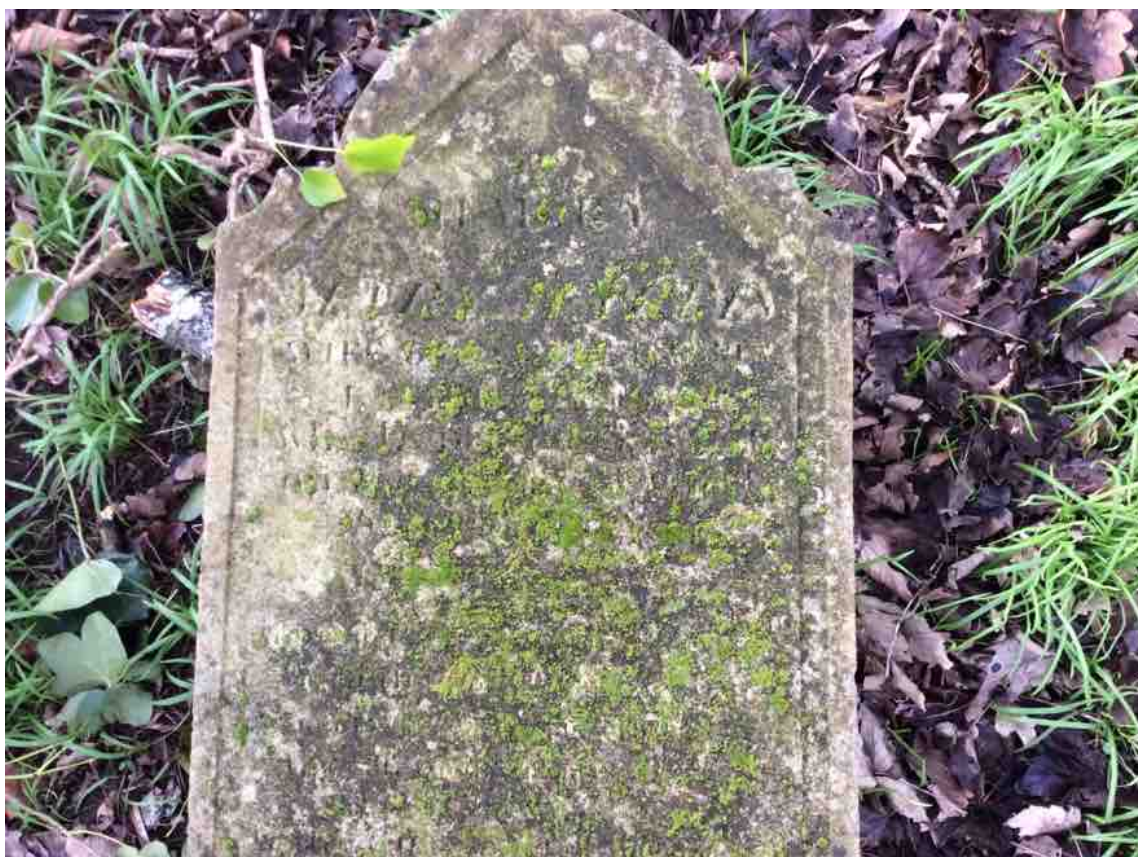
Headstone fallen flat on ground

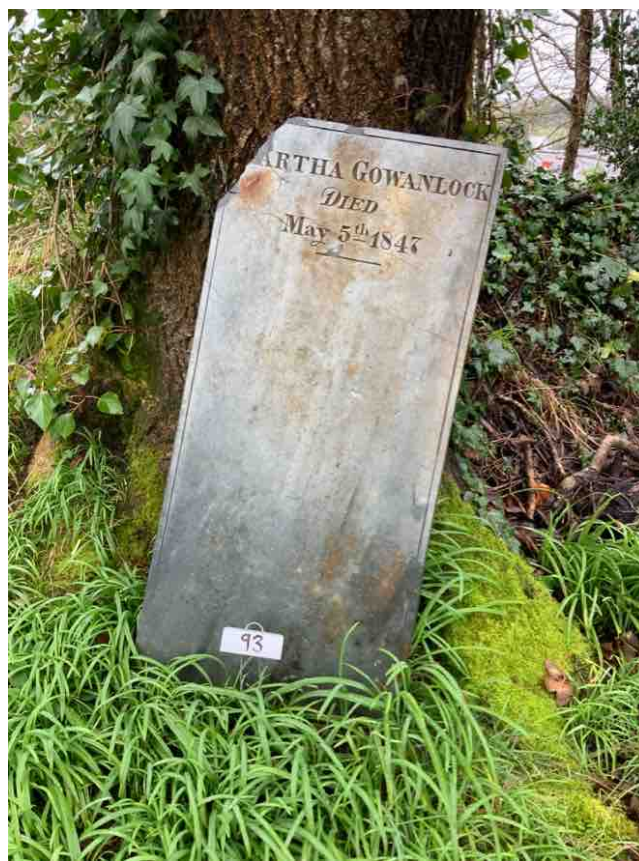
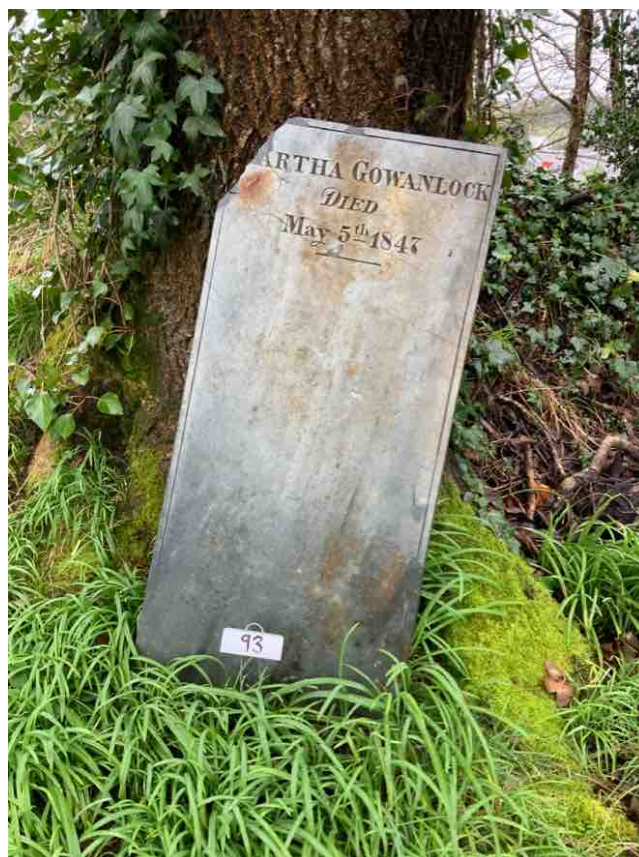
Missing section at top left

Headstone in good condition but original location not exactly known. Likely to be near C23 Walter Gowanlock, as she was his sister in law.

Loose headstone

Stable at present
