**16-0159**

**A SUMMARY DOCUMENT OF INITIAL STRUCTURAL  
INVESTIGATIONS INTO INSITU CONCRETE FRAME TO  
UPPER FLOORS**

**NEVILLE HOUSE,  
GEORGE STREET  
CORBY NN17 1QD**

**CORBY BOROUGH COUNCIL**

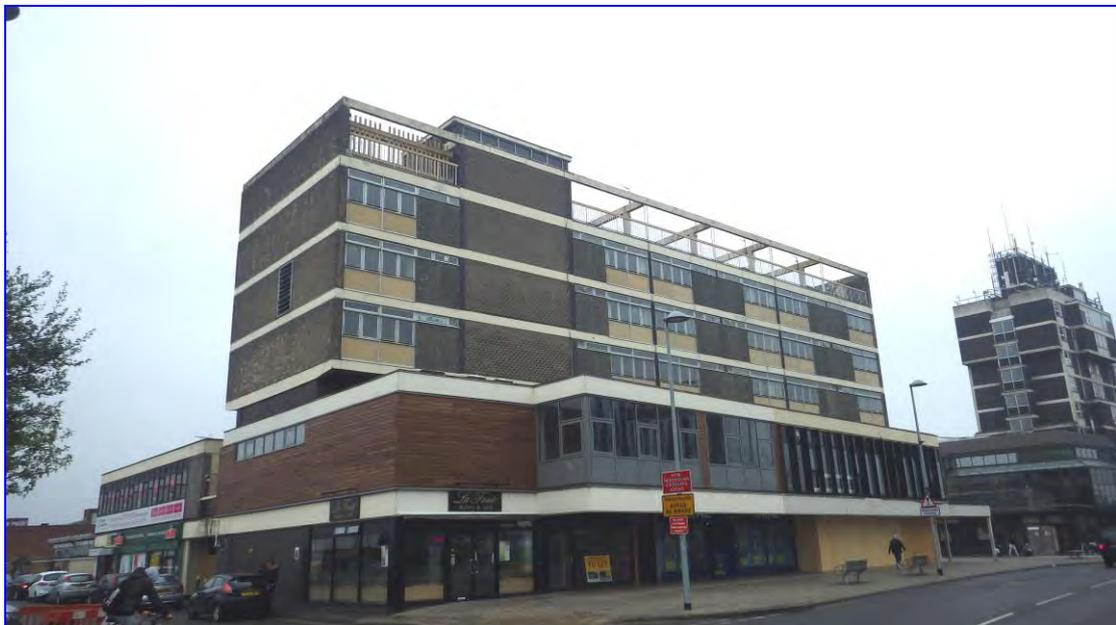
Photograph 1: General view of the structure showing the west main elevation and north gable end.

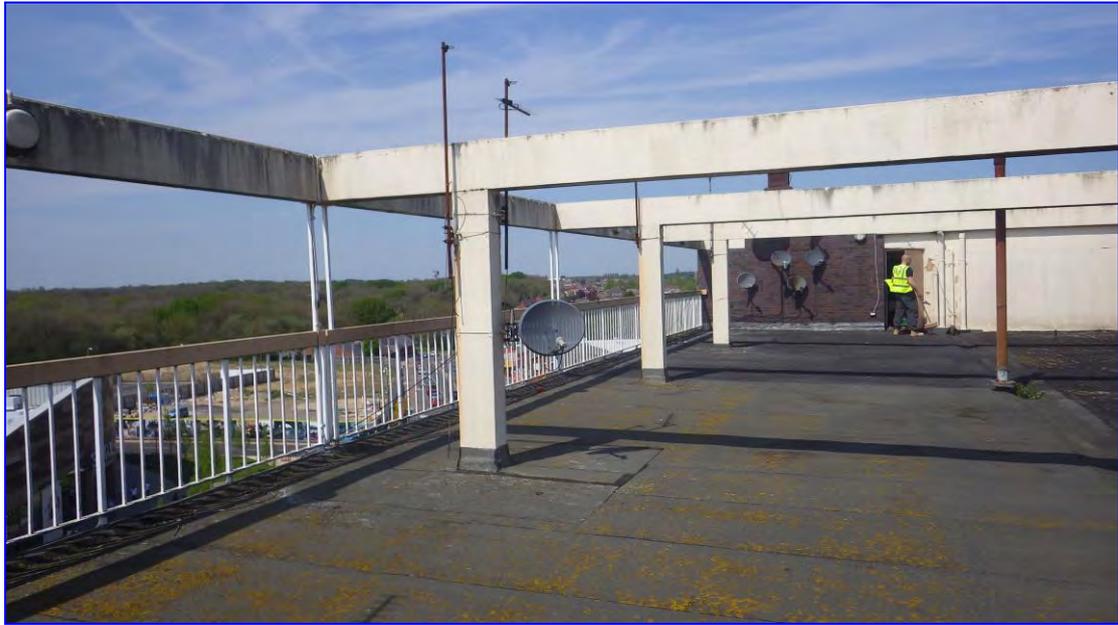
Photograph 5: General view at roof level.

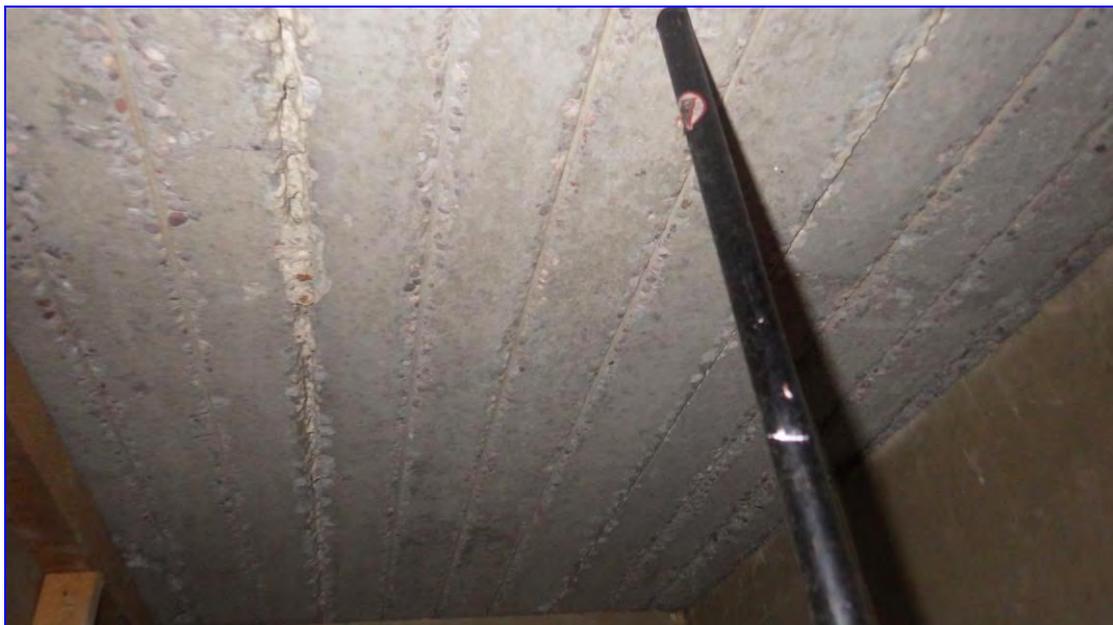
Photograph 23: View at TA11, 3<sup>rd</sup> floor soffit, showing planks.

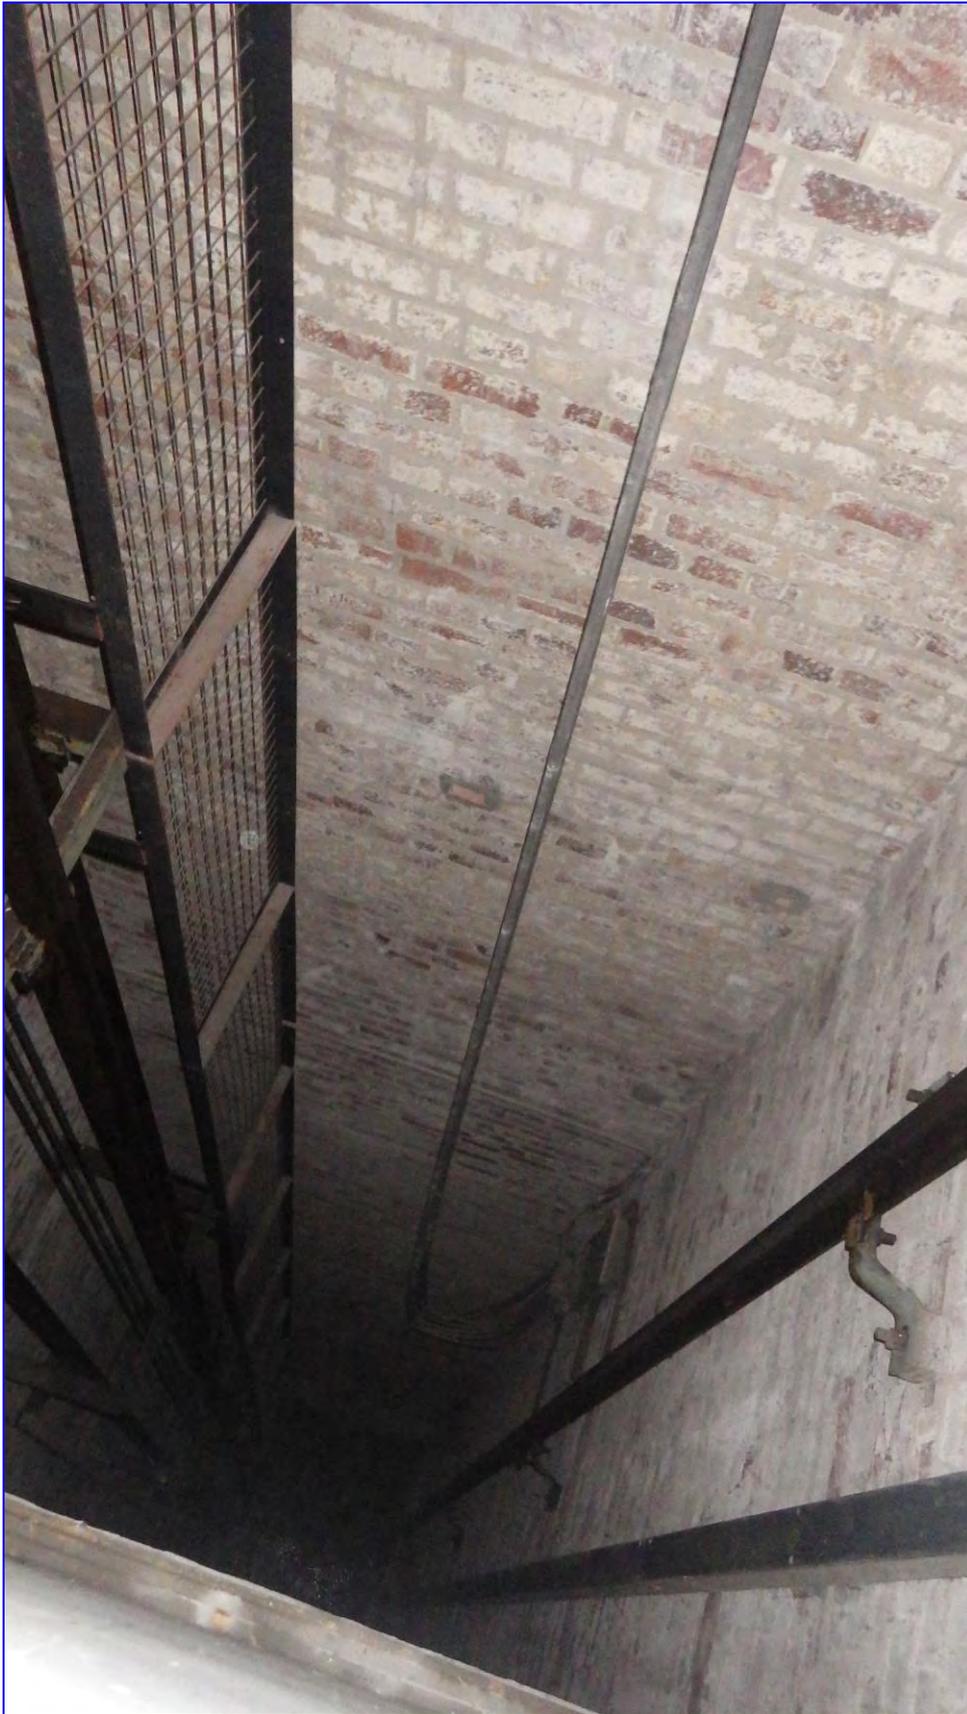
Photograph 25: A general view into the lift shaft.
