Structural Appraisal

Cotton Dell Bridge Culverts

Staffordshire Wildlife Trust

Ref: 8968

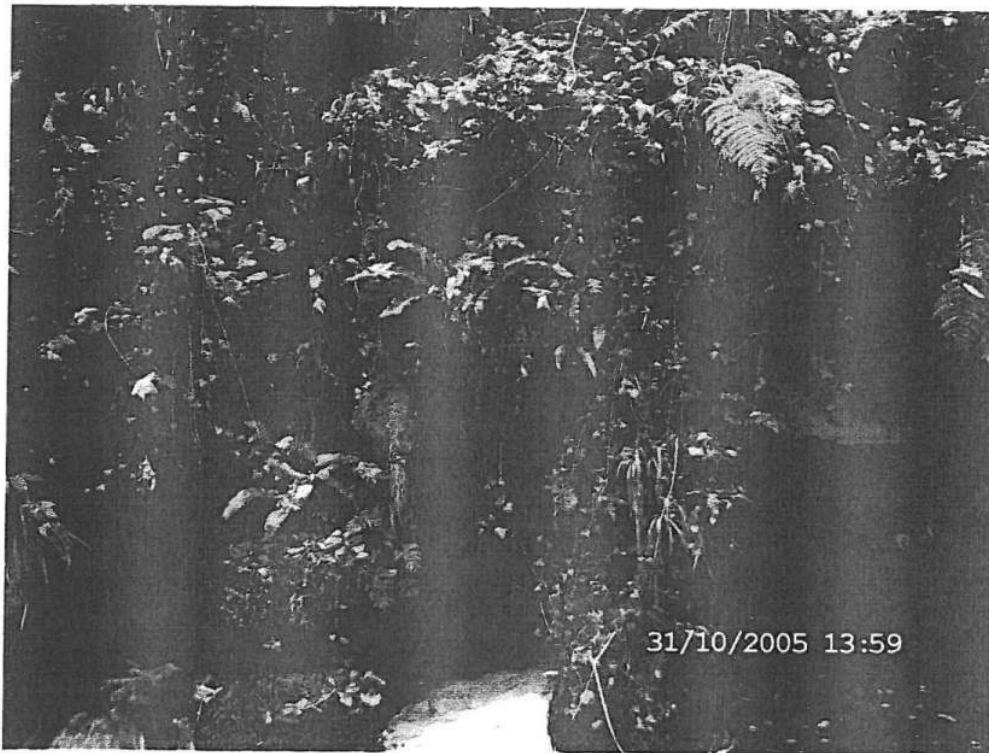
Photograph 1 – Downstream Headwall, Culvert "B".

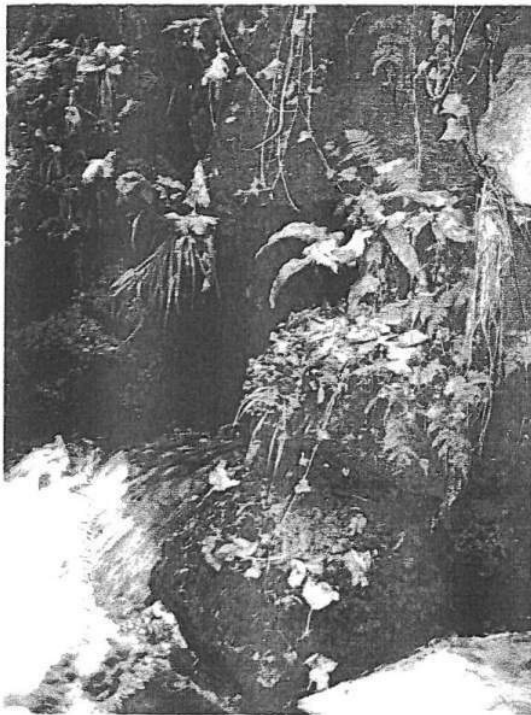
Photograph 3 – Downstream Headwall, Culvert "C".

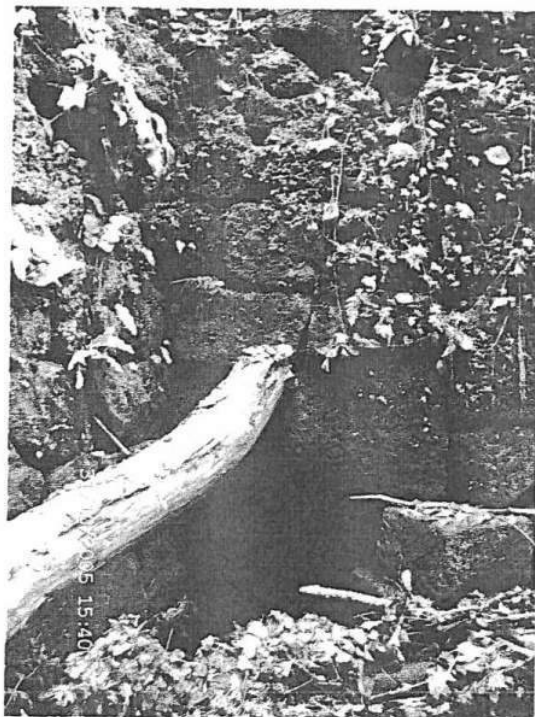
Photograph 23 – Upstream Headwall, Culvert "A".

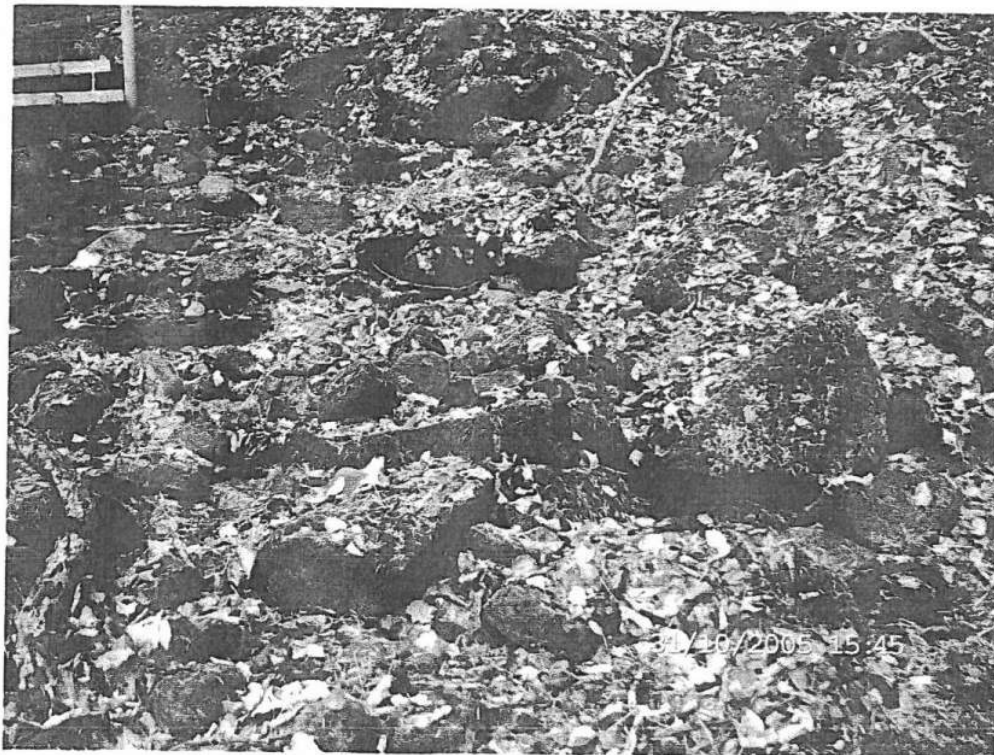
Photograph 29 – Loose Boulders in Stream Bed Upstream.
