**Jubilee Hall
Station Road
Anstey
Leicestershire
LE7 7AY**

Job Number: 9675

Anstey Parish Council

CCTV Inspection Report

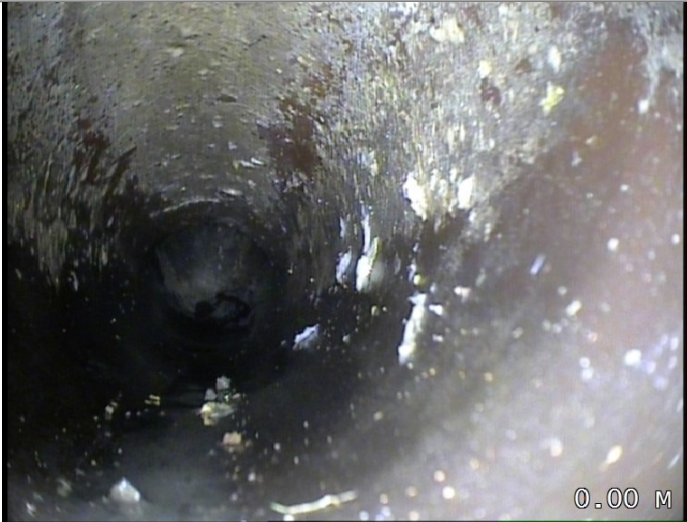
<p>0.00 M</p> <p>Start node type, manhole, reference MH1</p>

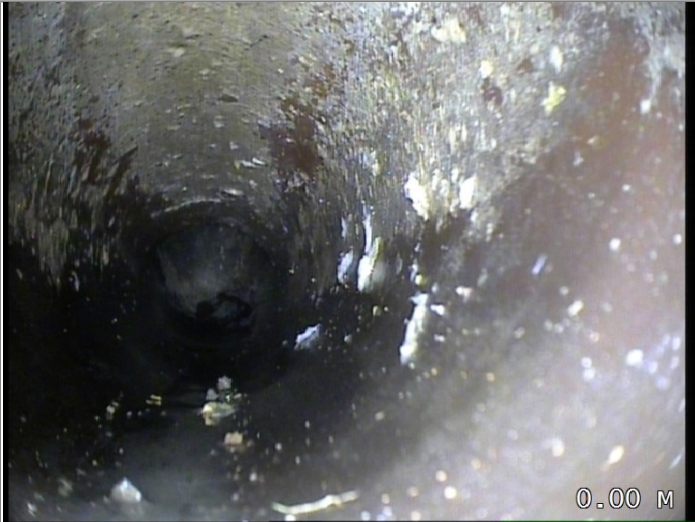
<p>0.00 M</p> <p>Water level 0% height/diameter</p>

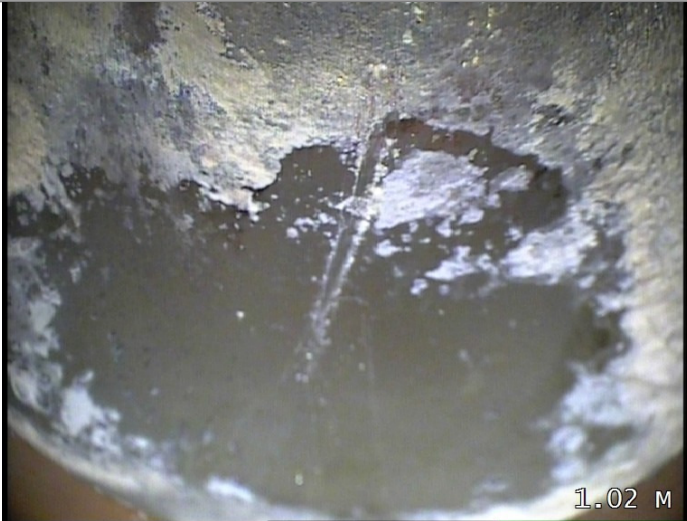
<p>1.02 M</p> <p>Line of drain/sewer deviates up full</p>

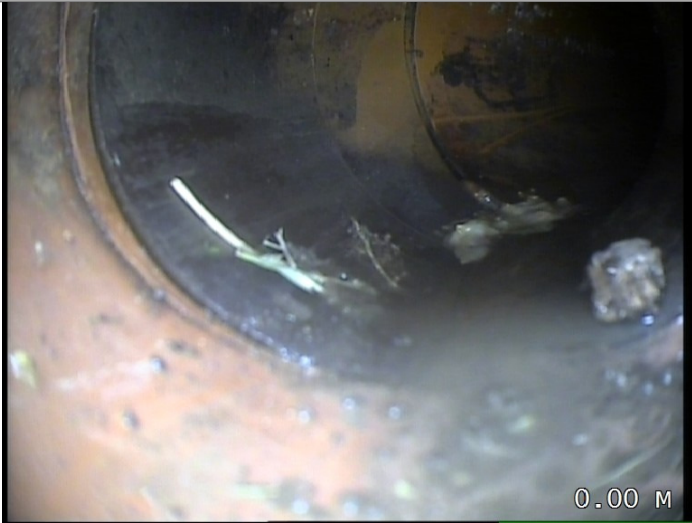
<p>0.00 M</p> <p>Start node type, inspection chamber, reference IC2</p>

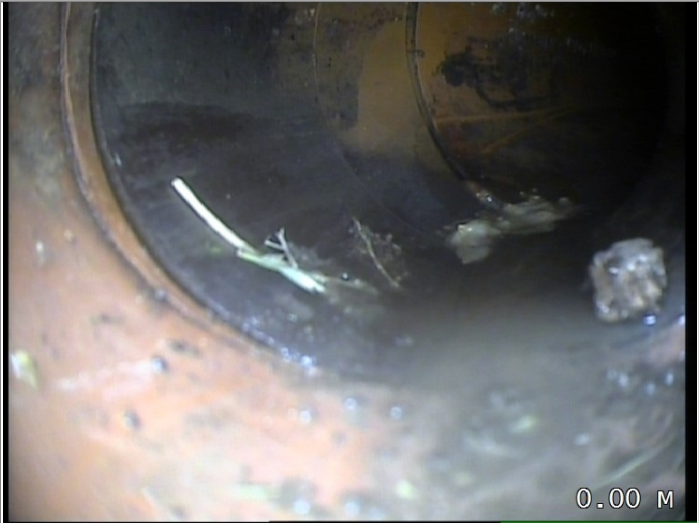
<p>0.00 M</p> <p>Water level 0% height/diameter</p>

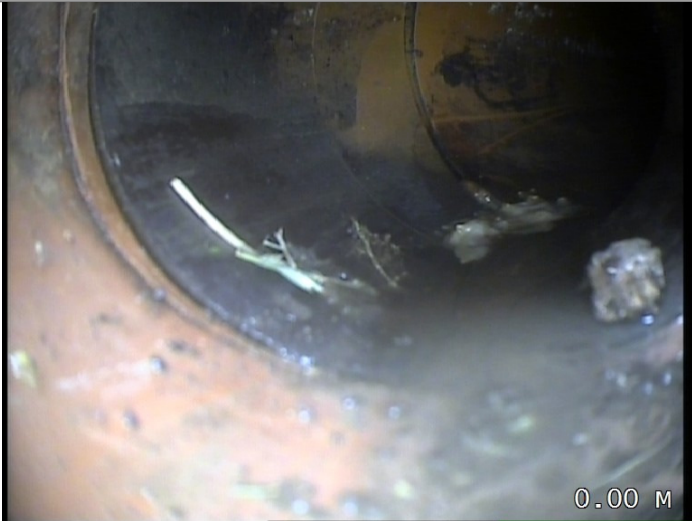
<p>0.00 M</p> <p>Line of drain/sewer deviates right half</p>

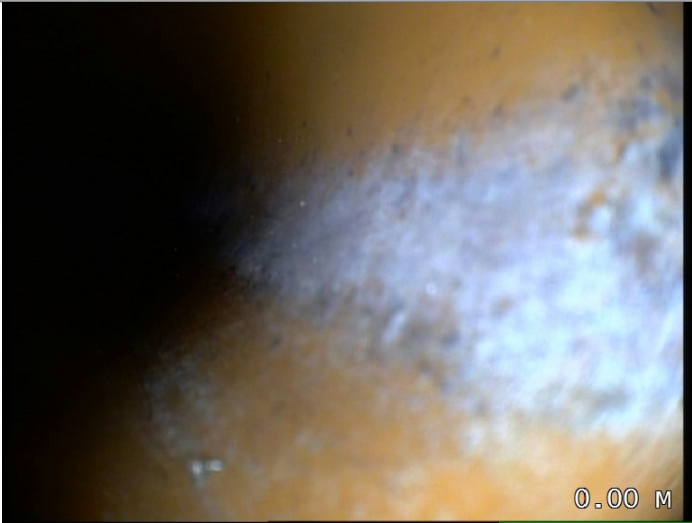
<p>0.00 M</p> <p>Start node type, inspection chamber, reference IC2</p>

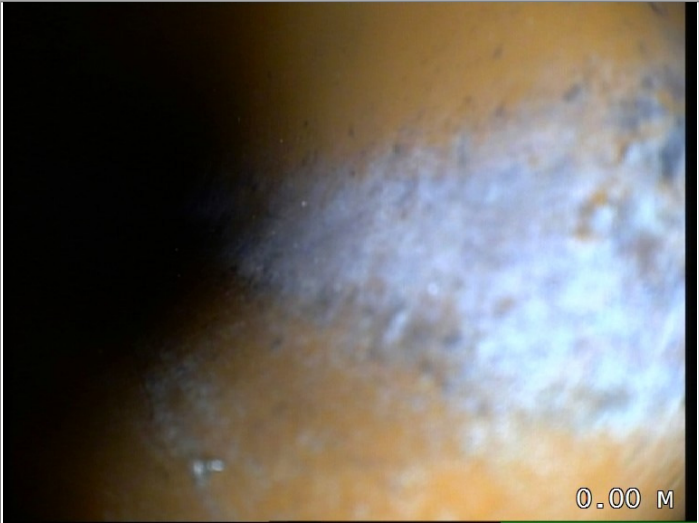
<p>0.00 M</p> <p>Water level 0% height/diameter</p>

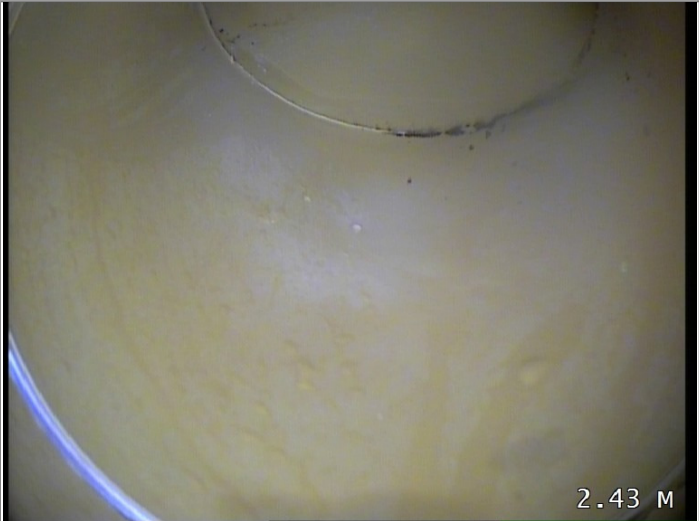
<p>2.43 M</p> <p>Line of drain/sewer deviates up full</p>

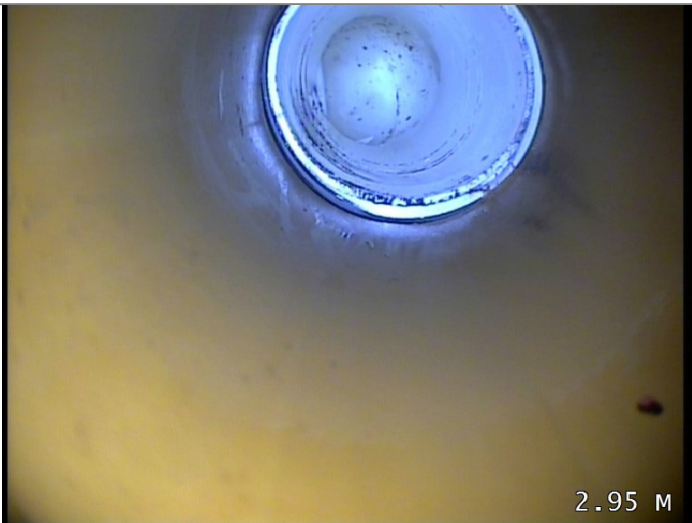
<p>2.95 M</p> <p>Finish node type, outfall, reference SP1</p>

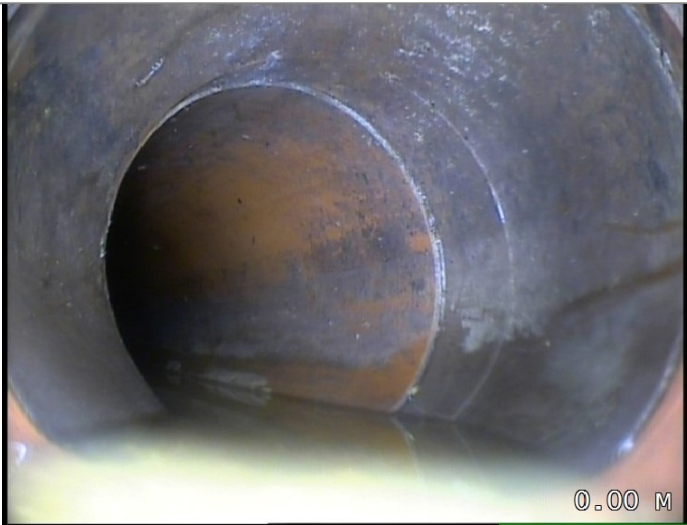
<p>0.00 M</p> <p>Start node type, inspection chamber, reference IC2</p>

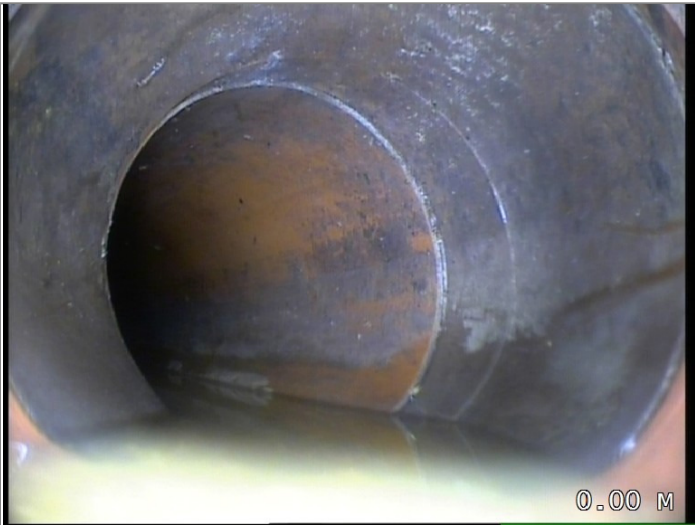
<p>0.00 M</p> <p>Water level 10% height/diameter</p>

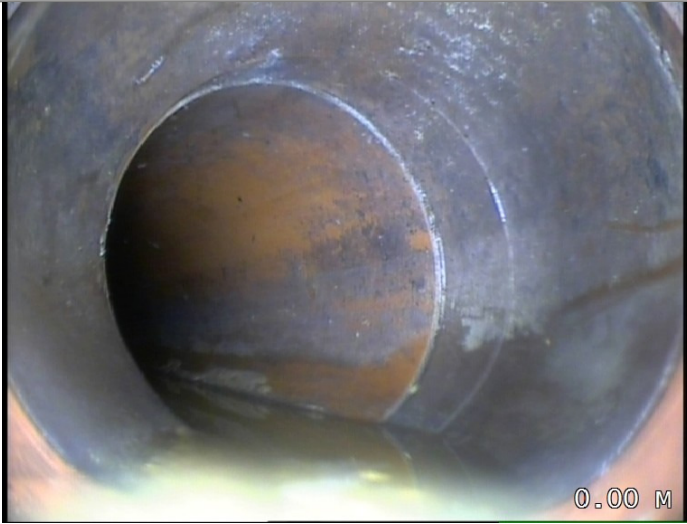
<p>0.00 M</p> <p>Line of drain/sewer deviates left half</p>

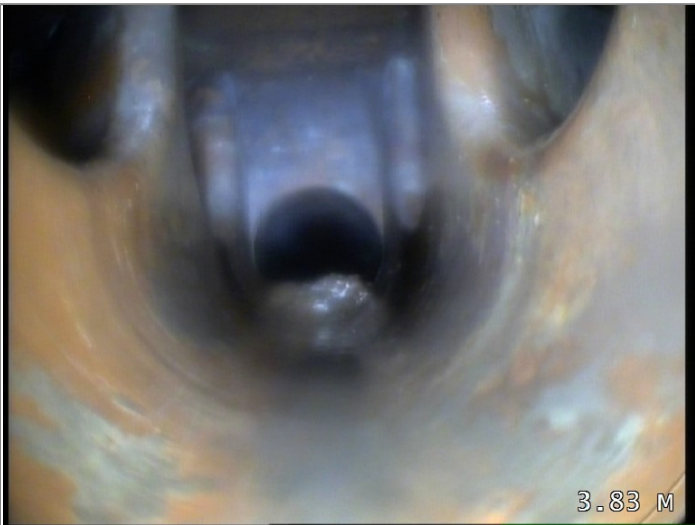
<p>3.83 M</p> <p>Finish node type, inspection chamber, reference IC3</p>

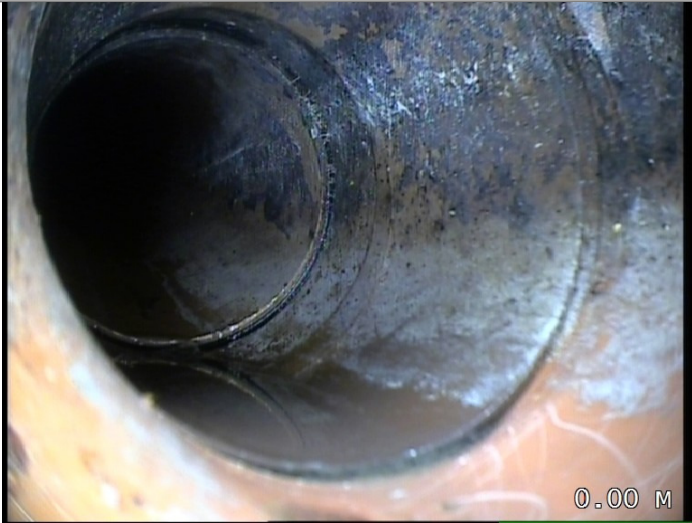
<p>0.00 M</p> <p>Start node type, inspection chamber, reference IC3</p>

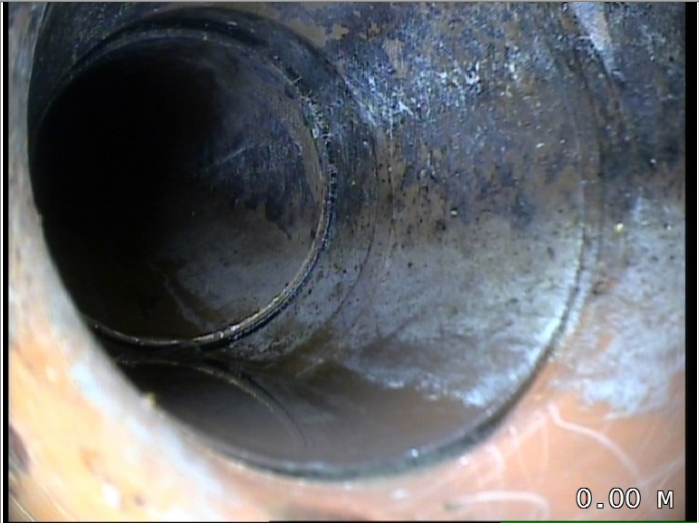
<p>0.00 M</p> <p>Water level 0% height/diameter</p>

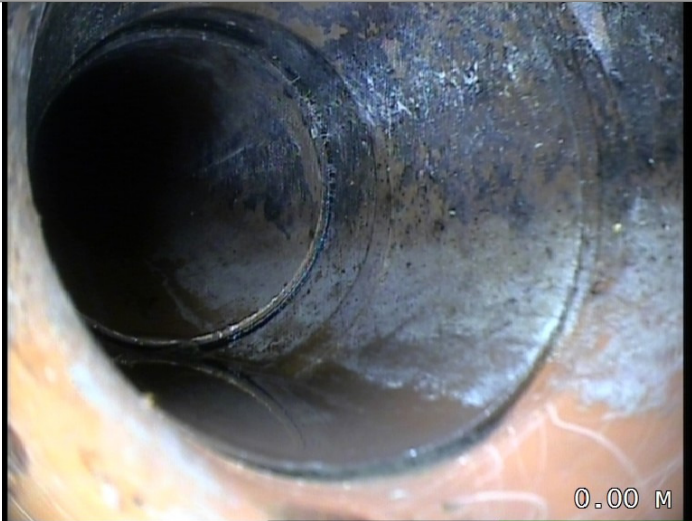
<p>0.00 M</p> <p>Line of drain/sewer deviates left half</p>

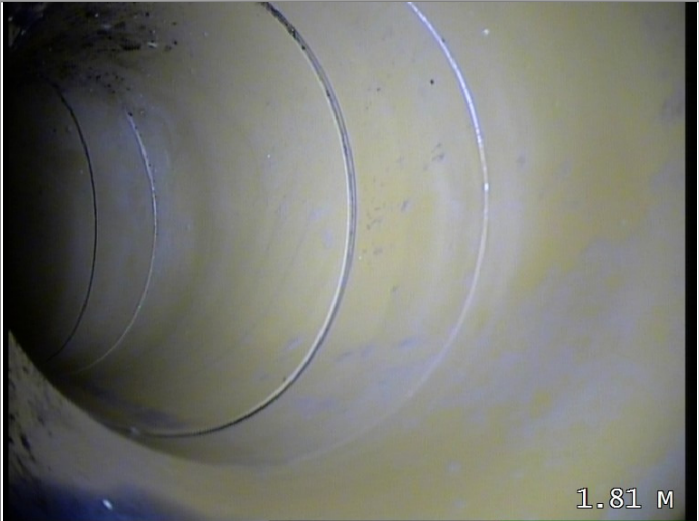
<p>1.81 M</p> <p>Line of drain/sewer deviates left half</p>

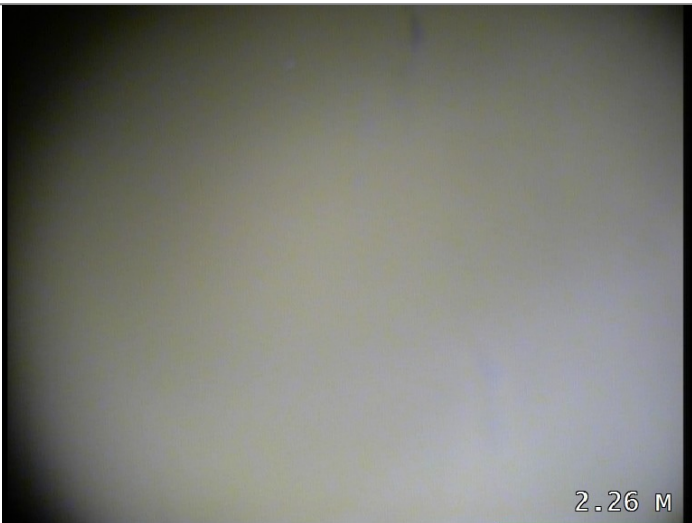
<p>2.26 M</p> <p>Line of drain/sewer deviates up full</p>

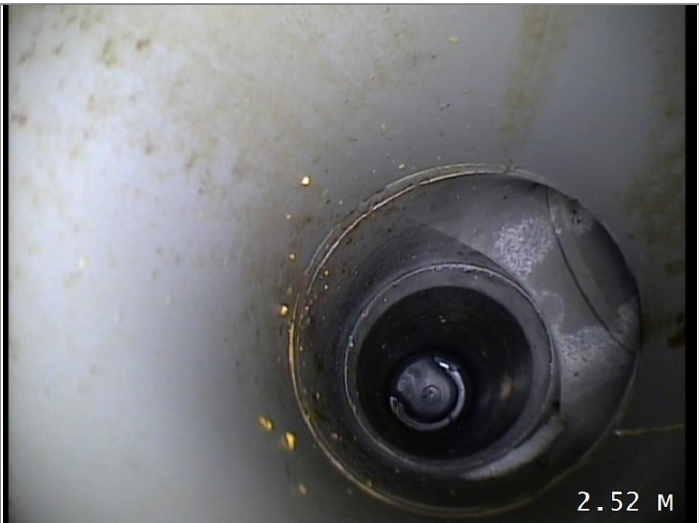
<p>2.52 M</p> <p>Finish node type, outfall, reference SP2</p>

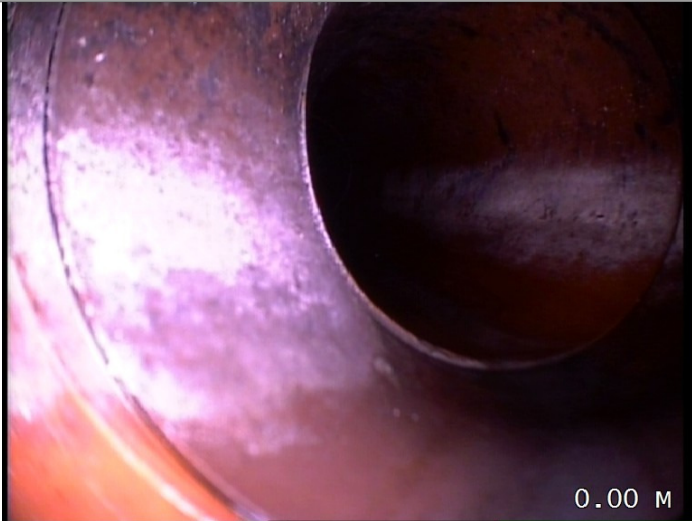
<p>0.00 M</p> <p>Line of drain/sewer deviates left quarter</p>

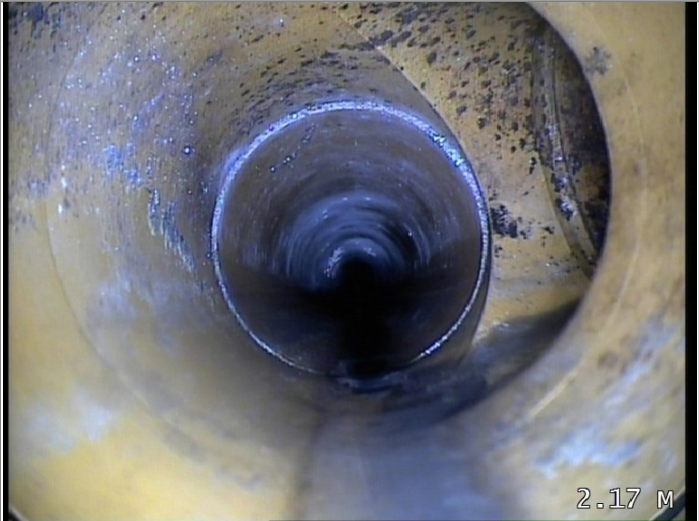
<p>2.17 M</p> <p>Junction at 3 o'clock, diameter 100mm</p>

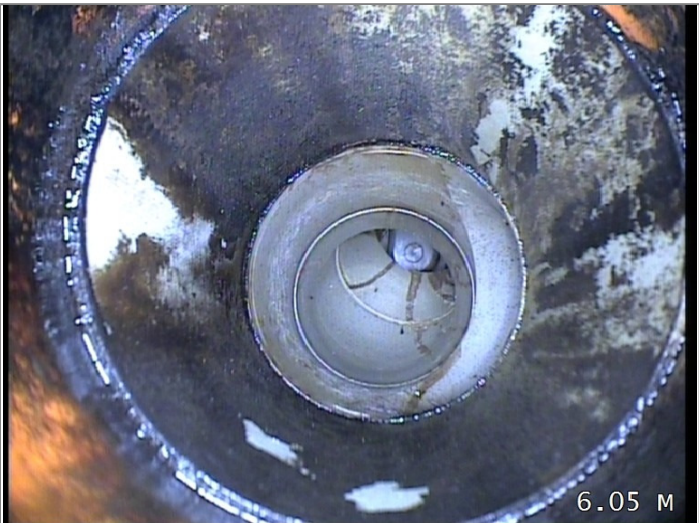
<p>6.05 M</p> <p>Finish node type, outfall, reference SP3</p>

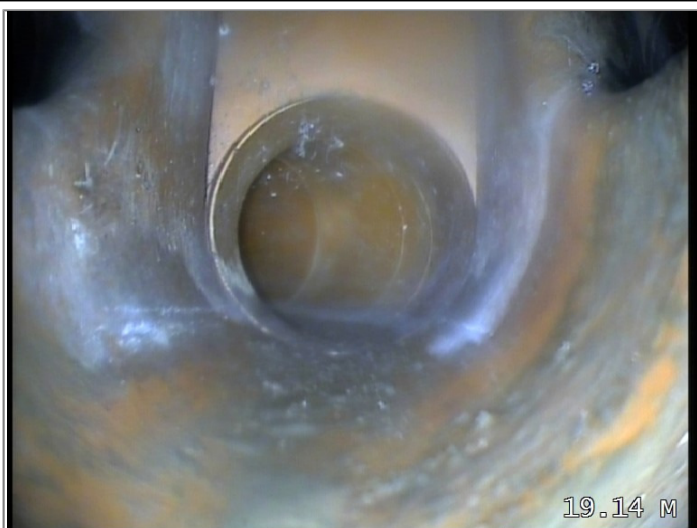
Finish node type, inspection chamber, reference IC4

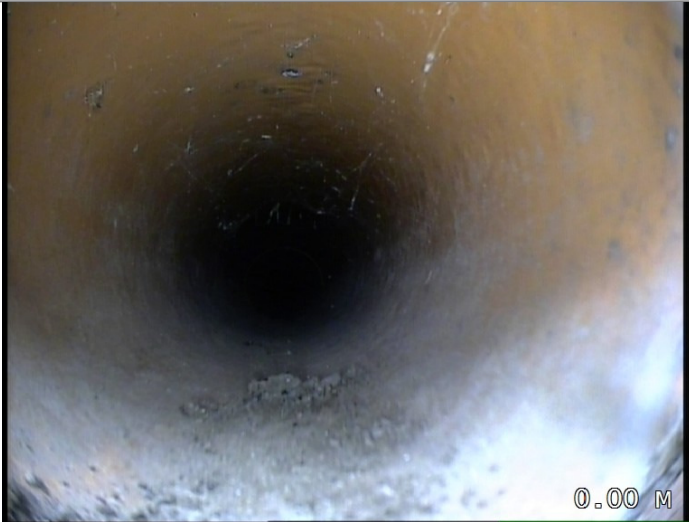
<p>0.00 M</p> <p>Start node type, inspection chamber, reference IC4</p>

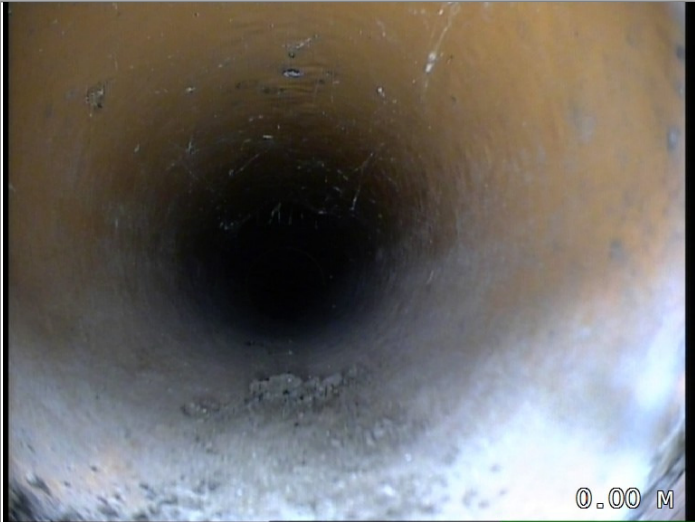
<p>0.00 M</p> <p>Water level 0% height/diameter</p>

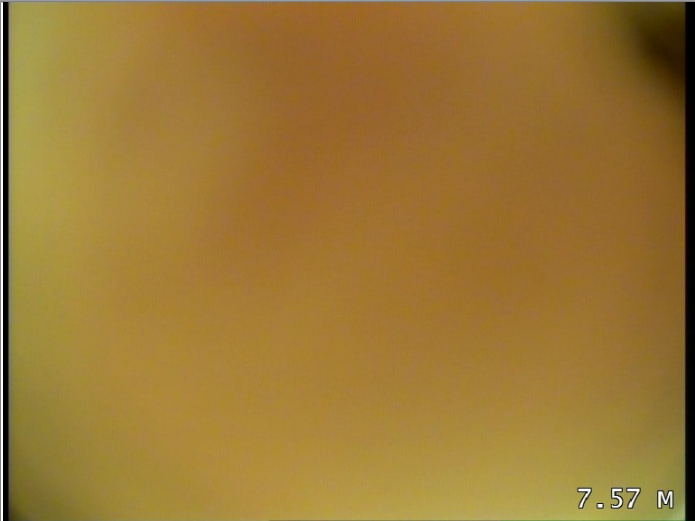
<p>7.57 M</p> <p>Finish node type, outfall, reference SP4</p>

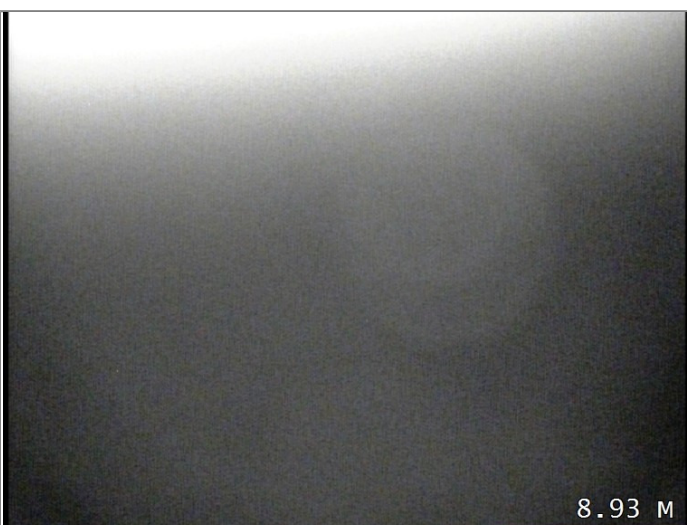
<p>8.93 M</p>	
<p>Settled deposits fine 25% cross-sectional area loss</p>		<p>Survey abandoned - Remark: Due to debris (B)</p>

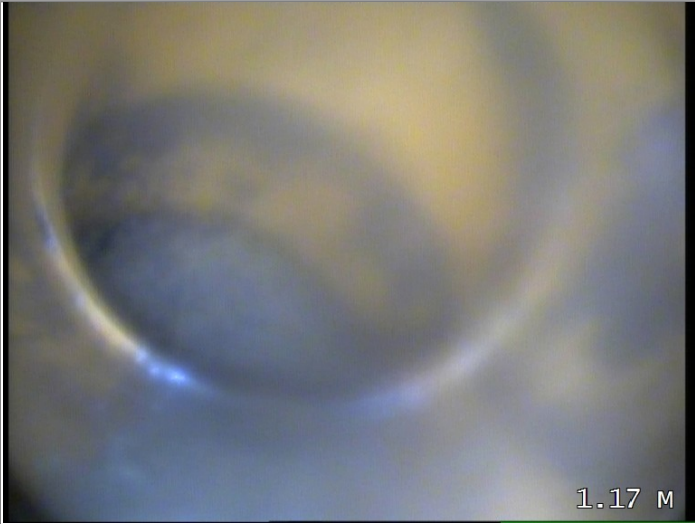
<p>1.17 M</p> <p>Line of drain/sewer deviates left half</p>

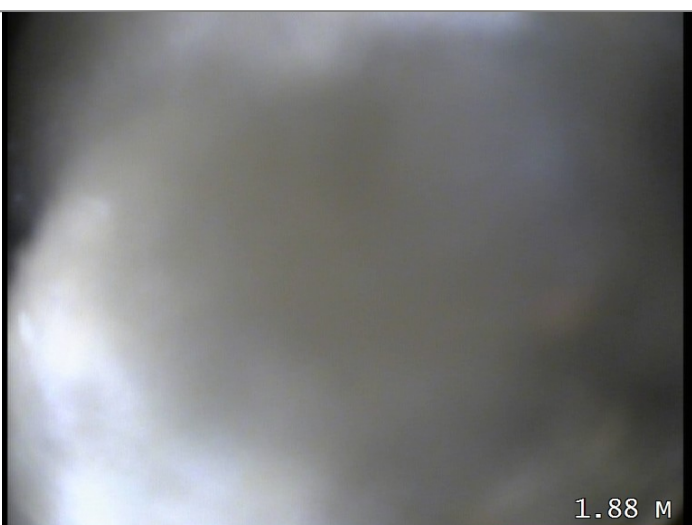
<p>1.88 M</p> <p>Line of drain/sewer deviates up half</p>

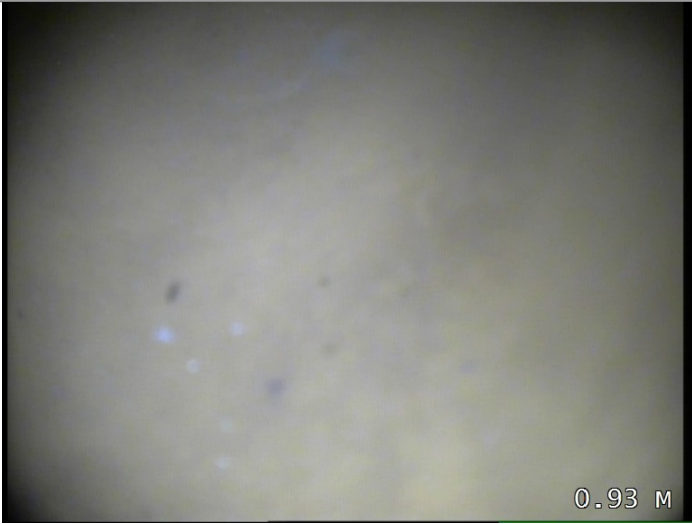
<p>0.93 M</p> <p>Line of drain/sewer deviates up full</p>

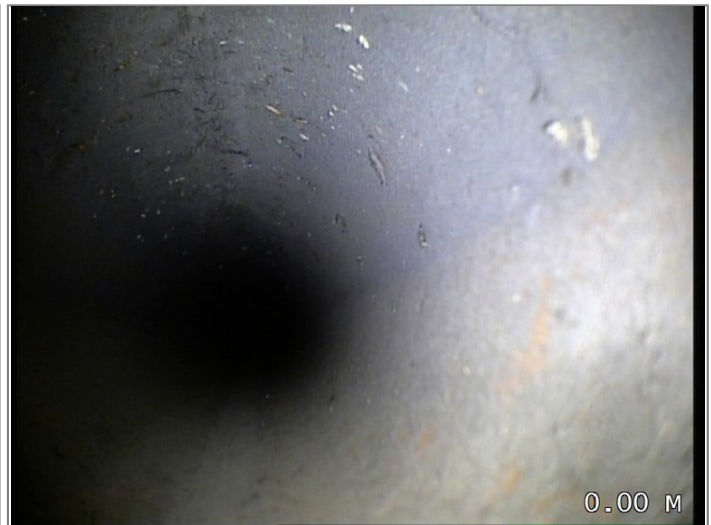
Water level 0% height/diameter

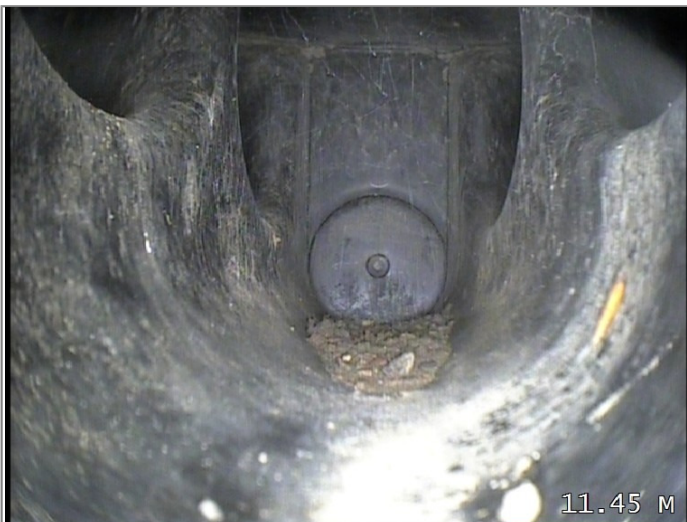
Finish node type, inspection chamber, reference IC10

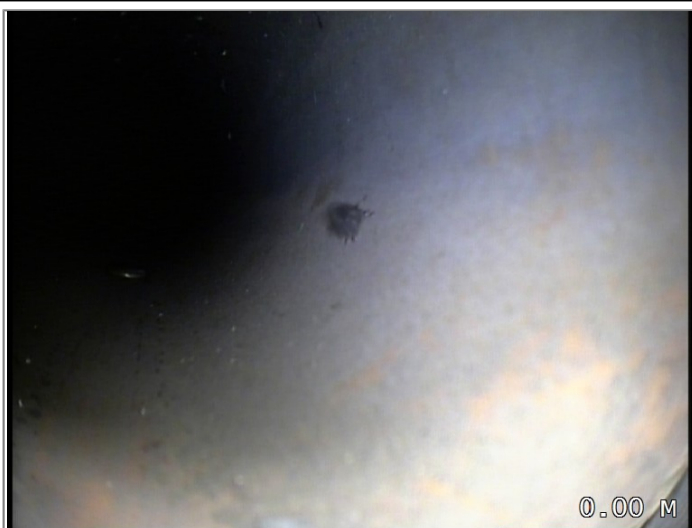
Start node type, inspection chamber, reference IC10

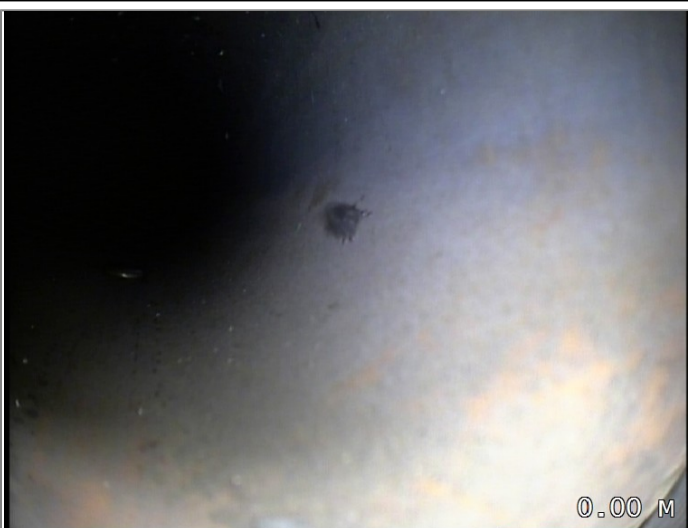
Water level 0% height/diameter

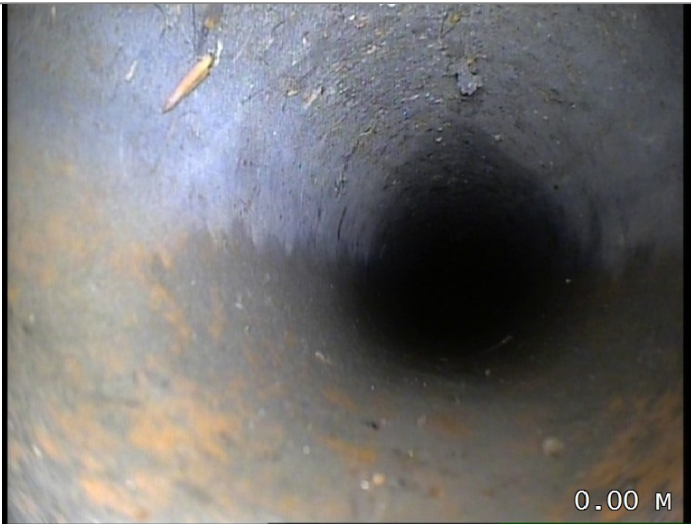
<p>0.00 M</p> <p>Start node type, inspection chamber, reference IC10</p>

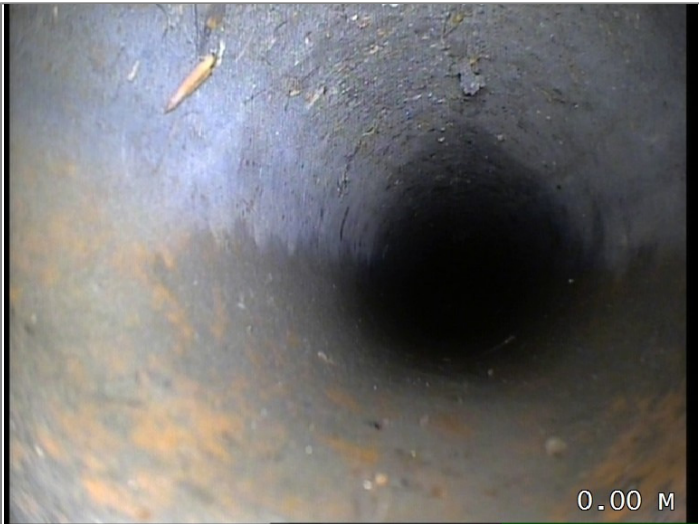
<p>0.00 M</p> <p>Water level 0% height/diameter</p>

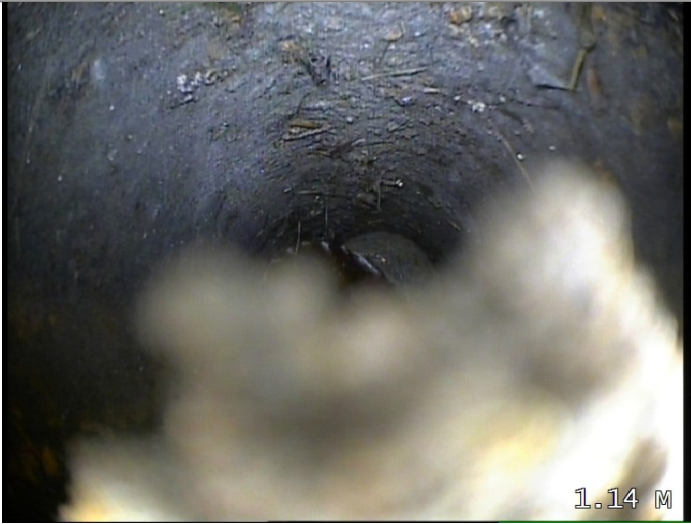
<p>1.14 M</p> <p>Settled deposits fine 25% cross-sectional area loss</p>

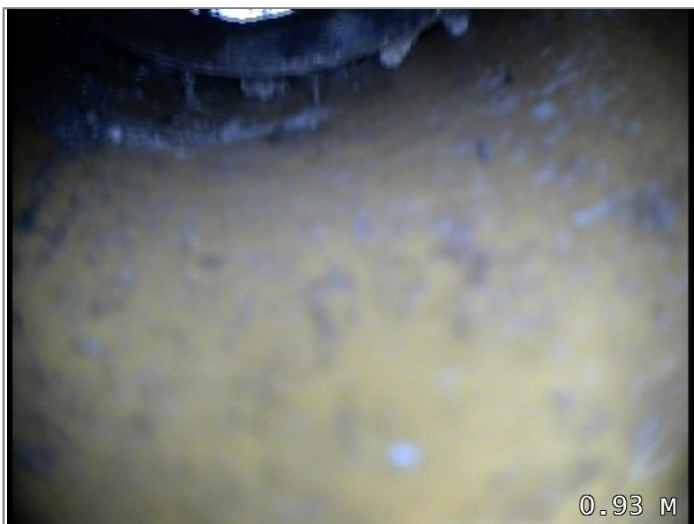
Finish node type, outfall, reference RWP3

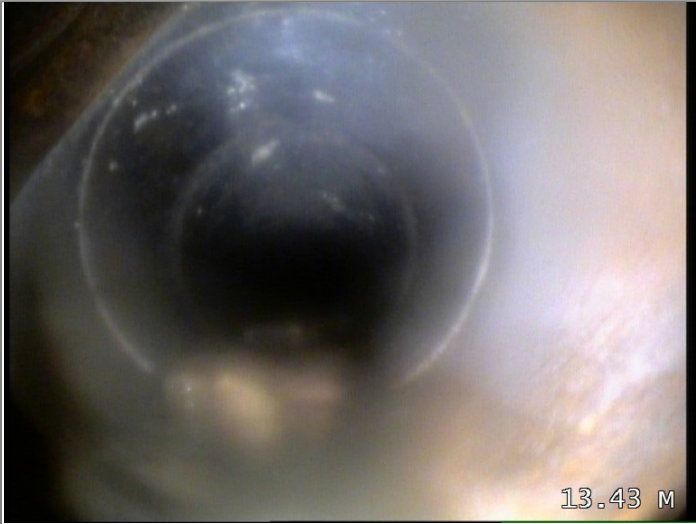
<p>13.43 M</p> <p>Junction at 10 o'clock, diameter 100mm</p>
