# **Cooper & Withycombe**

**The Harlington  
236 Fleet Road  
Fleet  
Hampshire  
GU51 4BY**

## **Condition Survey Report**

**January 2020**

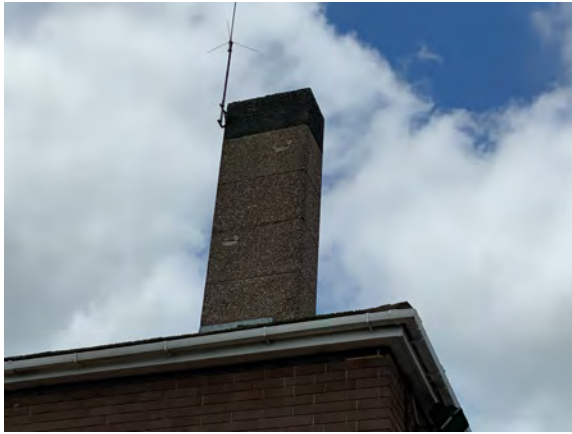
P1 Chimney stack. Reinforcement bar exposed.

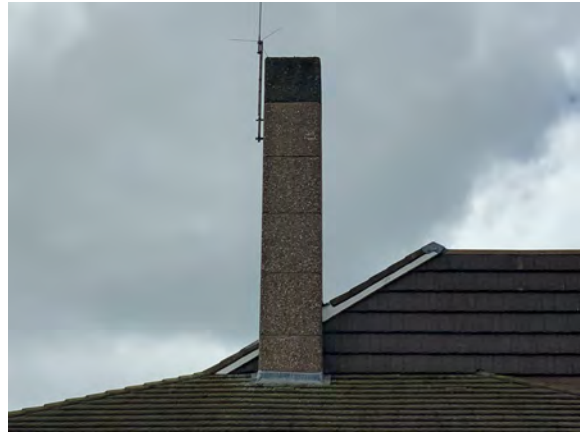
P2 Reinforcement bar visible on the second block down.

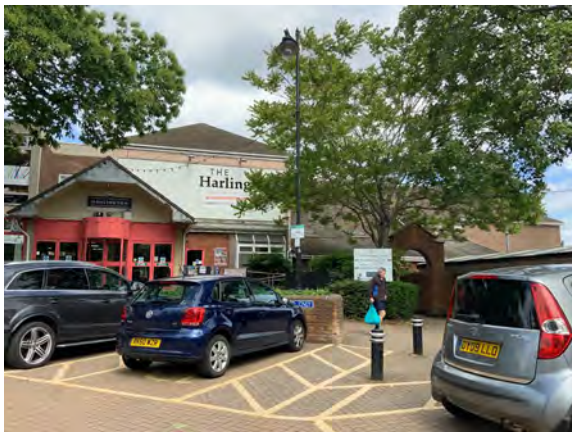
P3 Front roofs

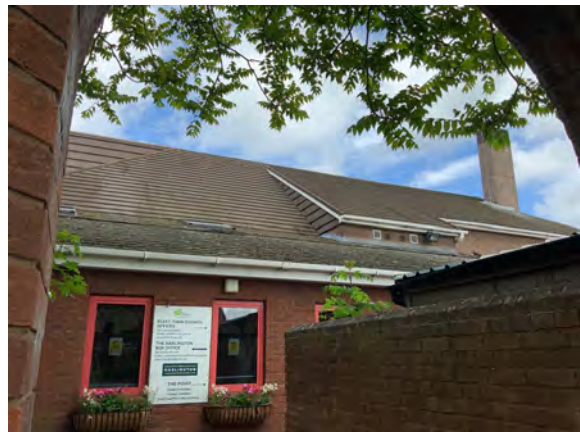
P4 Roof above Town Council Offices and main hall

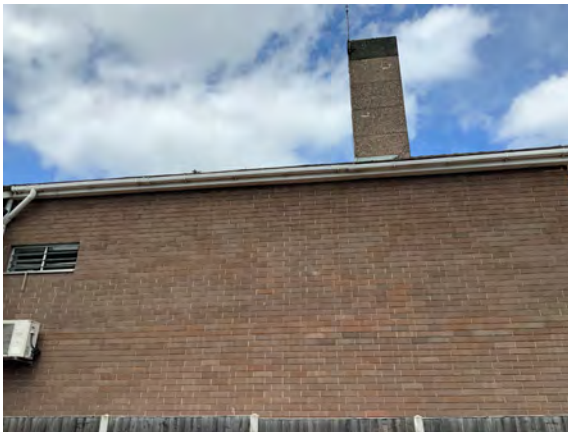
P7 Guttering above changing rooms. Some gutter joints disturbed.

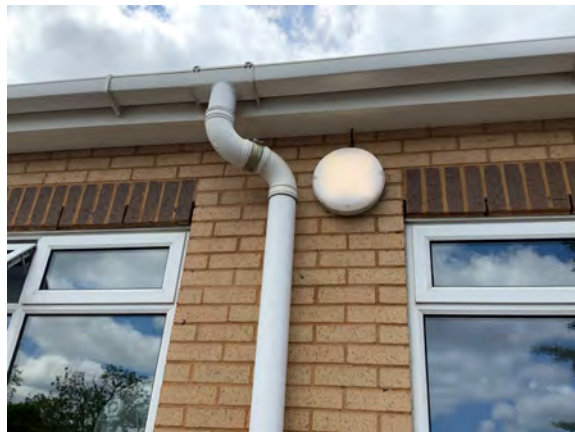
P8 North-east elevation of The Point. Damaged gutter to left hand side of front door.

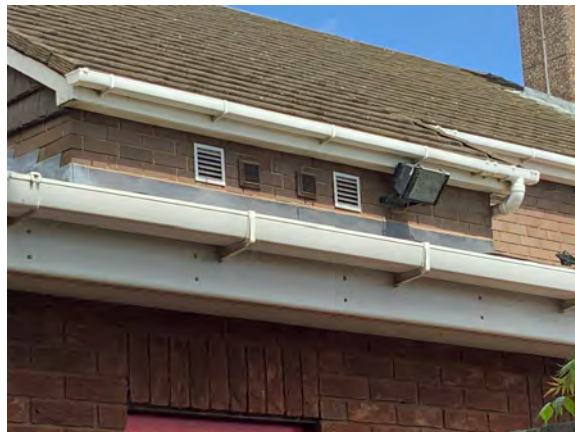
P12 South-east elevation above low pitch to Town Council Offices. Repaired cracking to wall.

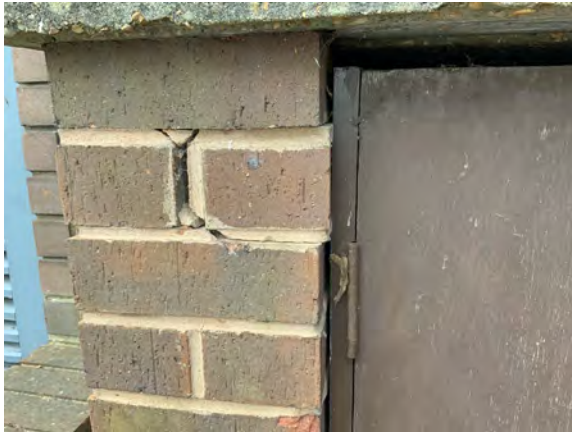
P13 North-east elevation, brick box to right hand side of double doors – damaged brick.

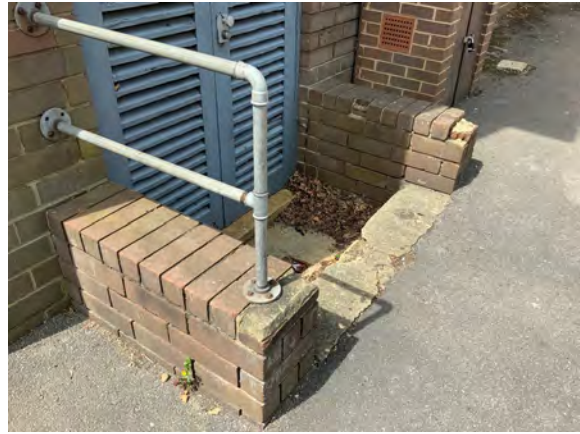
There is a step down to the double doors. This has a retaining brick wall on either side. These walls have suffered some impact damage.	Poor	Repair damaged brickwork	Essential	£800

P14 North-east elevation brick retaining walls down to double door to plant room.  
Damaged brickwork.

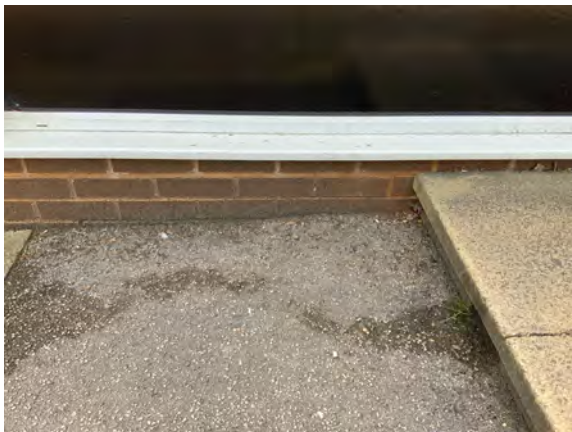
P15 Damp proof course to north-east elevation of The Point appears to be breached by steps.

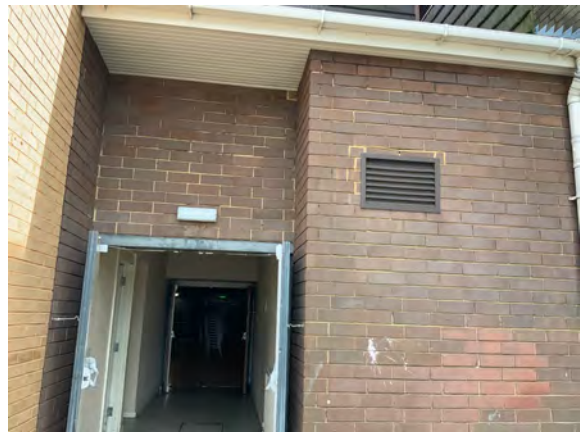
Ref	Item	Description	Condition	Action	Action Rating	Budget Cost			Photo
						Essential	Necessary	Desirable	
		There is some damaged pointing above the fire exit doors and above the extract fan in the wall. The two bricks above the extract fan have dropped slightly.	Poor	Re-point and replace damaged brickwork	Essential	£ 500.00			P16
		The high level wall to the rear of the bar store is stretcher bond brickwork with high level extract grill. this wall is partially covered in Ivy.	Poor	Remove ivy	Essential	£800			P17
		The rear of the café has a precast concrete frame with stretcher bond brick infill at low-level. There is no sign of damp proof course. There is some repaired concrete to the bottom left hand corner of this wall.	Adequate	None	No work required				P18
		The upper section of this wall is fully glazed.							
		At low level there is a fenced off store, comprising timber posts and vertical boarded panels.	Adequate	None	No work required

P16 Damaged pointing above fire exit and extract fan to rear of kitchen store.

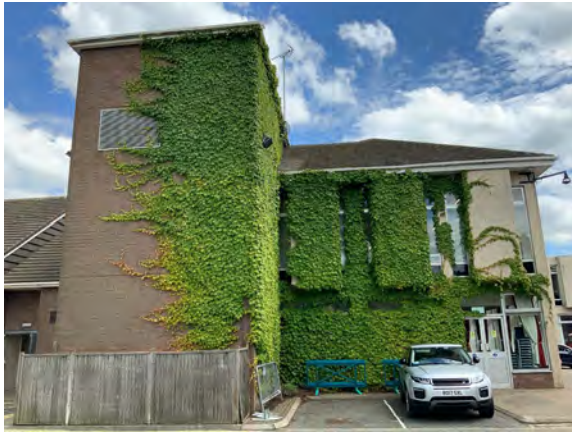
P17 Ivy covering some walls to rear.

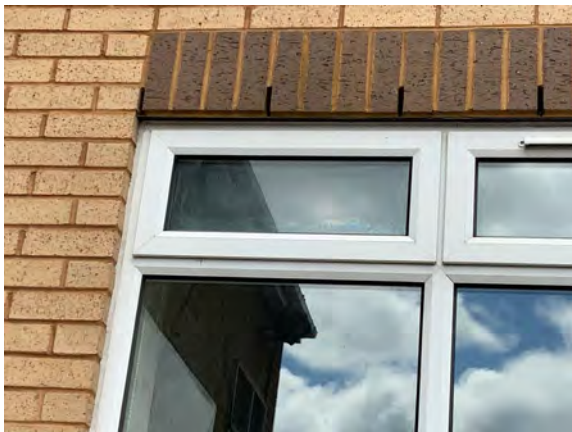
P19 North elevation of The Point, misting to top right hand window opener.

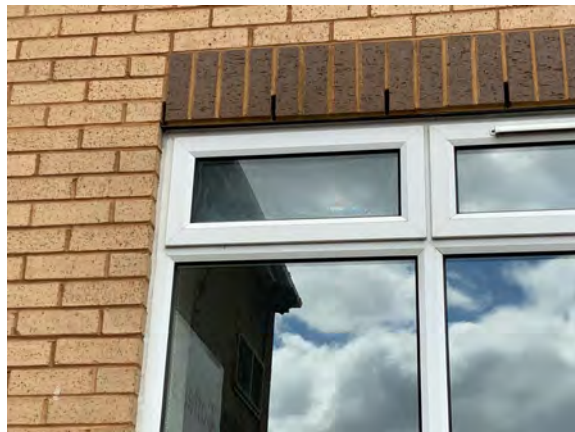
P20 North elevation of The Point, misting to top right hand window opener.

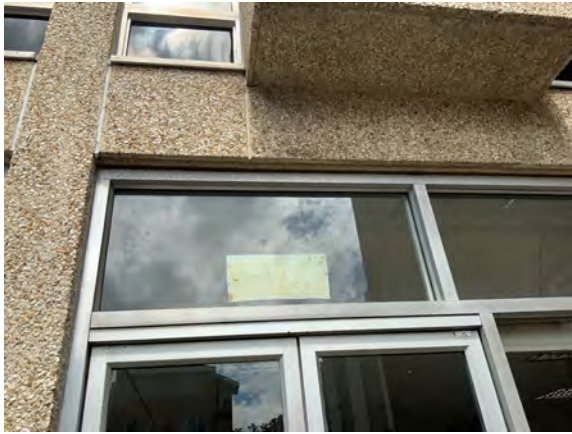
P21 South-west elevation above doors to foyer. Deteriorating finish to top window frames.

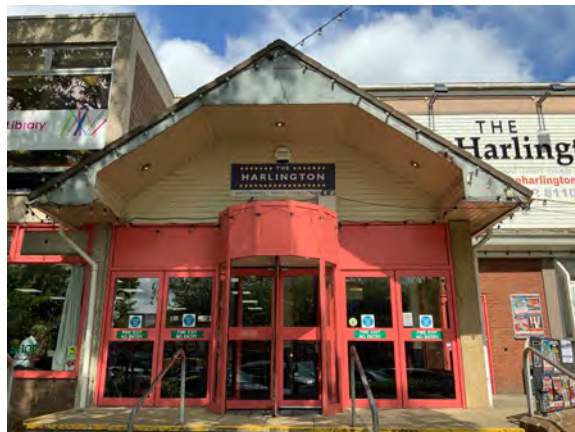
P24 Front fascia board to entrance starting to decay.

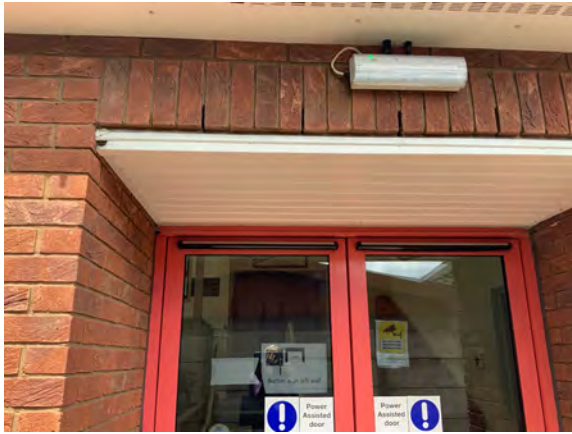
P25 Soffit above entrance to Town Council Offices. There is a cracked ceiling slat and damaged corner.

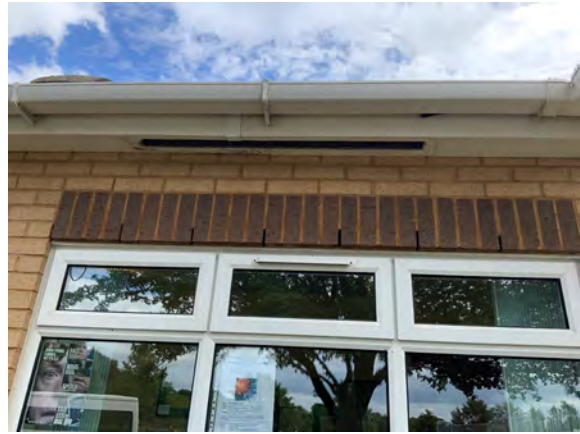
P26 Missing vent cover to the soffit to the left of the RVS front door.

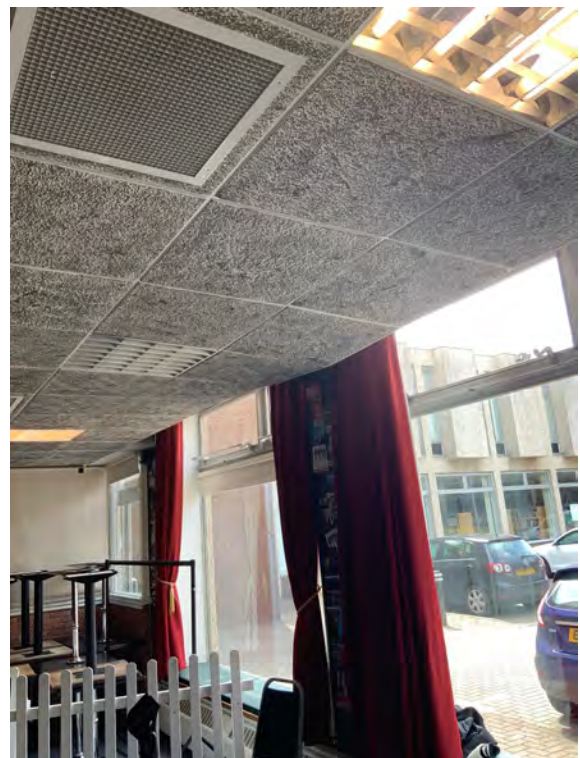
P28 Dropped area of ceiling grid to function room.

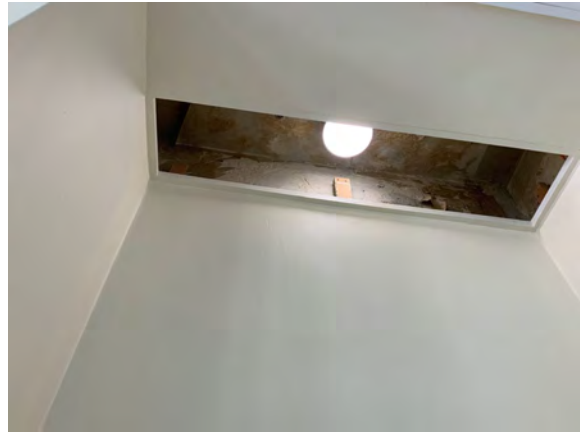
P30 Concrete structure to dance studio visible when light fitting cover missing.

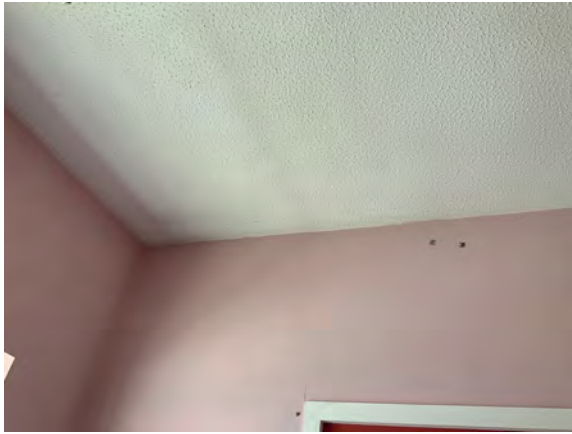
P33 RVS, crack to entrance lobby ceiling

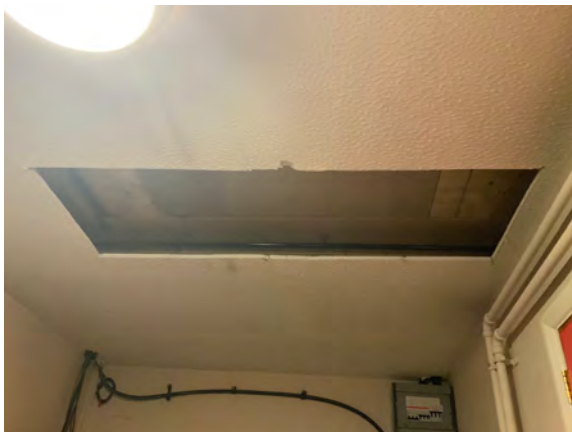
P35 Auditorium store room opening in ceiling with softwood and ply structure above.

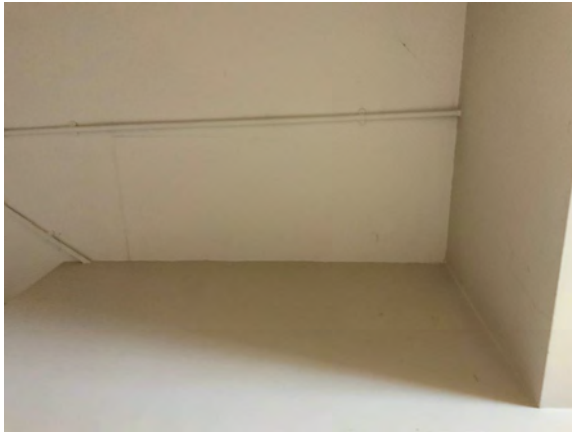
P37 Store Room adjacent RVS – L shaped crack around ceiling board

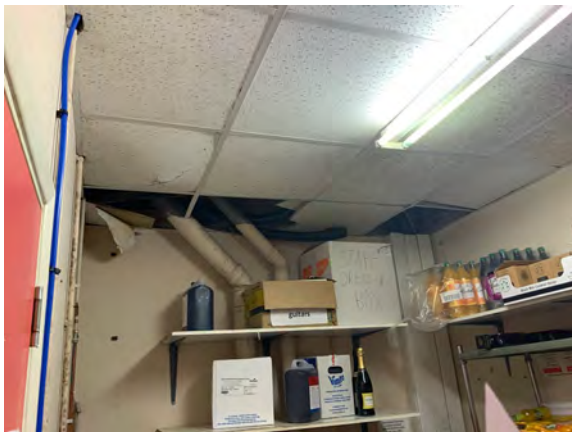
P39 Bar Store – Damage to ceiling tiles including water staining

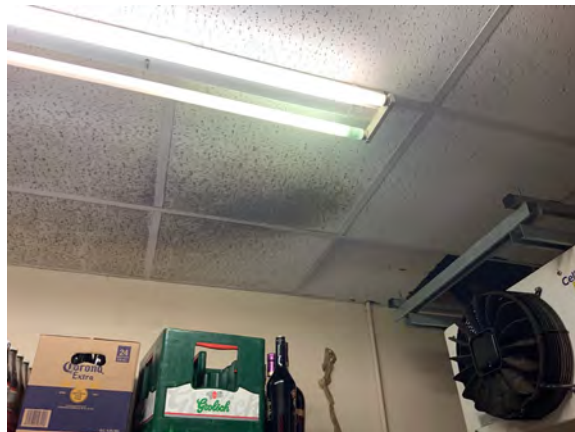
P40 Bar Store – Staining and missing tile next to air conditioning unit.

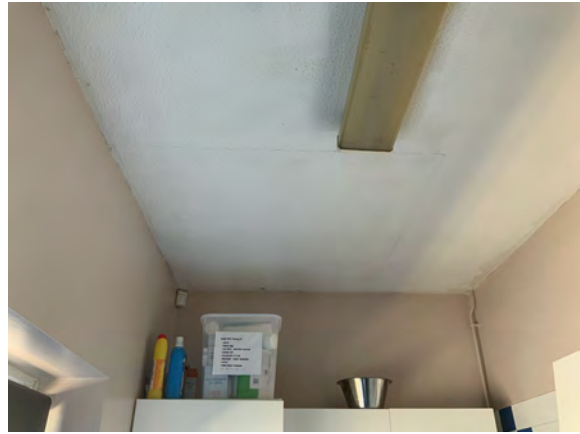
P43 The Point, Main Hall – L shaped crack around ceiling board in kitchenette

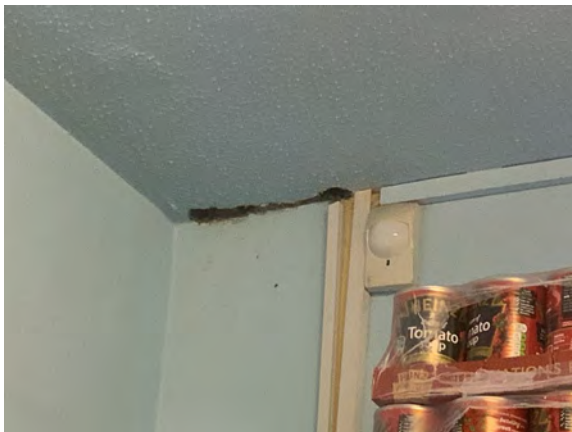
P44 The Point, Front Right Hand Office – Hole in ceiling, presumed for services.

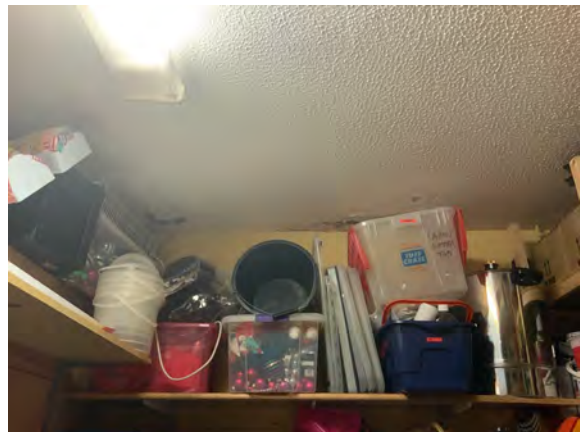
P45 The Point, Left Hand Store – Historic water leak to ceiling adjacent Harlington stage.

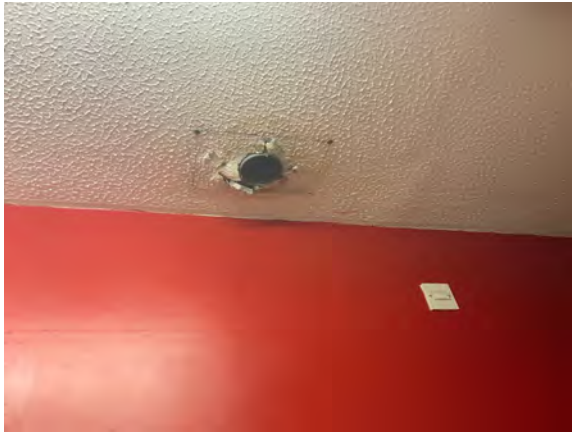
P46 The Point, Gents Toilet – Water leak to ceiling.

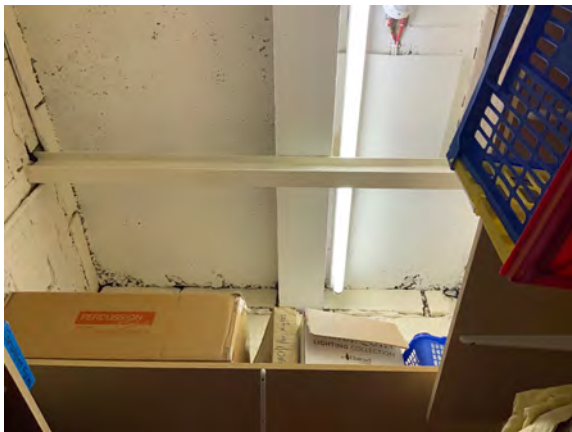
P48 First Floor / Store behind stairs – Poorly compacted edging.

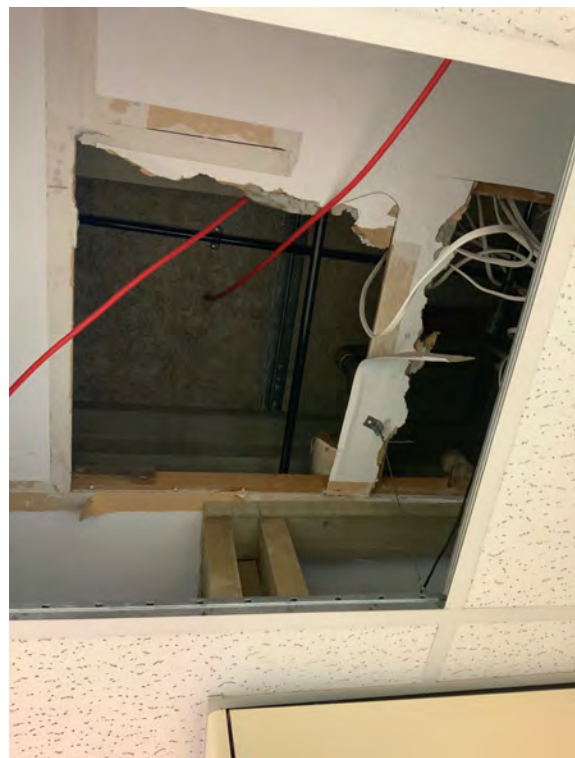
P49 First Floor, Ladies Toilet – Ceiling structure.

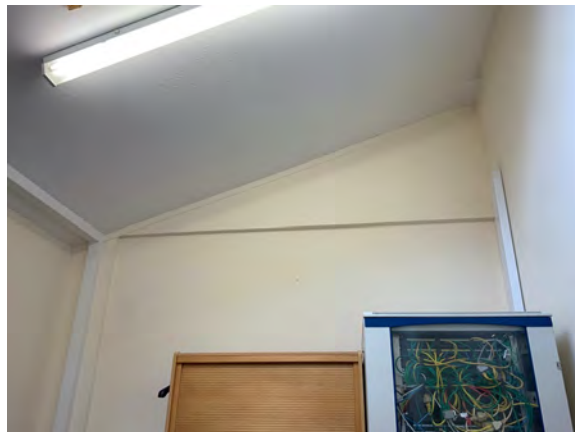
P53 Main Office – Joint cracking to edges of  
vaulted ceiling

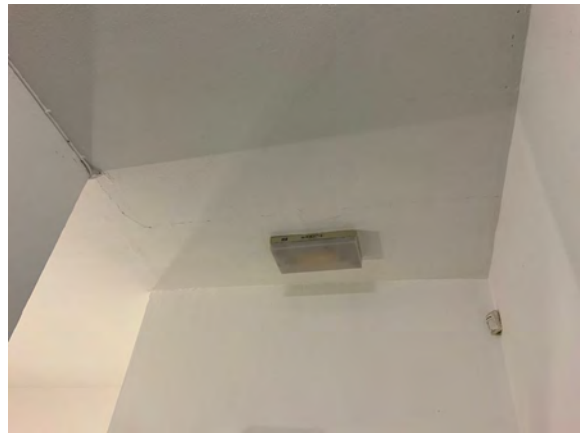
P55 – Dressing Room Corridor – Cracking to ceiling adjacent top of stairs

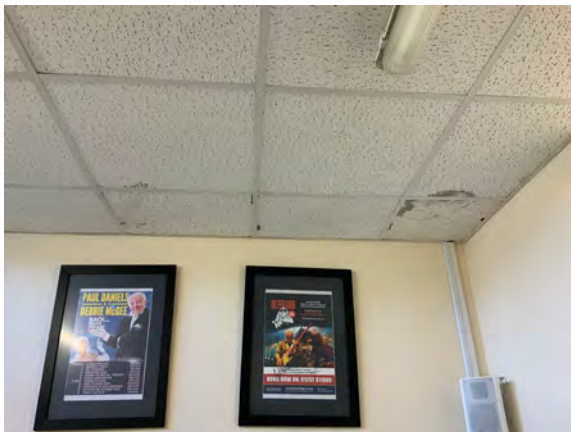
P56 Dressing Room2 – Finish to ceiling tiles deteriorated

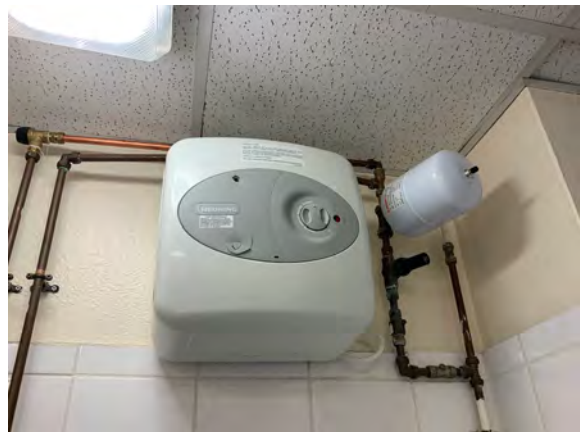
P57 Dressing Room 2 – Water heater.

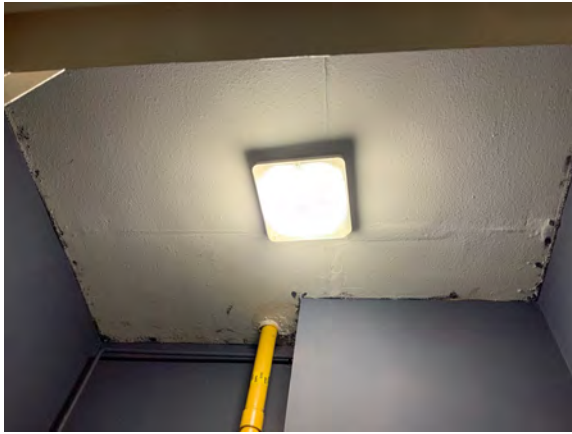
P58 Dressing Room Kitchenette - Ceiling

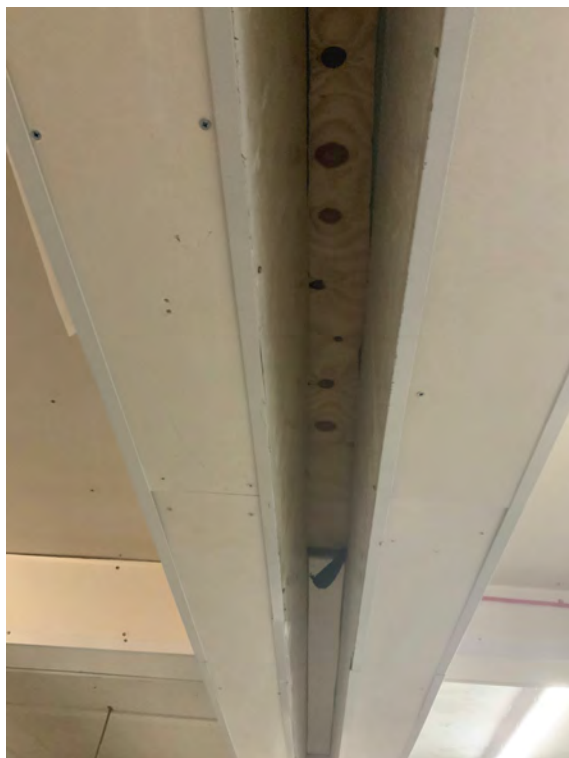
P60 Basement Stage Store – High level  
section of timber between beam boxing

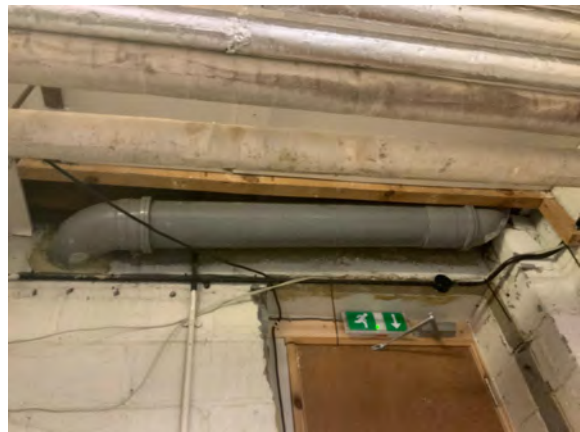
P61 Stage Store – Missing area of ceiling  
due to drainage

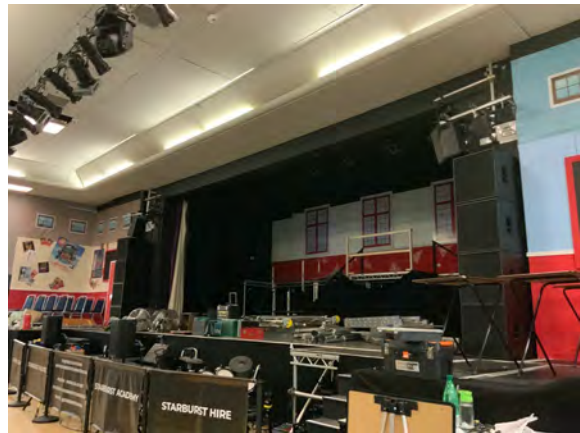
P63 Stage

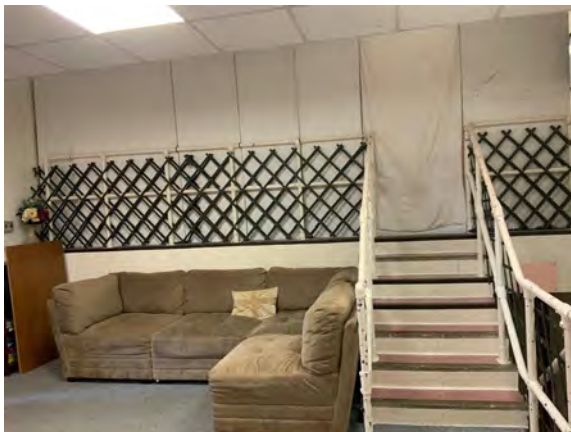
P64 RVS – Area between upper and lower dining rooms, including trellis.

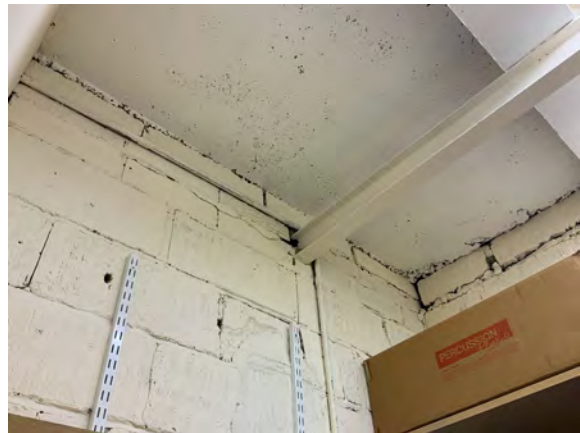
P90 First Floor, Store Behind Stairs –  
Cracking to blockwork joints

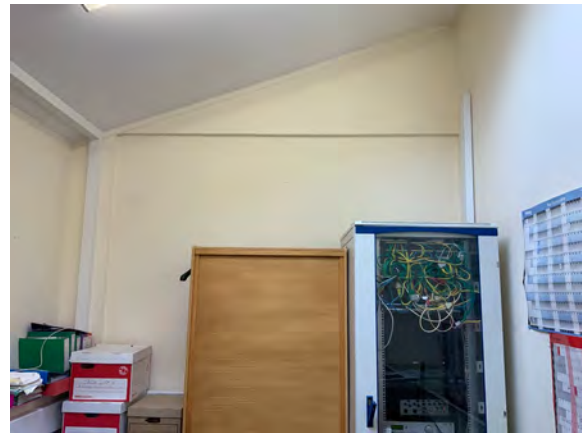
P95 Ben's Office – Open joints around window into wall joint

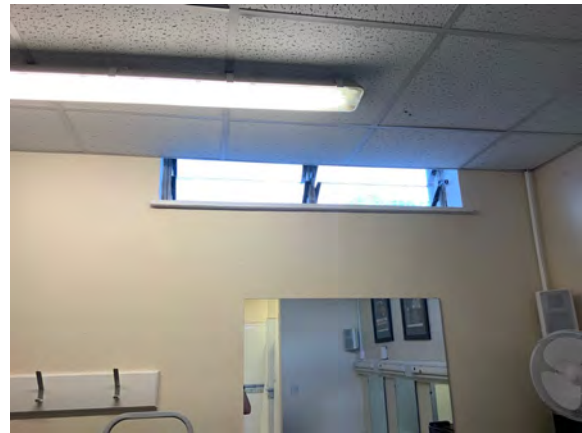
P103 Dressing Room 2 – Joint cracking to both sides behind coat rack

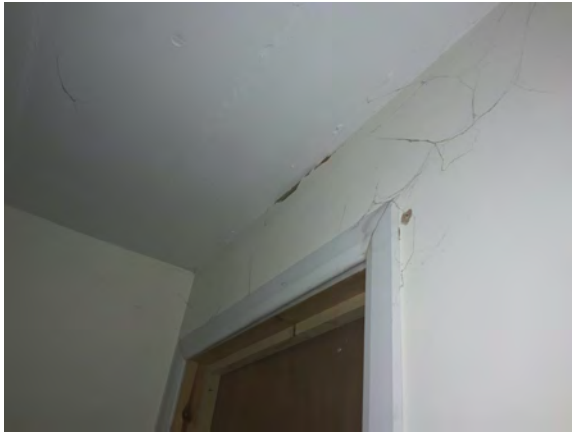
P114 Basement Stage Store – Cracks to left hand wall

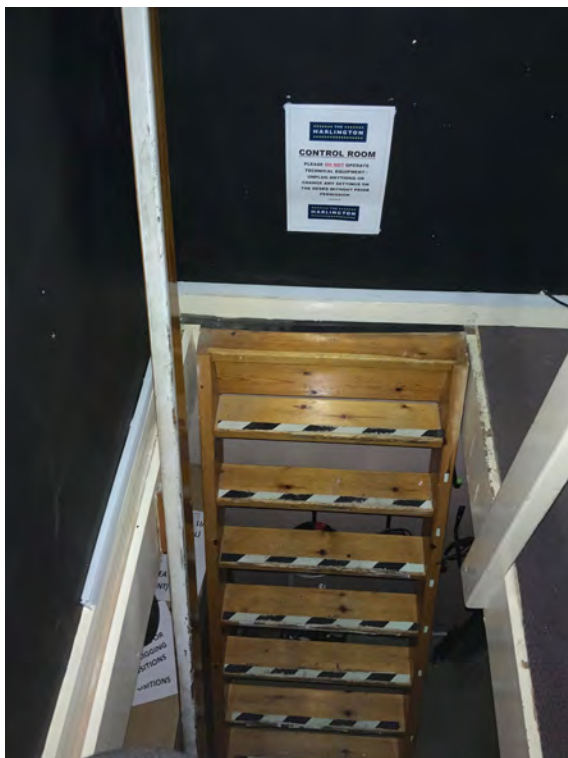
P152 Control Room Access Cupboard-  
Steep timber stairs to Control Room

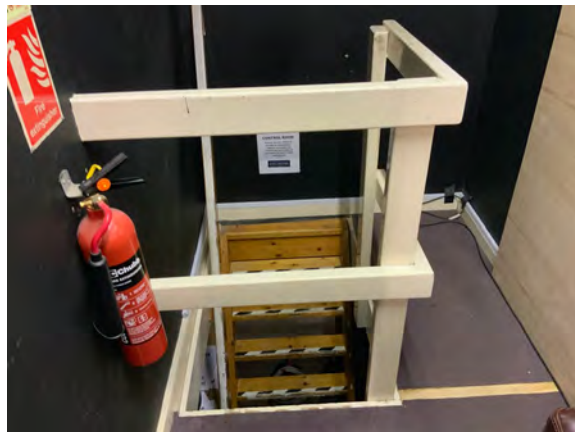
P153 Control Room Access Cupboard- No  
landing to top of staircase to Control Room

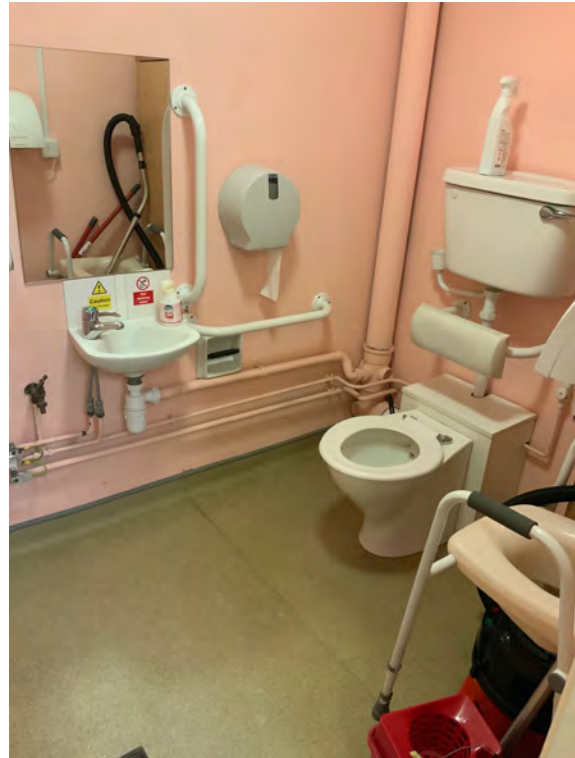
P159 Accessible toilet in RVS

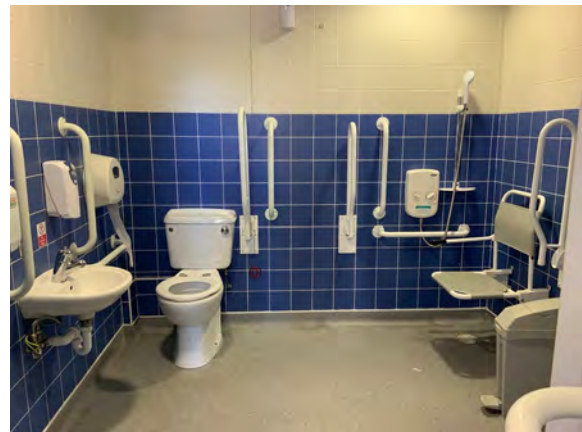
P165 First floor accessible toilet

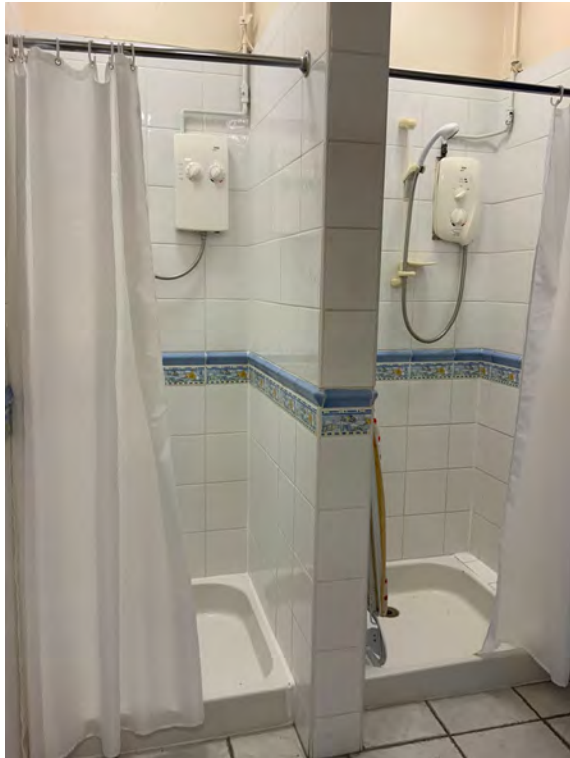
P166 Accessible shower room

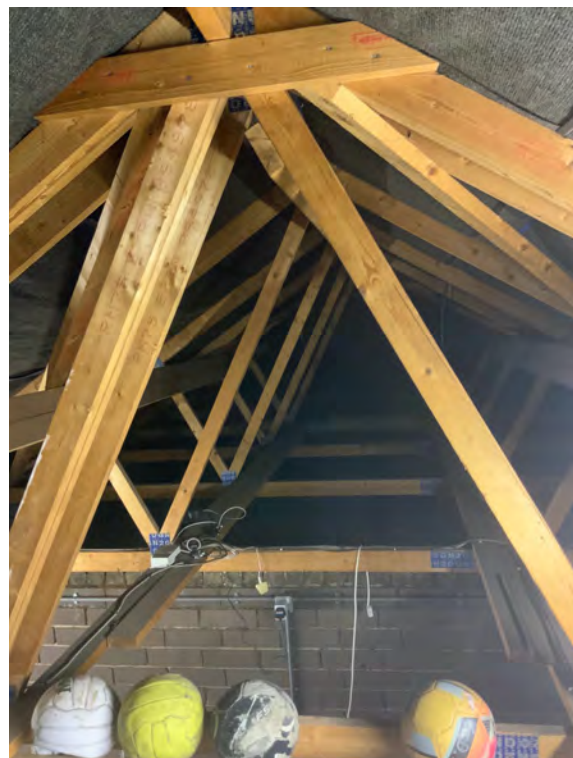
P169 Roof structure above kitchen -water  
ingress

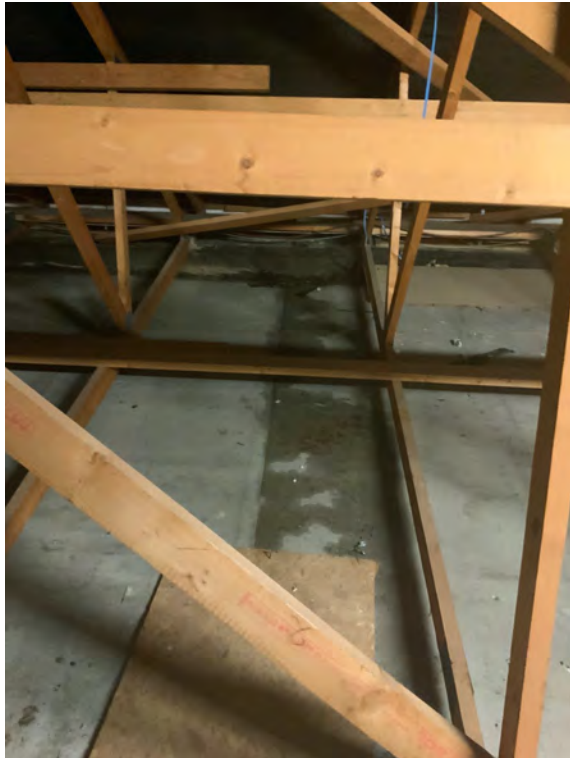
P170 Roof space above kitchen – roof  
structure

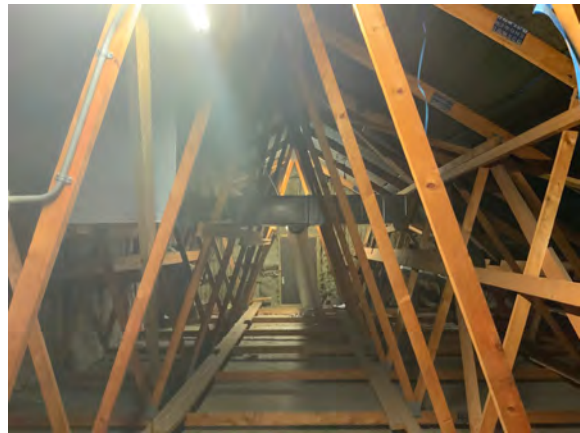
P171 Roof space above dance studio –  
Water ingress

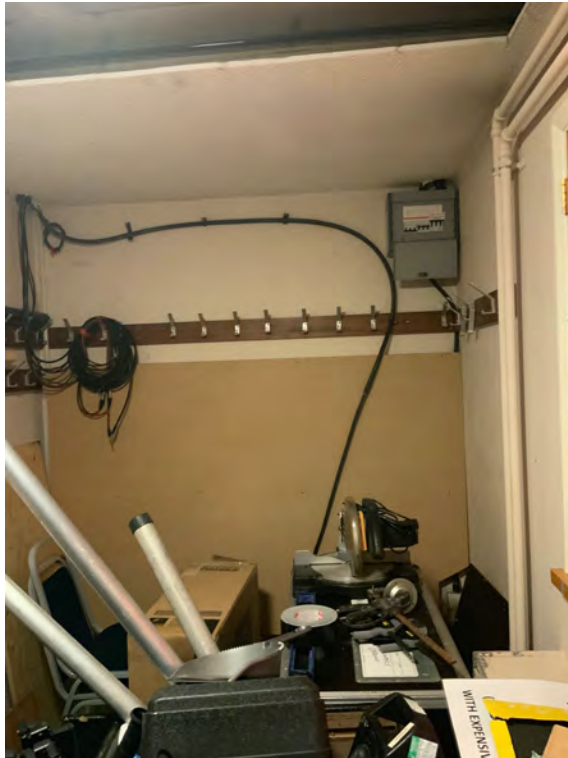
P175 Auditorium store – consumer unit and cabling

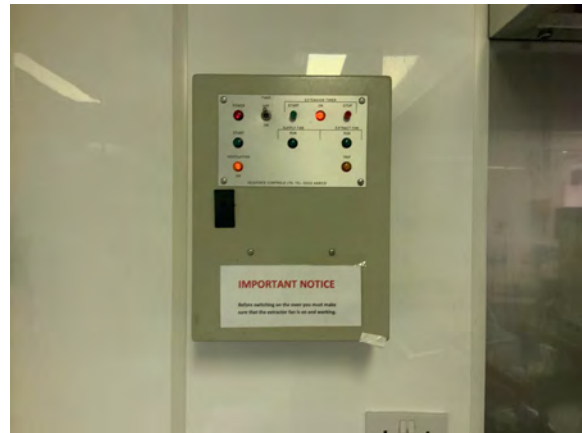
P176 Kitchen – Isolator for extractor fans

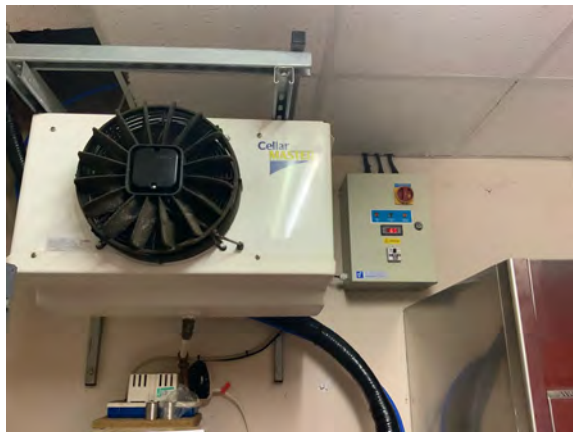
P177 Bar store – Isolator for adjacent air conditioning units

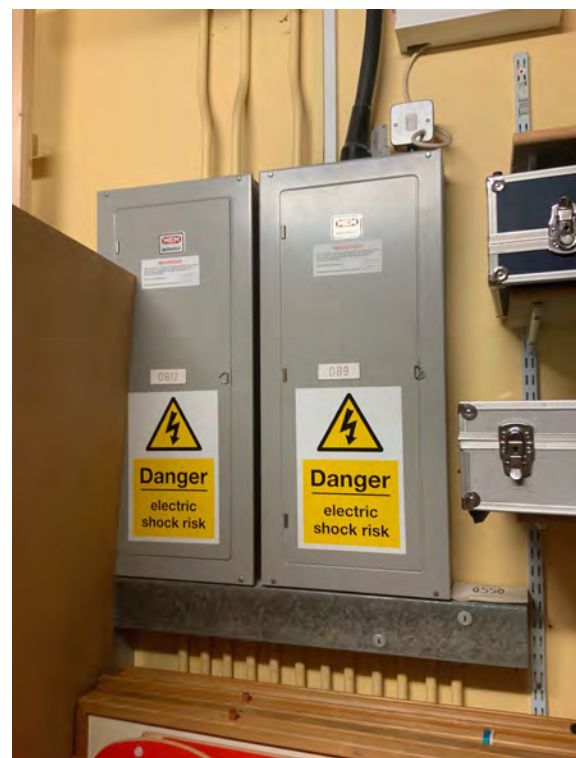
P178 The Point – Distribution Board in left hand store

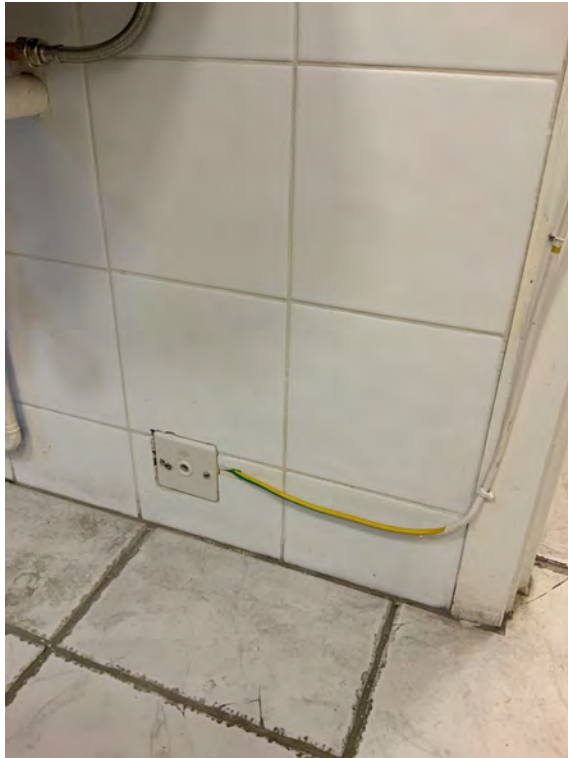
P179 Dressing Room 1 -Earth set into tiling  
beneath wash basin

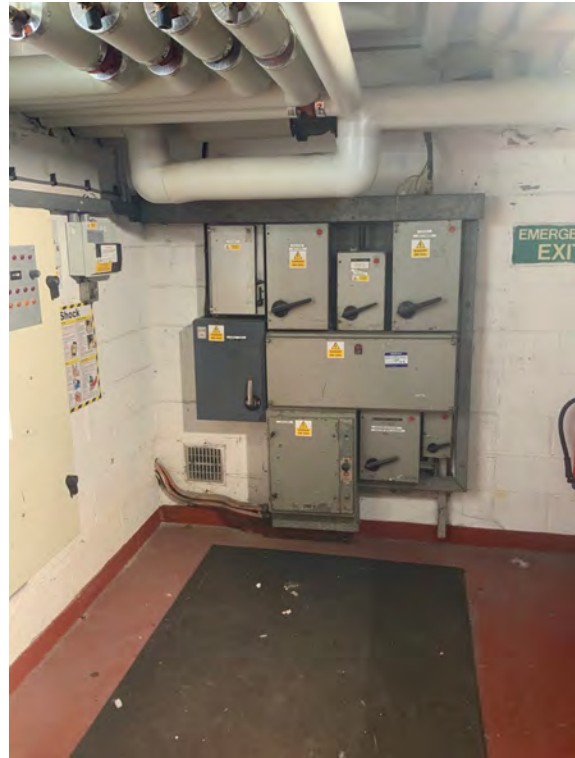
P180 Boiler room electrics

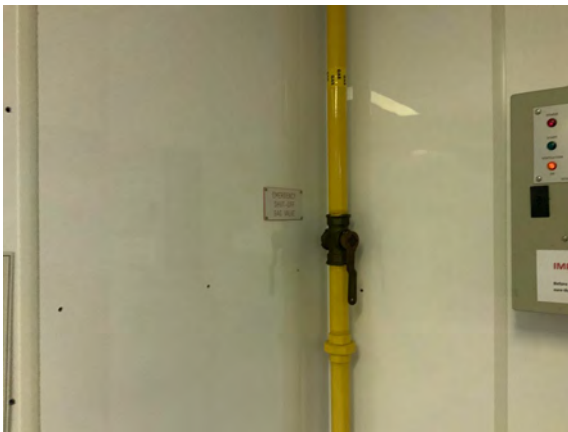
P181 Kitchen / gas valve

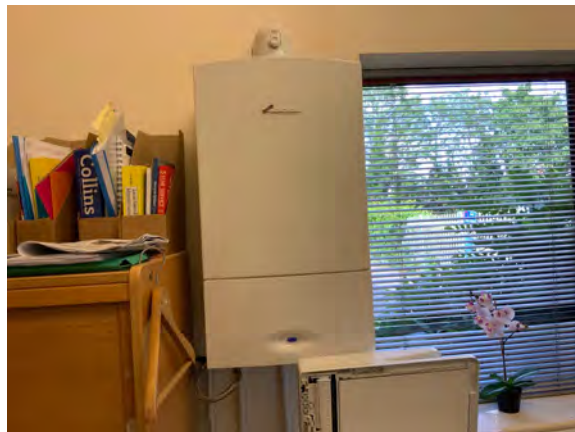
P182 Parish Clerk's Office – Wall mounted  
Worcester boiler

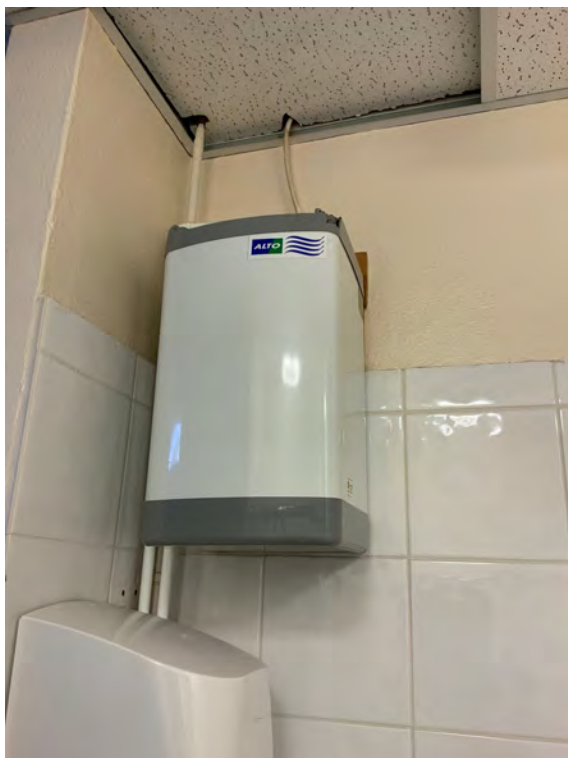
P185 Dressing Room 1 – Alto wall mounted water heater

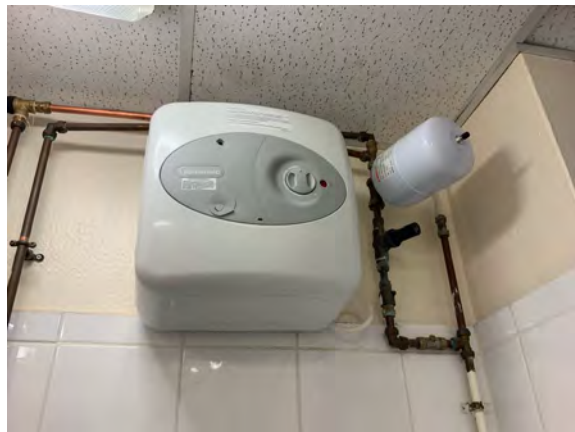
P186 Dressing Room 2 – Water heater

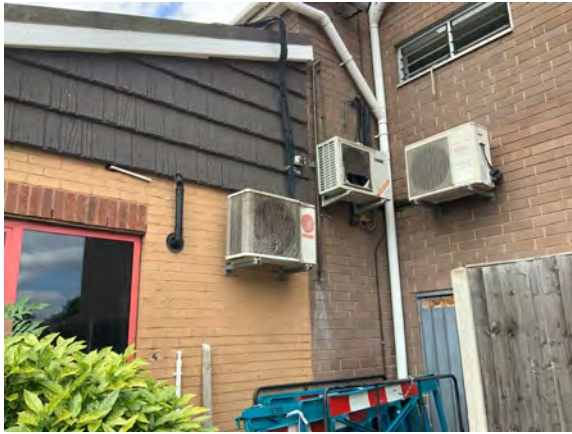
P187 Two air conditioning condenser units attached to the side return of the Town Council Offices appear in poor condition

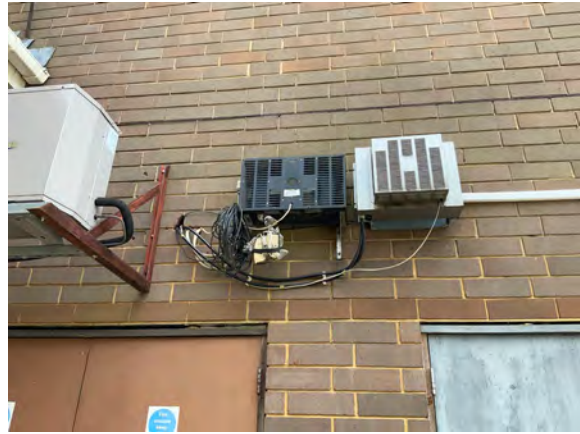
P188 North-east elevation at high level, fan units outside the bar have uncovered electrical connections

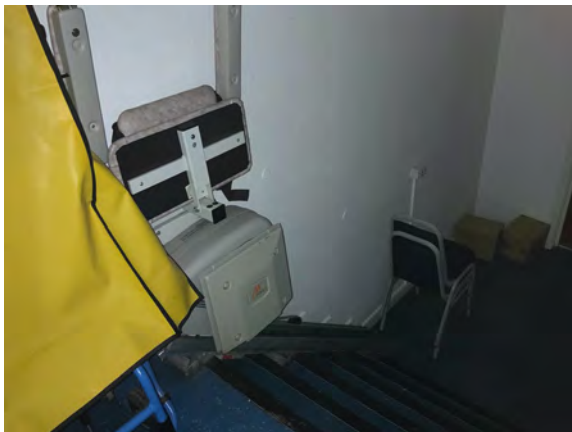
P189 Dressing Room Corridor - Stairlift

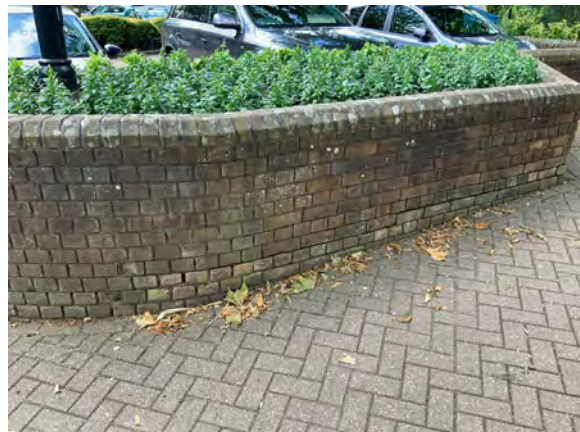
P190 Brick planter to the front of the building would benefit from re-pointing

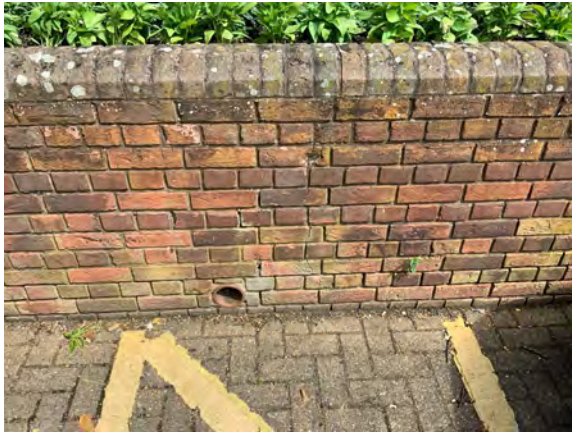
P191 Minor cracking to brick planter in front of accessible parking bay on the north elevation

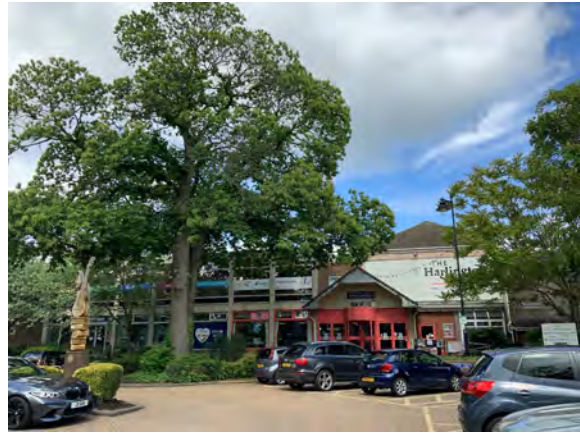
P192 Oak tree and planting to the front, north elevation

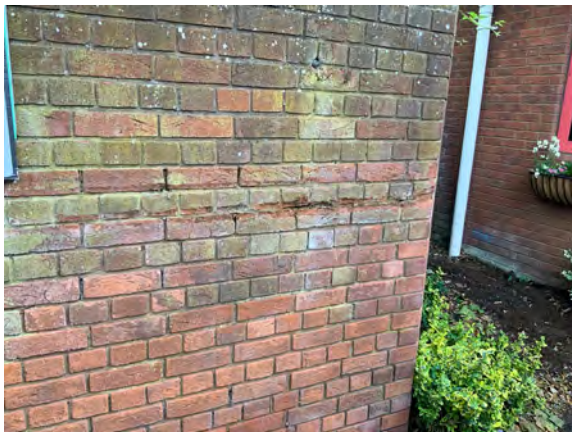
P193 Impact damage to wall behind accessible entrance ramp leading to Fleet Town Council

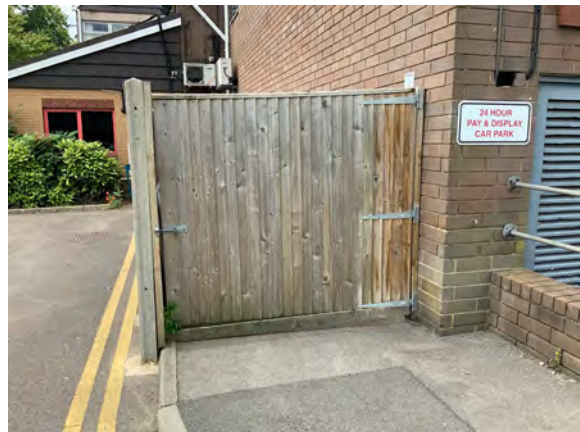
P194 The gate to the bin store on the north elevation is in poor condition

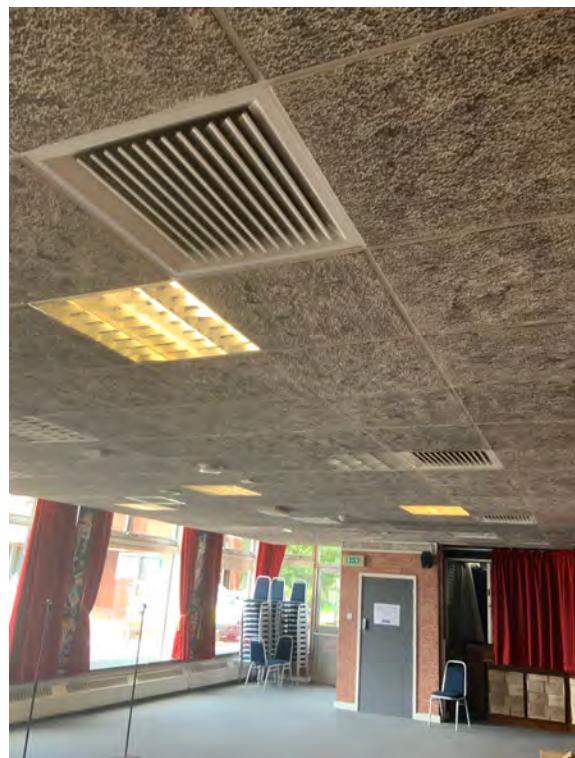
P198 Function Room lighting

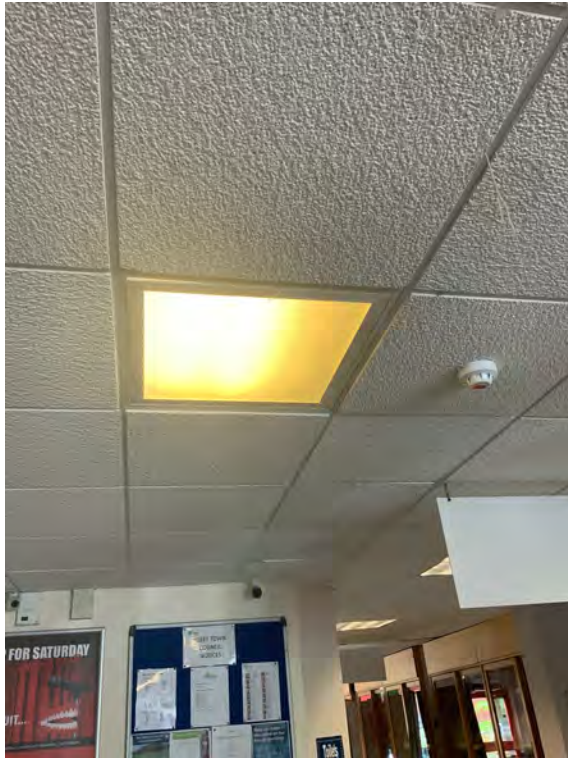
P199 Original ceiling lights in foyer. Also showing area of water ingress

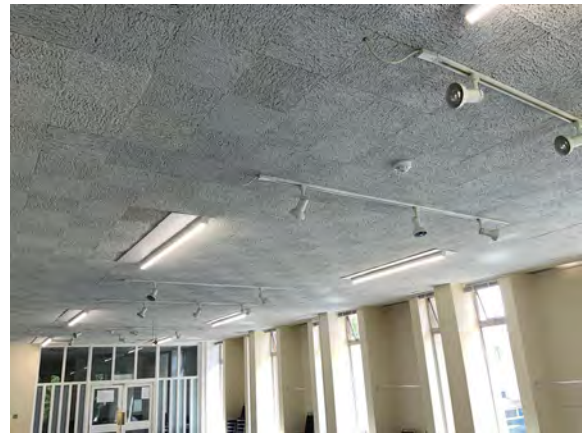
P200 Dance Studio lighting

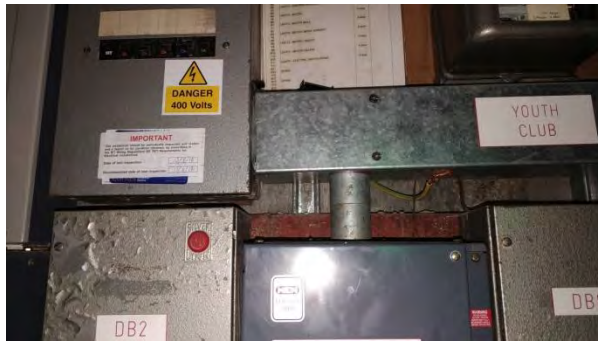
From the main incoming switch, busbar trunking serves numerous fuse switches and trunking serves further fuse switches. There are two distribution boards at high level in the space.

It is clear that the system has been adapted and expanded over the years.

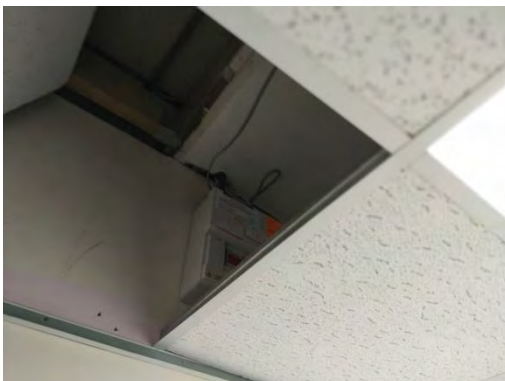
The distribution boards vary in age and quality, some are of an age where they would be considered beyond manufacturer's life expectancy. Others still are defunct models with limited spare part availability.

It is recommended that the electrical sub-distribution system is removed in its entirety and replaced with new boards and sub-main cabling from the new main
