# **Cooper & Withycombe**

**The Harlington  
236 Fleet Road  
Fleet  
Hampshire  
GU51 4BY**

## **Condition Survey Report**

**January 2020**

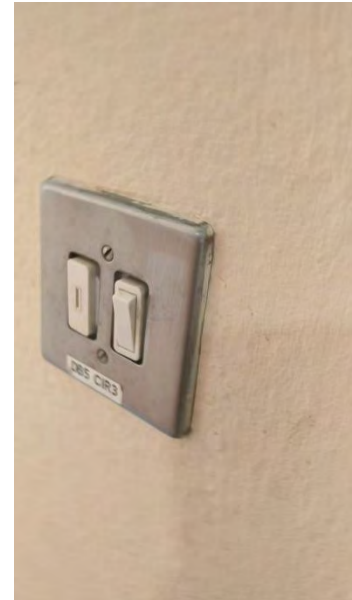
The majority of equipment was installed some time ago and are of an age where they would be considered beyond their expected life and consideration should be given to replacing them, particularly if there are a number of changes to be wrought with the refurbishment as the power layout requirements would be potentially different to how they have currently been provisioned.

It is recommended that the electrical outlets are removed and replaced with new to suit the requirements of the refurbishment, which will be generally quite different to the current arrangement.

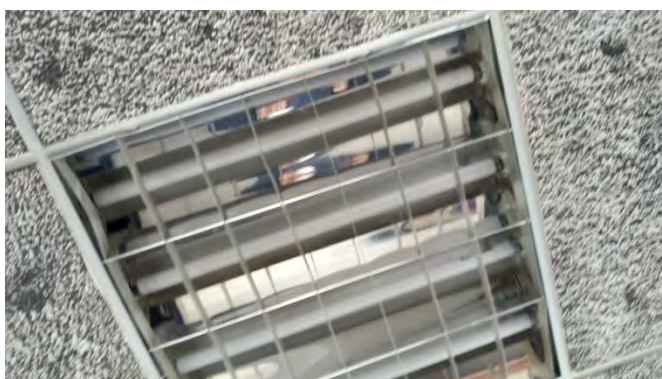
The lighting generally is aged and visually not very appealing. There are exceptions to this, for example in the Ground Floor Café area, Fleet Council Offices and some of the bar lighting. In addition, the older lighting is much more inefficient and energy intensive than modern LED equivalents.

Some of the spaces have been provided with replacement LED luminaires that have lifted the lighting levels and ambience of the space, making the juxtaposition of the old and the new more pronounced.

It is recommended that the entire lighting installation is removed and replaced with new, LED based luminaires, potentially retaining some of the newer LED luminaires installed within the last 5 years

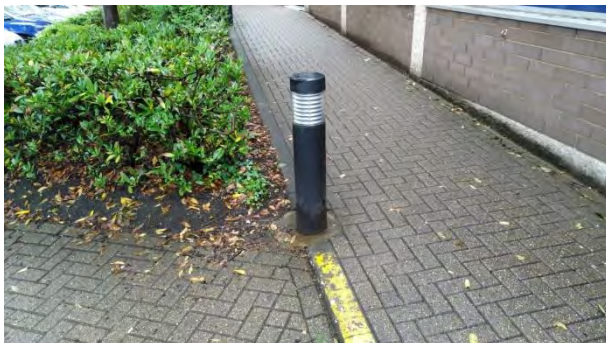
The external lighting varies both in age and suitability. There are small bollards along the side and front of the theatre that appear in reasonable condition, along with façade mounted floodlights to illuminate the car park in front of the Theatre, notionally for event usage

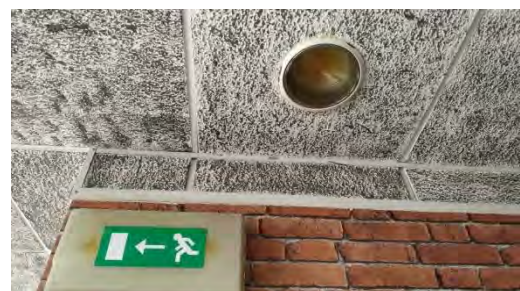
Emergency lighting is generally present throughout the property and immediately outside most exit doors, however, again the luminaires are generally of an age that they should be replaced. It should be noted that a few of the luminaires have been replaced with modern LED fittings.

It is recommended that, along with the general lighting system, the emergency lighting is replaced with new.

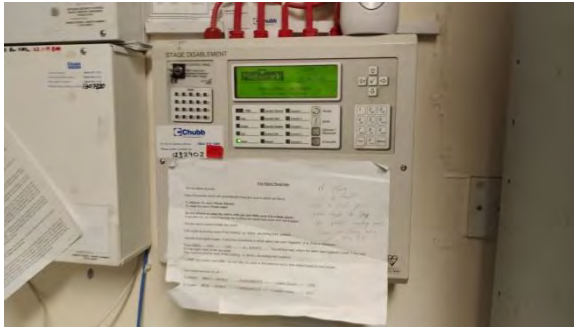
The existing fire alarm and detection system features a Menvier MX4000 analogue addressable fire alarm panel with additional keyable switch to isolate devices during performances. The panel is located in the main Office behind reception, but there is a repeater panel near the café that is visible through the front windows.

Although the system is a more modern analogue addressable type, bells are used throughout rather than sounders – this is often the case where the bells can be rung to signal purposes other than fire events, such as intermissions, or performance starting.

The property seems well provisioned with automatic detection devices throughout, although some of the cabling that can be seen has not been installed in compliance with the relevant standards. The cabling that has not been installed correctly has not, in places, been secured to the building fabric or containment correctly. As a consequence, there is an entanglement risk during a fire which would need to be addressed.

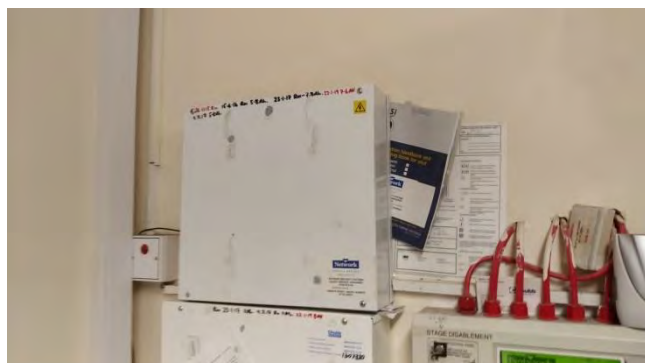
The existing system is a Scantronic 931 and is complete with door contacts, volumetric detectors and arm/disarm keypads. The head end appears to be within the Theatre office and numerous extenders can be seen around the property at high level to serve the various devices.

Again, this is an obsolete system at the end of its design life and it is recommended that this is replaced with newer equipment.

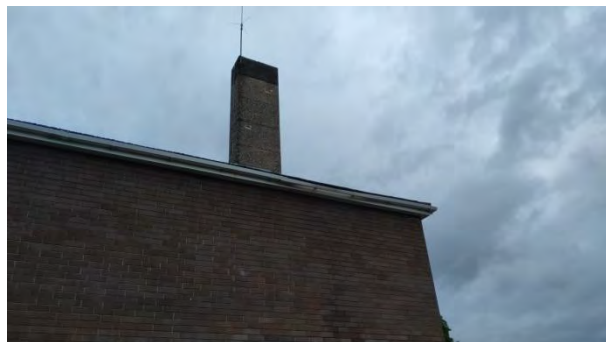
There is an existing lightning protection system in place, evidenced by the air rods on the roof and the down conductors on the external façade leading to floor recessed earth pits. Assuming the system is compliant and tested satisfactorily, we expect no alterations to the installation other than to accommodate the refurbishment works.

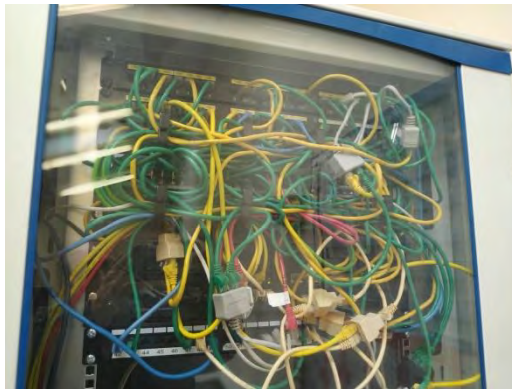
The cabinet can be seen to be quite messy in terms of the way the equipment is located and the cabling has been undertaken – which is reasonably usual where amendments have been made piecemeal.

Given the nature of the refurbishment works, it is unlikely that few data cables within the theatre would benefit from being retained and modified, it would therefore be desirable to provide a new communications cabinet in the Theatre Office that is connected to the existing Fleet Council Office, thereby providing some limited separation between the two entities.

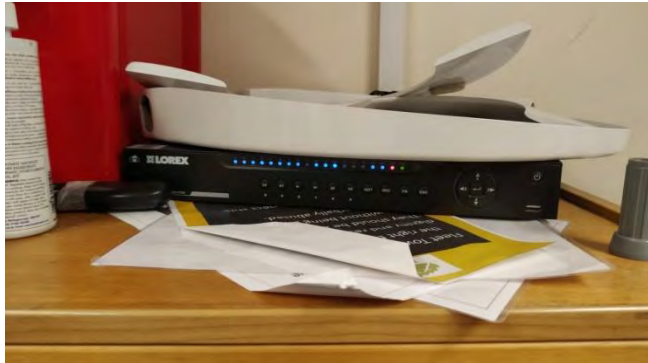
A CCTV system has been installed within the last few years, covering relevant areas both in and around the theatre building. The cameras and NVR are manufactured by Lorex, a brand that is popular in America, but not very well serviced in the UK. We would expect this system to be removed and reinstated to facilitate the works. Cabling would be run as necessary if any of the cameras, or additional cameras are required, and the head end moved from the top of a cupboard into a new communications cabinet.

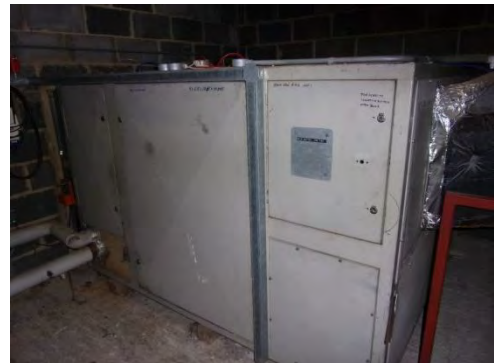
The auditorium air handling unit was found to be in a very poor condition, obsolete, electrically and thermally inefficient, with evidence of poor air tightness. The casing to the air handling unit and the majority of the ductwork was found uninsulated. The ductwork appears to be in reasonably good condition. The air handling unit is original, but was refurbished 26 years ago. The air handling unit exceeds its economic life of 30 years and therefore we would recommend that this air handling unit is replacement.

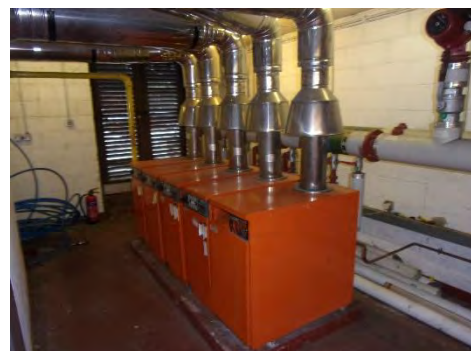
- Five MHS Sangiorgio Regency GBS Series 2 221-52 Gas-fired atmospheric floor standing boilers, with a heat output of 67kW and a total heat output of 335kW.
- Zilmet 500 litre expansion vessel
- MHS pressurisation unit – Series PM
- Six secondary circulation pumps for constant temperature heating circuits
- Five primary circulation shunt pumps
- Three-way diverting control valve fitted to each air handling unit

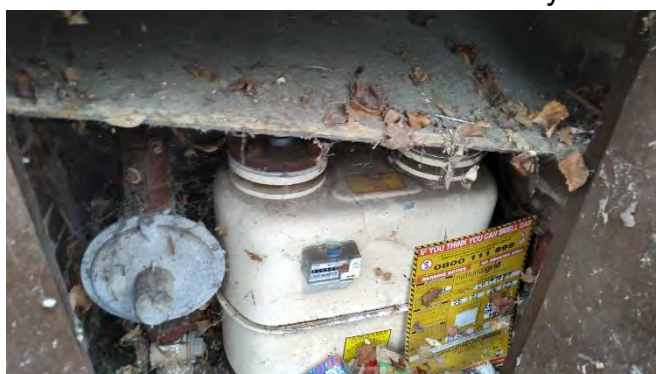
The gas meter cupboard outside the boiler plant room is within a floor mounted locked enclosure. The enclosure is dirty and litter strewn and would benefit from

being cleaned. In addition, the internal lining has broken loose from the fixings and is sitting on the pipework and the corrosion on the pipes indicates the cabinet is not weathertight. The cabinet would benefit from being replaced. The U65 gas meter appears to be in reasonable condition. The gas pipework

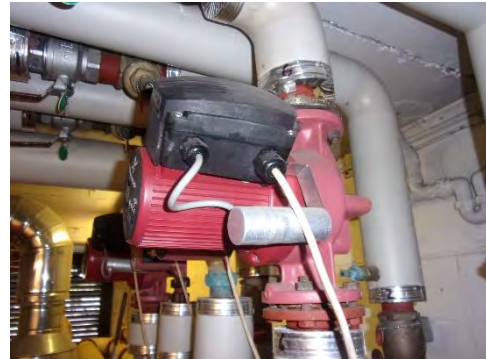
The primary circulation shunt pumps are all from the Grundfos UPC or UPS range, which are typically over 20 years old. All of these pumps are in poor condition and need to be replaced.

The majority of the secondary circulation pumps (five of six) are from the Grundfos UPC or UPS range, which are typically over 20 years old. Only one of the pumps, the Grundfos Magna 1, is anticipated to be less than ten years old. We would recommend that all of the secondary circulation pumps are replaced for twin-head circulation pumps, for duty / standby operation. We would propose pumps from the Grundfos Magna 3D range.

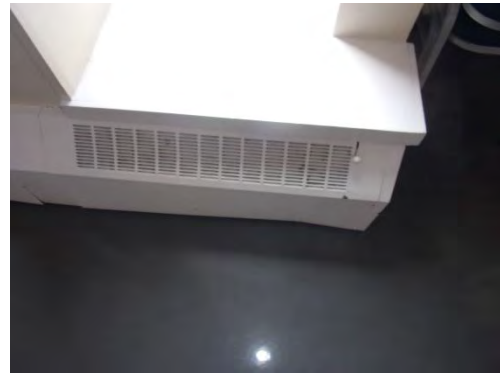
The passive perimeter heaters fitted in rooms such as dance studio, function room, library, canteen and parts of the corridor are all in a very poor condition, part of the original 1972 install and overall they do not work effectively to heat the space. With the exception of the function room and dance studio, we would recommend replacement of these existing heaters for a unit such as the Sill-Line continuous pedestal heaters.

For the dance studio and the function room, which are susceptible to overheating, due to the glazing and building orientation, we would recommend comfort cooling / heating, consisting of external mini-VRF condenser unit and 4-way blow ceiling cassettes.

- Strip out and remove passive casement heaters within the library, canteen and some corridor areas. Provide a replacement, such as the Sill-Line continuous pedestal heaters.

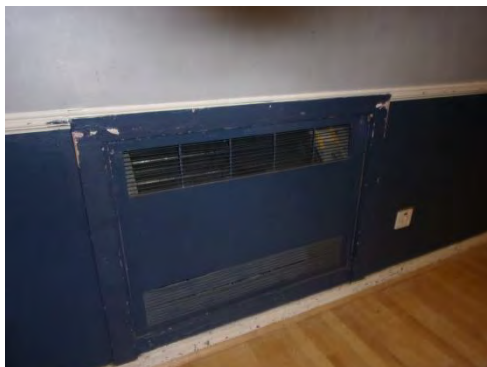
The existing auditorium fan convectors do not provide a uniform heat distribution profile within the space and have reached the end of their useful life. Heat is mechanically supplied into the auditorium around the perimeter which is then directed towards the outer edge of the audience seating area. This is inefficient method to heat the hall as the heat will simply rise and the majority of the heat will be transferred through the roof. For this reason, we would recommend

removing the existing fan convectors and installing LTHW radiant heating panels within the suspended ceiling grid system. It would be necessary to extend the LTHW pipework to serve the radiant heating panels. We would recommend the installation of PICV control valve (such as Crane D995 Peak Pro PICV), Y-strainer and flushing bypass to each radiant heating panel with a constant flow regulator installed at the end of heating circuit to

maintain minimum flow. Each of the PICV's to the radiant heating panels are provided with a 0-10v modulating actuator head to vary the flow through the panels via black-bulb sensor within the auditorium.

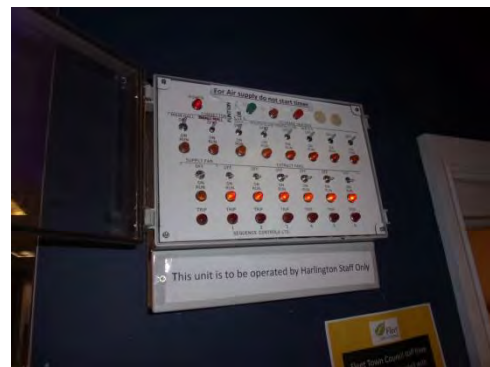
The heating and ventilation controls are failing to function and currently manual intervention is necessary to operate the plant. There is a significant inadequacy of room thermostats generally throughout the building. Where thermostats were identified during our survey, the condition was found to be significantly poor and therefore it is a fair supposition to suggest that the thermostats are also unlikely to be working correctly. It is also reasonable to suggest that the controls are far in excess of 20 years, which is the economic life factor, given under CIBSE Guide M.

We would recommend that all the control systems are replaced throughout for a building management system.

- Strip out and remove existing heating and ventilation controls and provide new building management system. Replacement of three-way control valve actuators, sensors, control wiring etc,
