Congregationalist Cemetery, Ponsharden

Proforma Condition and Repairs Schedule

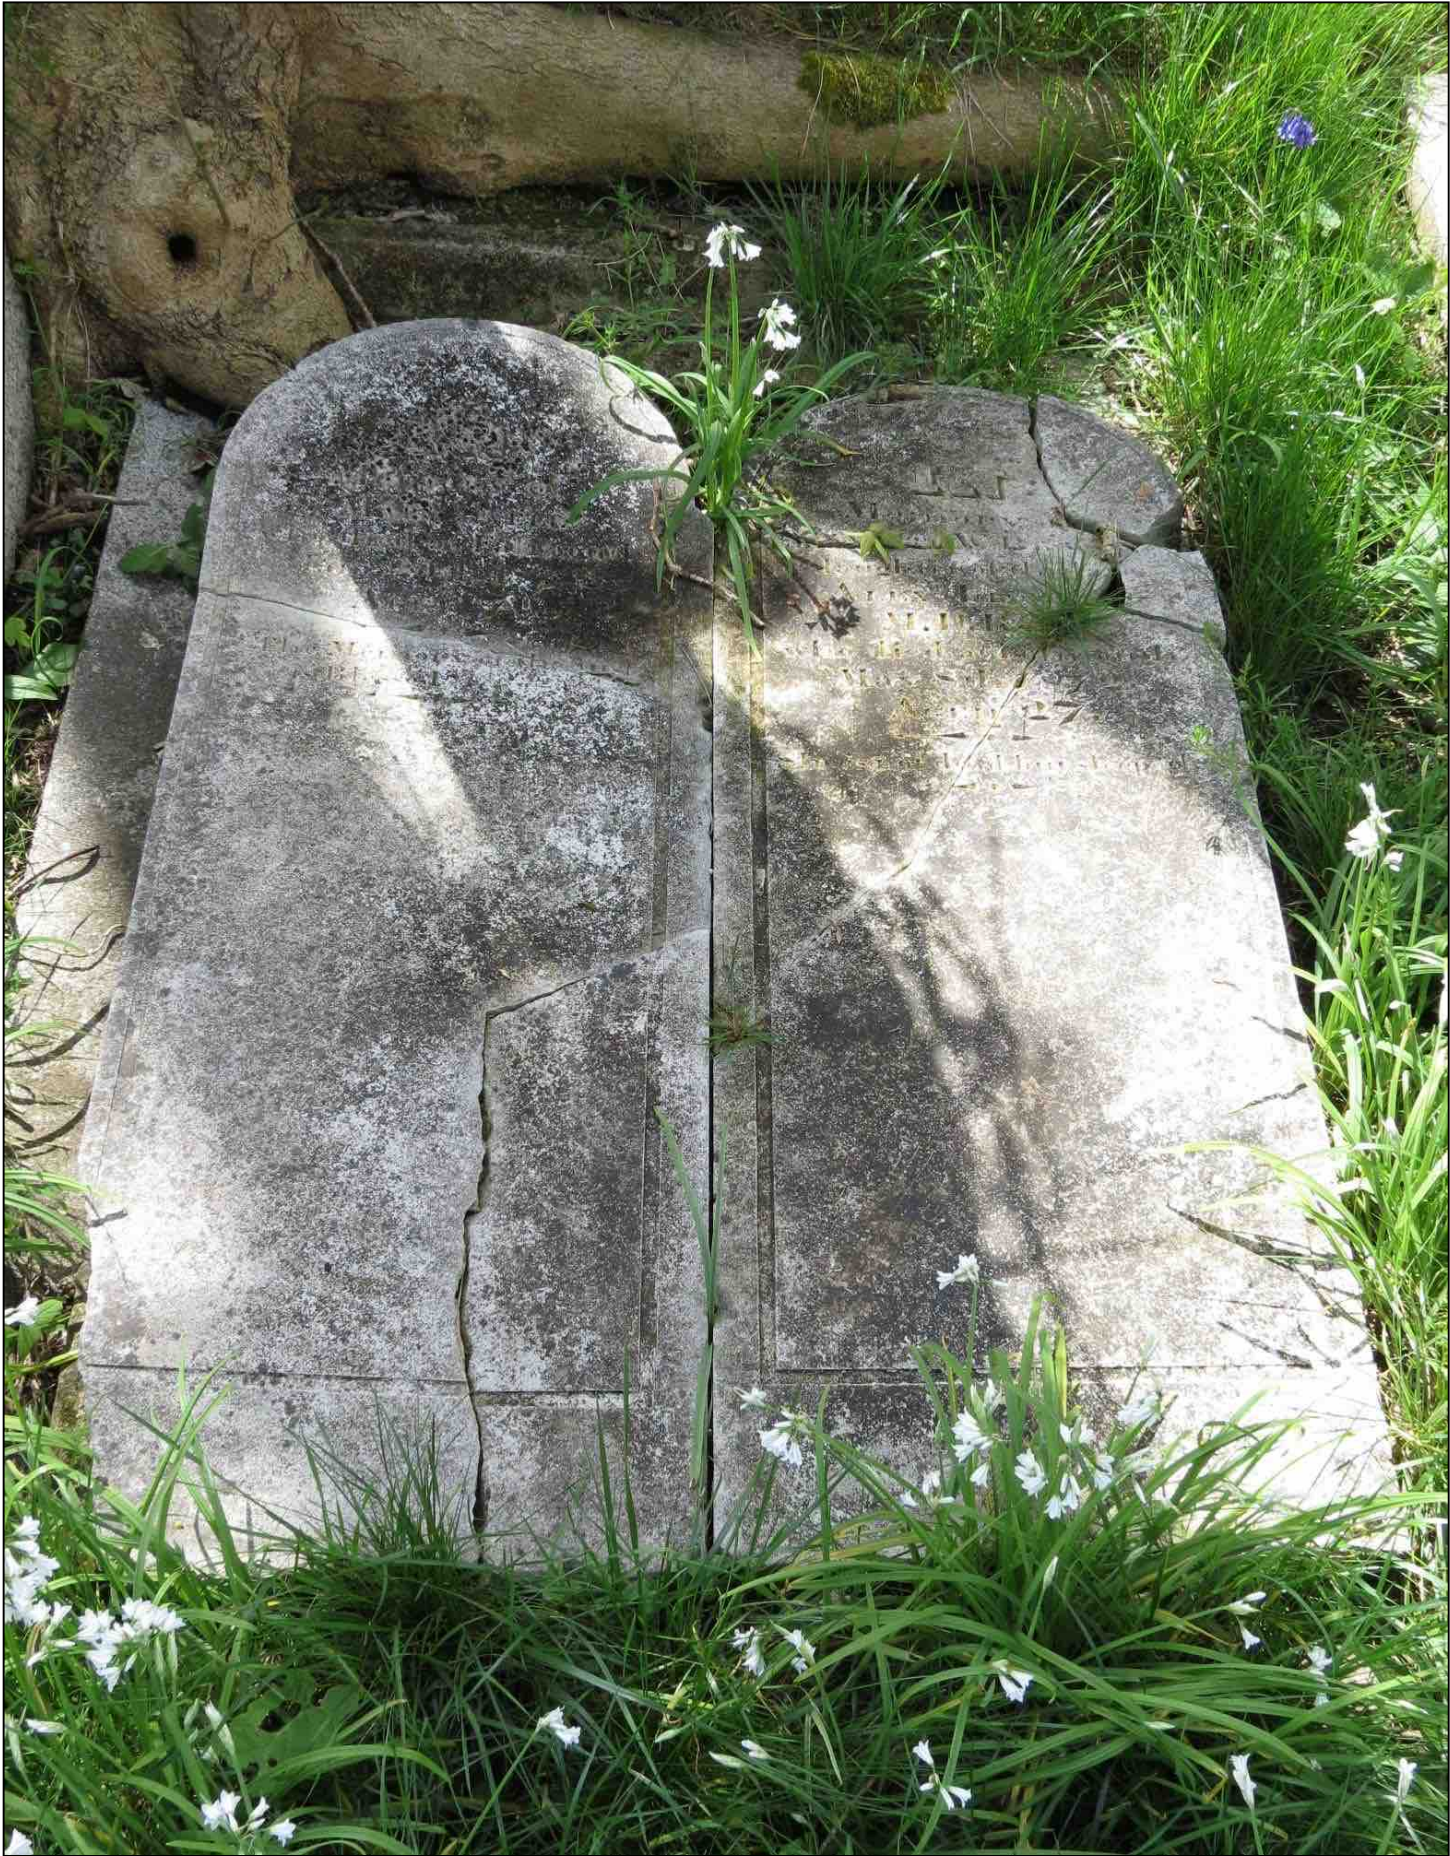
Monument 40

Possibly unstable as leaning against tree
