LEGIONELLA RISK ASSESSMENT

CUSTOMER : NATURAL ENVIRONMENTAL RESEARCH COUNCIL

SITE : BRITISH GEOLOGICAL SURVEY, KEYWORTH

DATE : 20 MARCH 2017

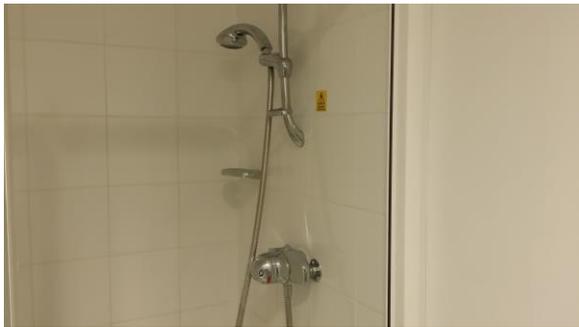
S 1 (EIGL 3)

| Shower | Location | Contamination | Usage | Hot > 50°C | Cold < 20°C | Type |
|---|---|---|---|---|---|---|
| Comments Used as an emergency shower | | | | | | |

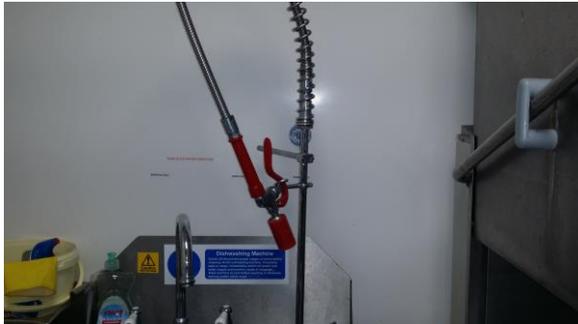
RS 1 (SRMR)

| Shower | Location | Contamination | Usage | Hot > 50°C | Cold < 20°C | Type |
|---|---|---|---|---|---|---|
| RS 1 | Kitchen | Light scale | At least weekly | - | No | Rinse Spray |

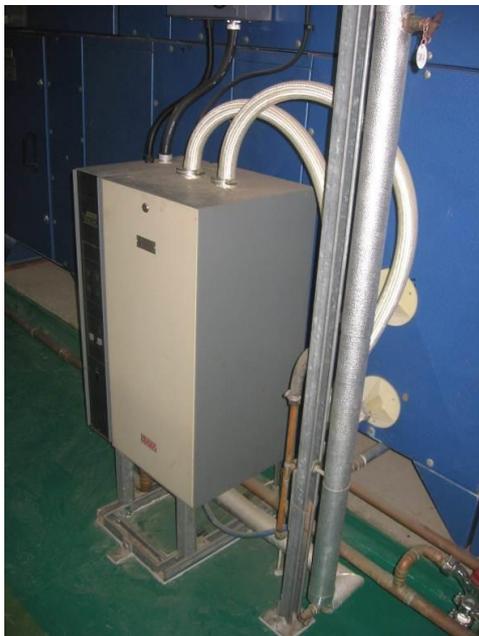
STEAM HUMIDIFIER

| | Assessment of Risk | Very low / negligible |

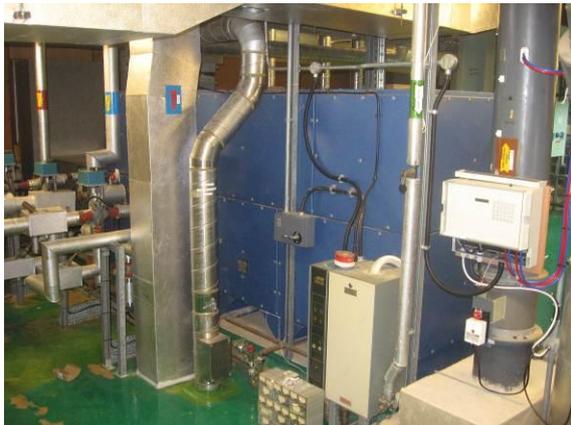
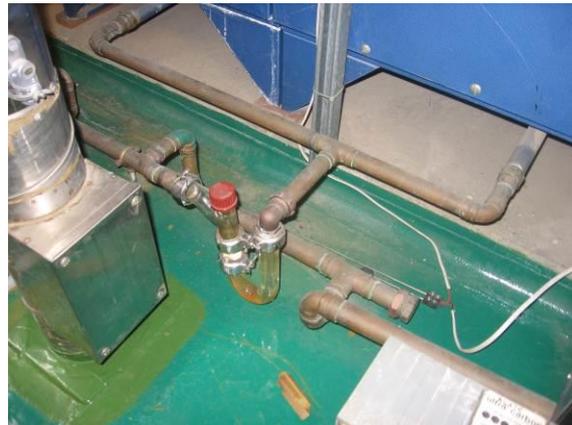
AHU U-TRAP

| | Assessment of Risk | Low |

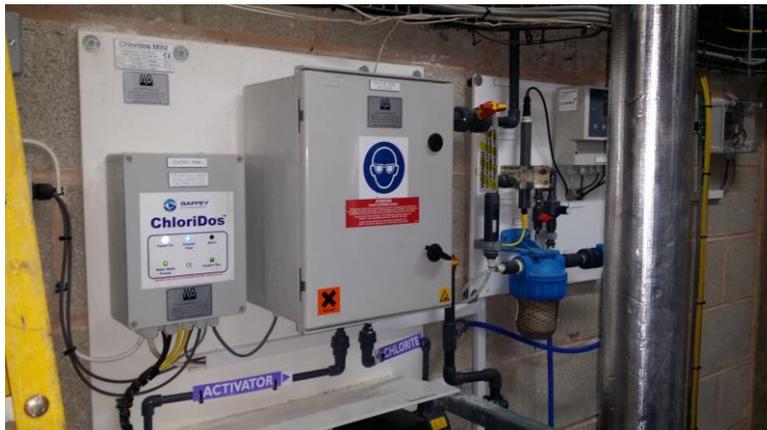
CHLORINE DIOXIDE DOSING SYSTEM

| | Assessment of risk | Very low |

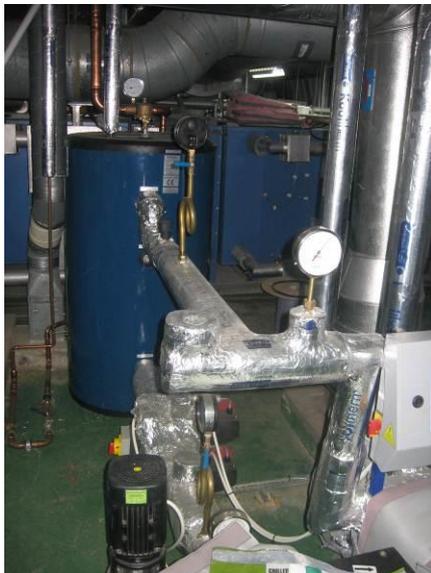
CHILLED WATER STORAGE VESSEL

| | Assessment of Risk | Low |

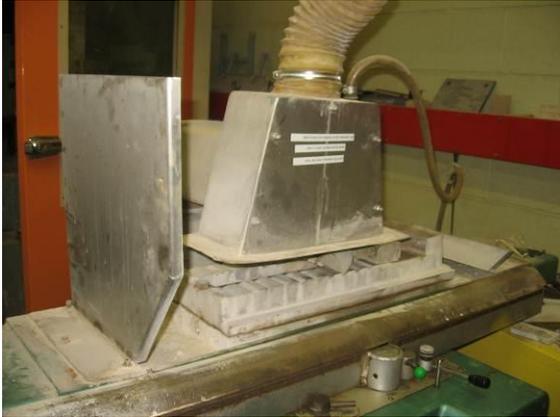
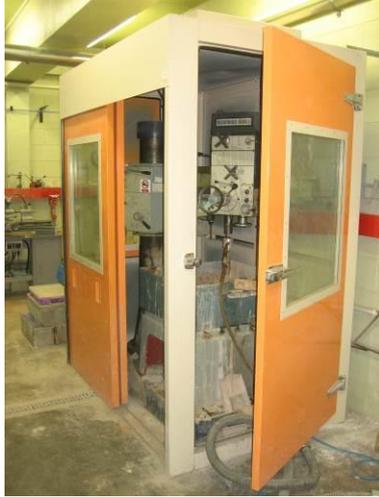
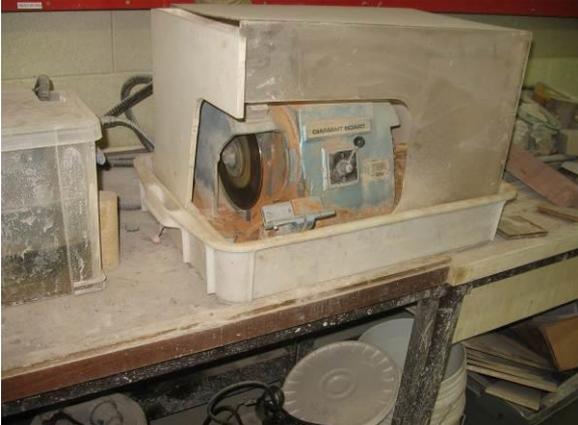
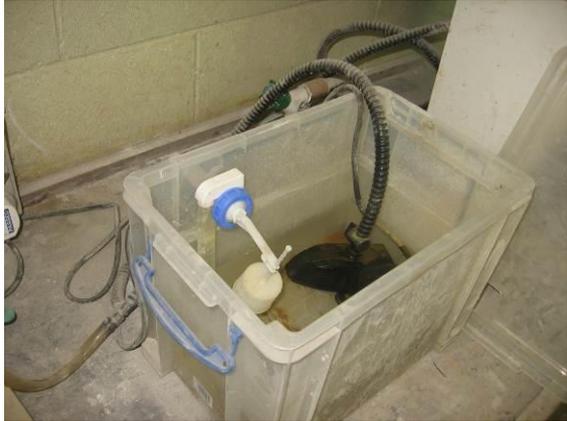
| TYPE | Type of System | Coolant cutting machines |
| <p>GRINDER</p> | <p>CUTTER</p> | |
| <p>CUTTER</p> | <p>TANK SUPPLYING WATER TO CUTTER</p> | |

The cutting lubricants can support legionella and other bacteria which can cause respiratory disease. Lubricants should contain a biocide and systems should be cleaned regularly every six months.

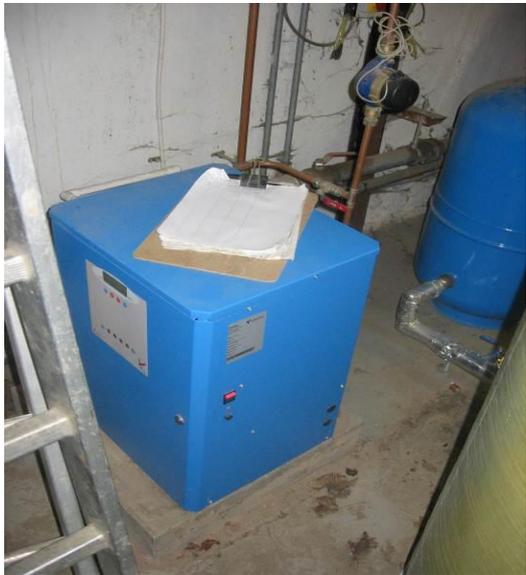
| PU 1 | | |

| | Assessment of Risk | Very low |

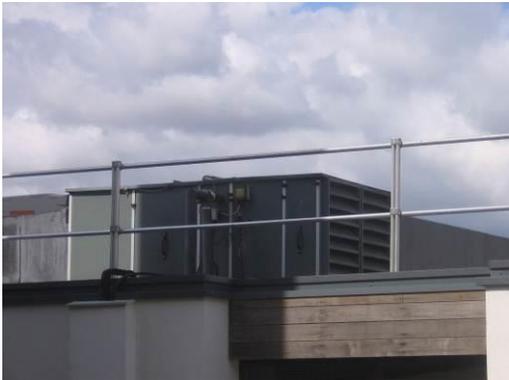
| LOCATION | Location of outlet | Roof |
|---|---|---|
| AHU 1 | | |

| LOCATION | Location of outlet | Roof |
|---|---|---|
| <p>Water condensing from the cooled air at the cooling coils within the air handling units may create conditions suitable for bacteria to grow. The cooling coils and drainage trays of these units could support bacteria growth and should be regularly inspected and maintained in a clean condition.</p> | | |

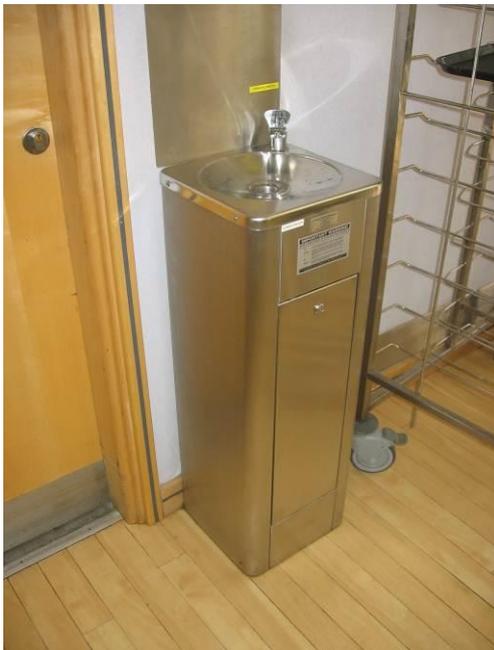
DW

| LOCATION | Location of outlet | Restaurant |
|---|---|---|
| | Assessment of risk | Very low / negligible |

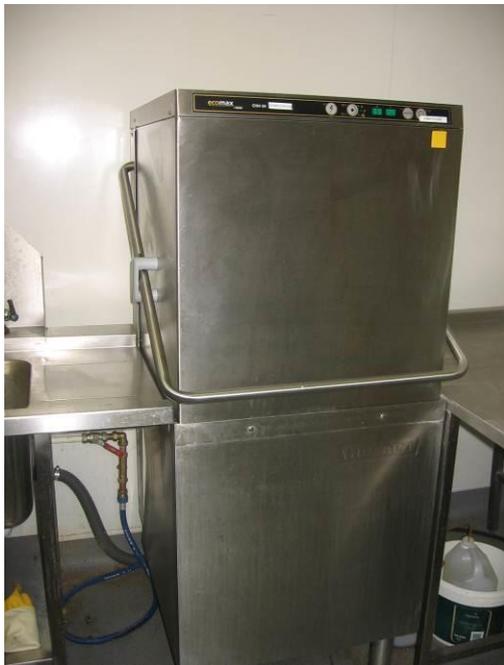
DW

| LOCATION | Location of outlet | Kitchen |
|---|---|---|
| | Assessment of risk | Very low / negligible |

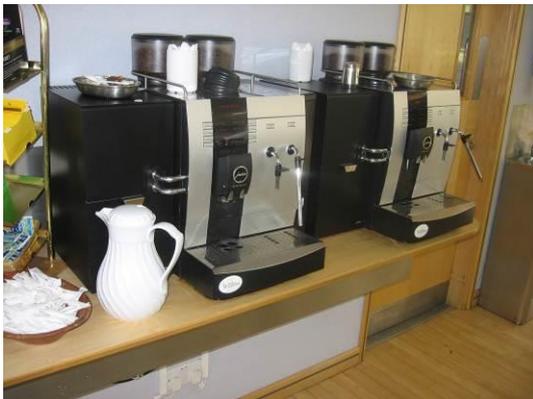
VM

| LOCATION | Location of outlet | Restaurant |
|---|---|---|
| | Assessment of risk | Very low / negligible |

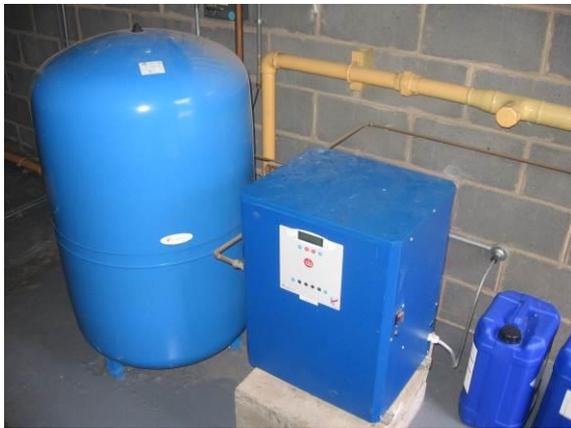
PU 1

| | Assessment of Risk | Very low |

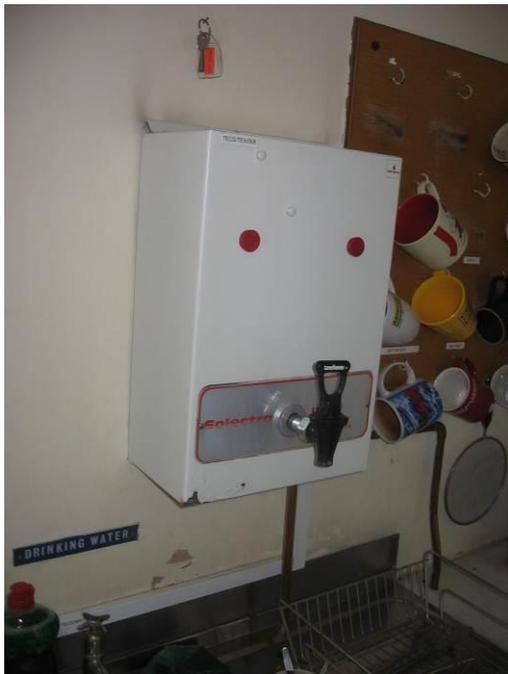
WB

| LOCATION | Location of outlet | Mess room |
|---|---|---|
| | Assessment of risk | Very low / negligible |

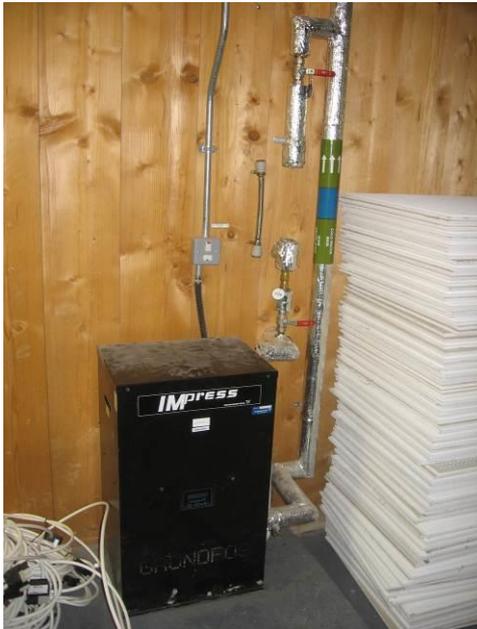
PU1

| | Assessment of Risk | Very low |

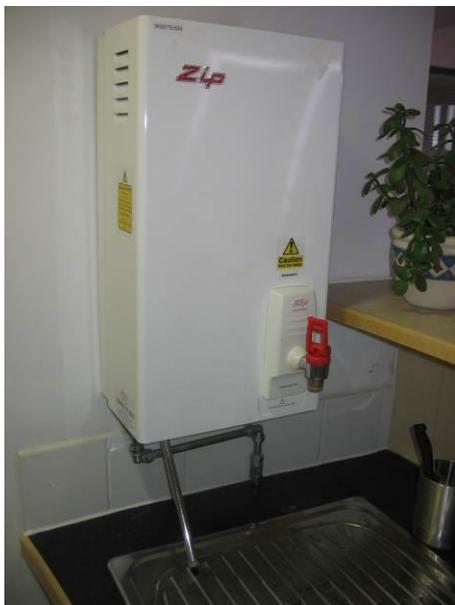
WB

| LOCATION | Location of outlet | First, upper ground and lower ground tea points |
|---|---|---|
| | Assessment of risk | Very low / negligible |

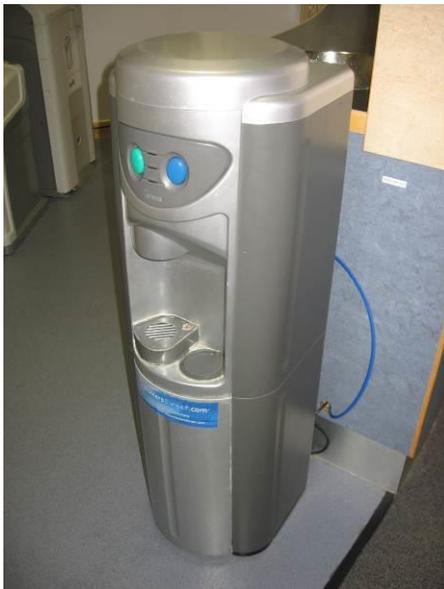
CW

| | Assessment of risk | Very low / negligible |

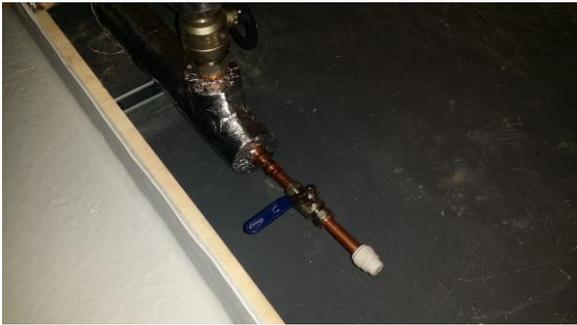
CWST 2 (WSB) OUTLET DEADLEG
