# **Beverley Town Council New Town Hall Project Manager**

## **TENDER PACK**

# Condition Report

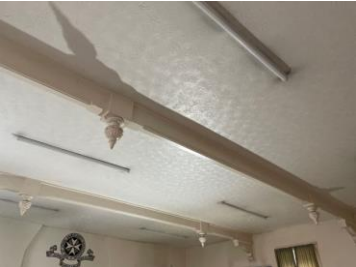
| | Inspection Date | Surveyor | Survey Type | Floor | Analysis | |
|---|---|---|---|---|---|---|
| Surveyor Comments | Textured coating to ceiling of main hall | | | | Review Date | N/A |

| | Inspection Date | Surveyor | Survey Type | Floor | Analysis | |
|---|---|---|---|---|---|---|
| Recommendations / Actions | No action required | | | | | |

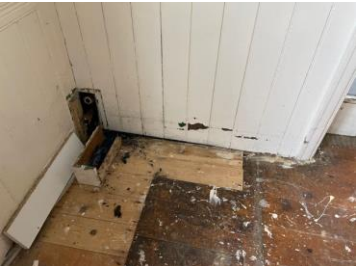
| | Inspection Date | Surveyor | Survey Type | Floor | Analysis | |
|---|---|---|---|---|---|---|
| Surveyor Comments | Thermal insulation to metal pipework within corner boxing | | | | Review Date | N/A |

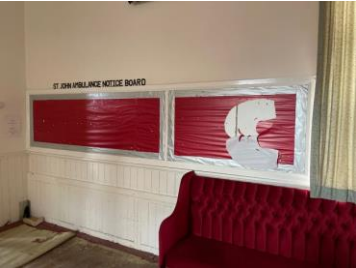
| | Inspection Date | Surveyor | Survey Type | Floor | Analysis | |
|---|---|---|---|---|---|---|
| Surveyor Comments | Insulation board notice board | | | | Review Date | N/A |

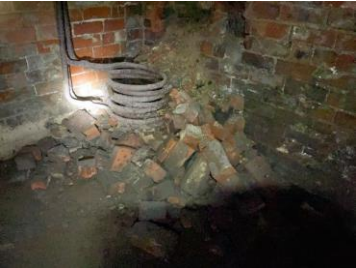
| | Inspection Date | Surveyor | Survey Type | Floor | Analysis | |
|---|---|---|---|---|---|---|
| Surveyor Comments | | Thermal insulation residue to coil of metal pipework | | | Review Date | N/A |

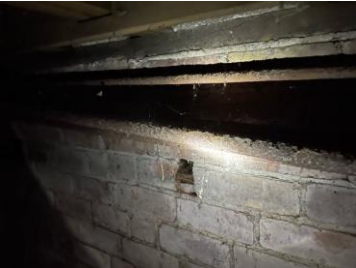
| | Inspection Date | Surveyor | Survey Type | Floor | Analysis | |
|---|---|---|---|---|---|---|
| Surveyor Comments | Thermal insulation residue to metal pipework | | | | Review Date | N/A |

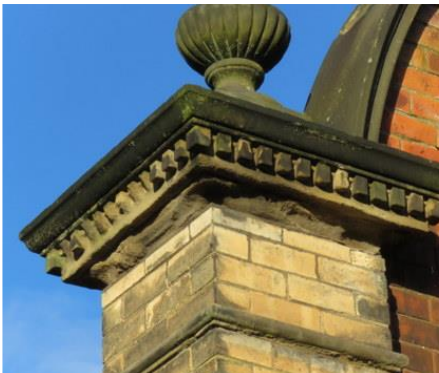
Eroding stone to most stone details.

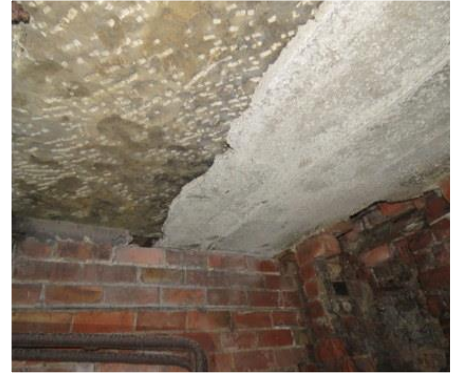
York stone and concrete fire place half beneath chimney.

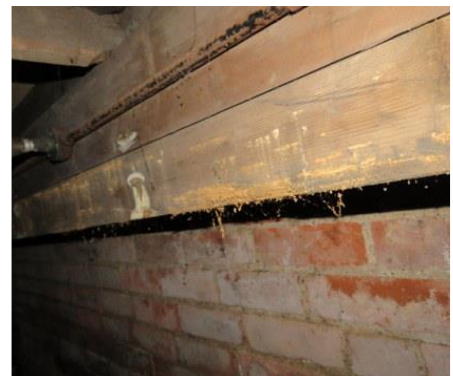
Beetle activity to floor joists beneath main reception room.

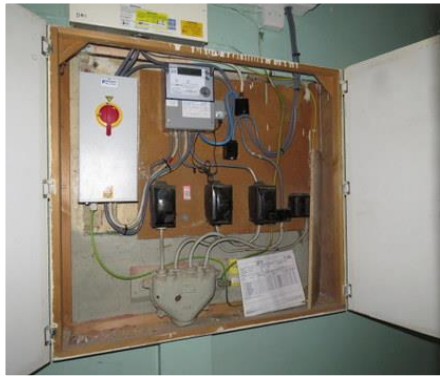
Electrical services.
