CCTV Inspection Report

**WILLINGTON PARISH COUNCIL,
TWYFORD ROAD,
WILLINGTON.
DE65 6BN**

01/06/2023

Job Number: 01/06/23-EG

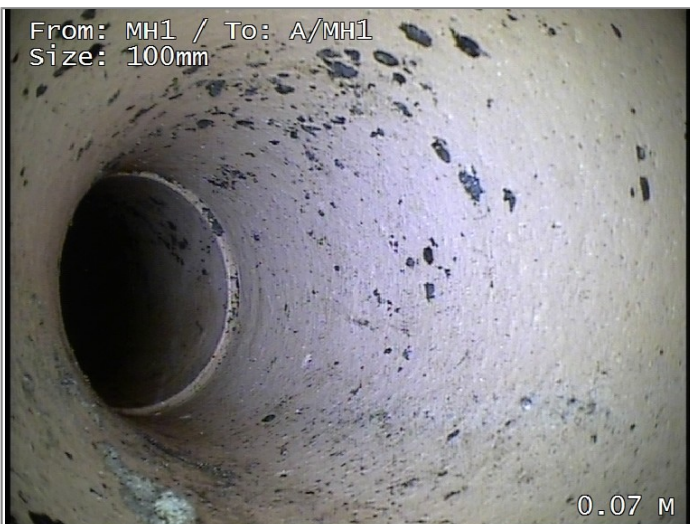
Line of drain/sewer deviates left

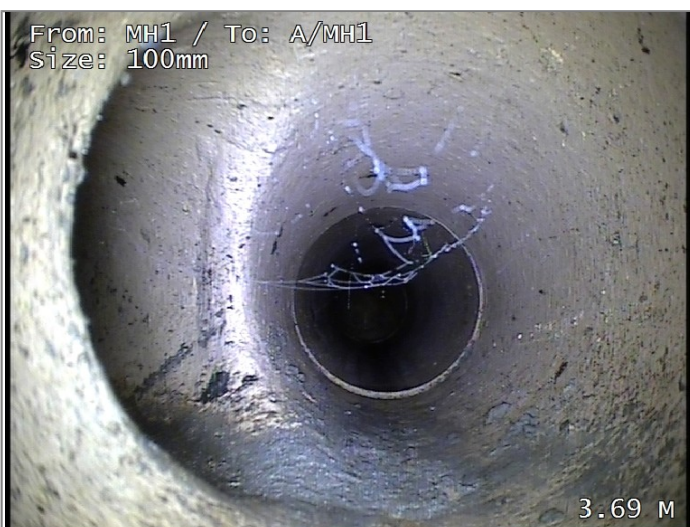
Junction at 9 o'clock, diameter 100mm

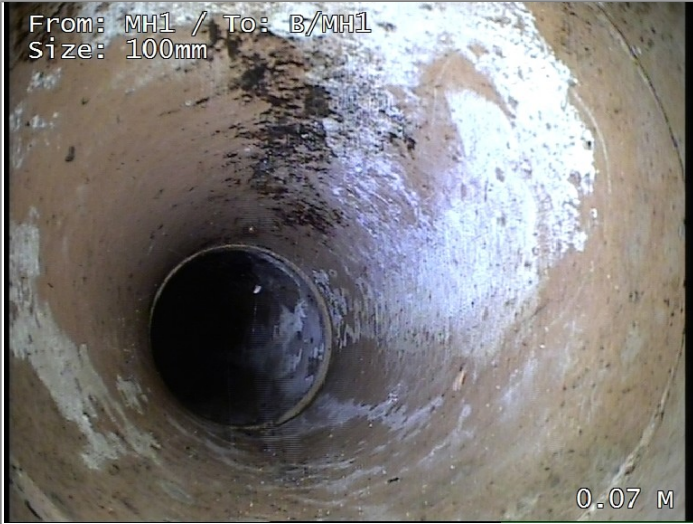
<p>0.07 M</p> <p>Line of drain/ sewer deviates left</p>			
<p>From: MH1 / To: B/MH1 Size: 100mm</p>

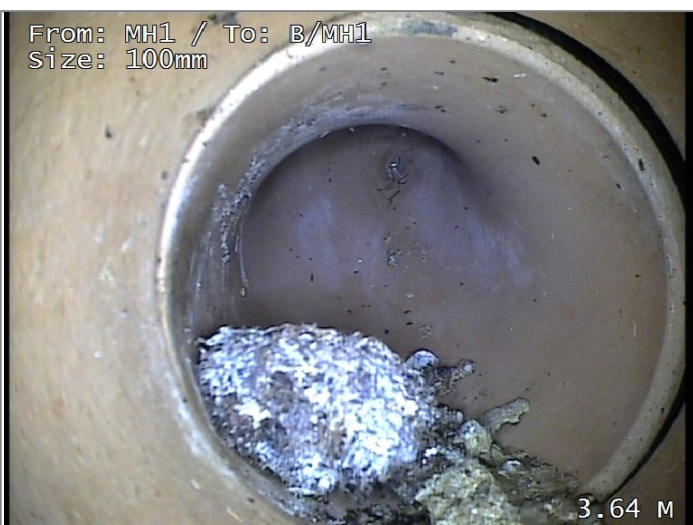
<p>3.64 M</p> <p>Line of drain/ sewer deviates up</p>			
<p>From: MH1 / To: B/MH1 Size: 100mm</p>

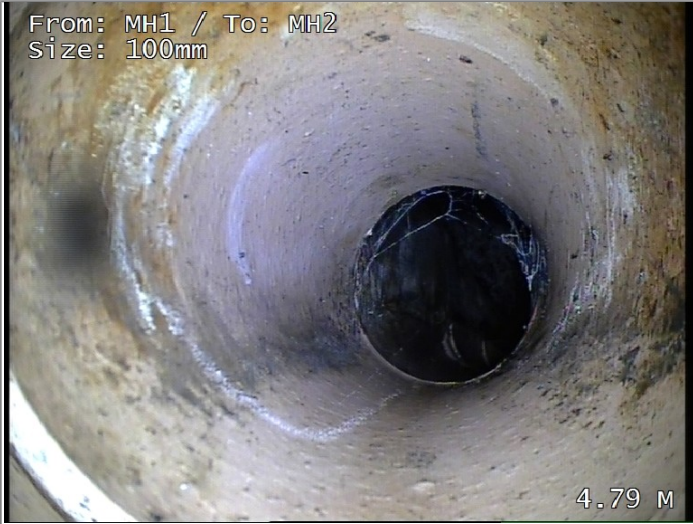
<p>From: MH1 / To: MH2 Size: 100mm</p> <p>4.79 M</p> <p>Line of drain/sewer deviates right</p>

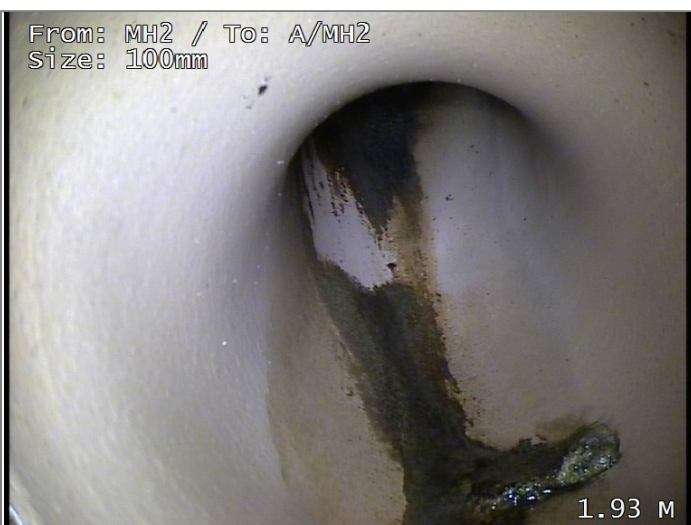
<p>1.93 M</p> <p>Line of drain/sewer deviates up</p>

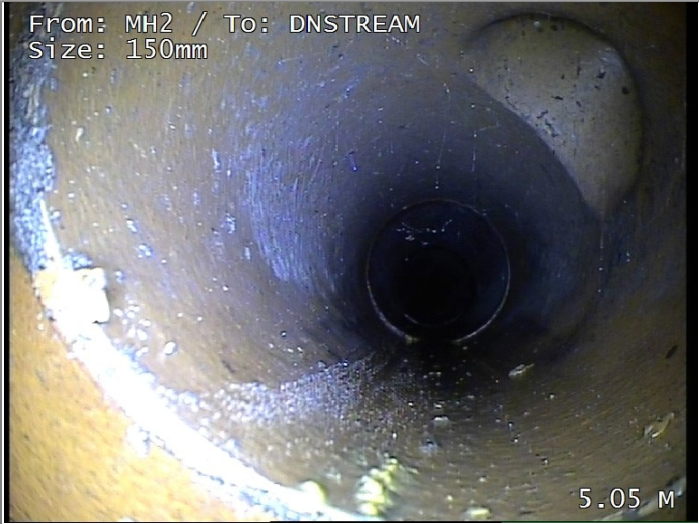
<p>5.05 M</p> <p>Junction at 1 o'clock, diameter 100mm</p>			
<p>From: MH2 / To: DNSTREAM Size: 150mm</p>

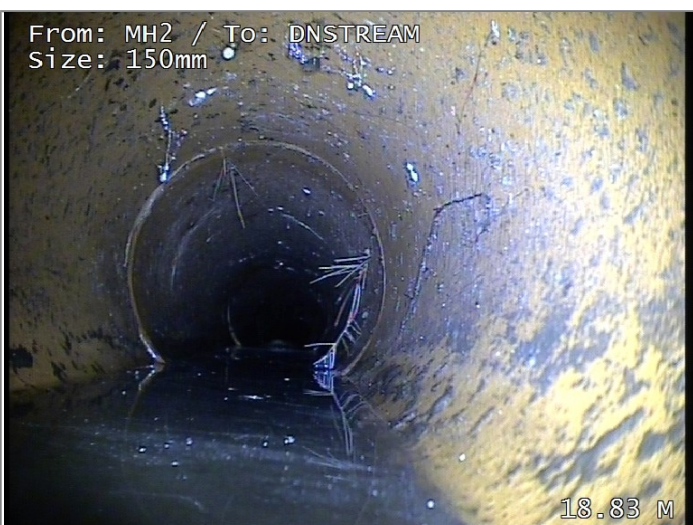
<div>18.83 M</div> <div>Water level 5% height/diameter</div> </div>			
<div> <div> From: MH2 / To: DNSTREAM Size: 150mm </div>

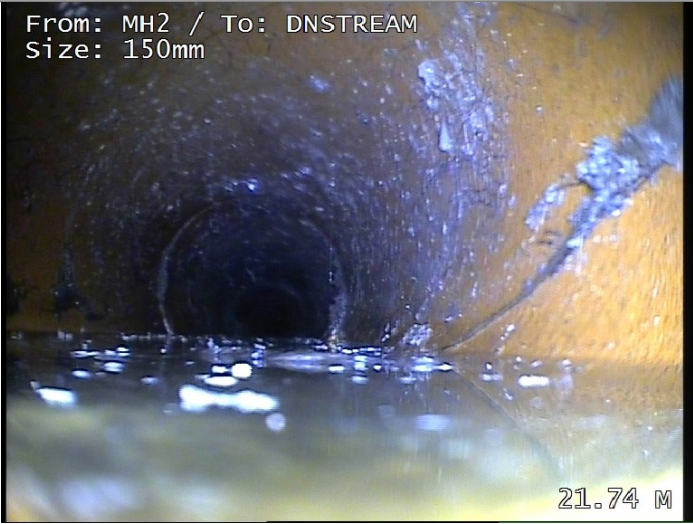
<div>21.74 M</div> <div>Water level 20% height/diameter</div> </div>			
<div> <div> From: MH2 / To: DNSTREAM Size: 150mm </div>

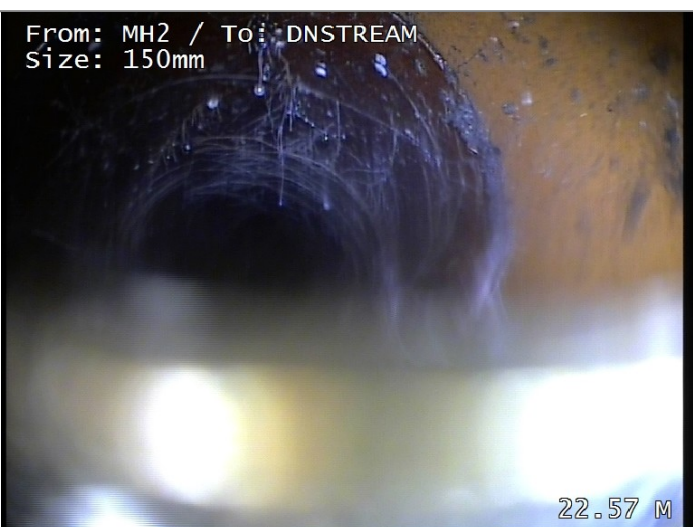
<div>22.57 M</div> <div>Water level 40% height/diameter</div> </div>

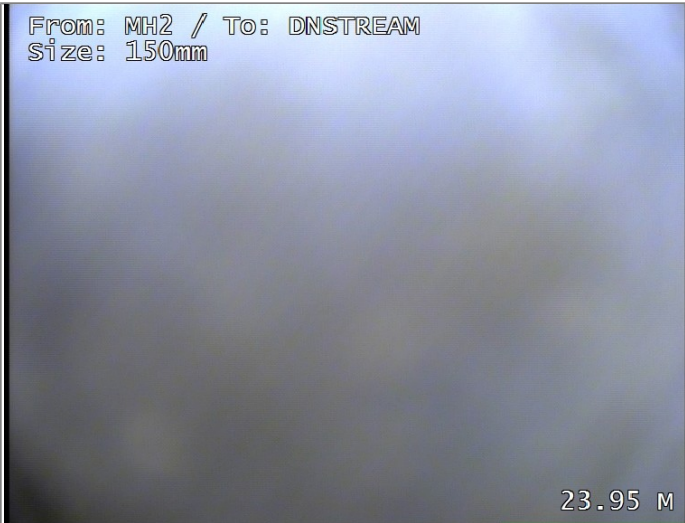
Loss of vision, camera under water, Start

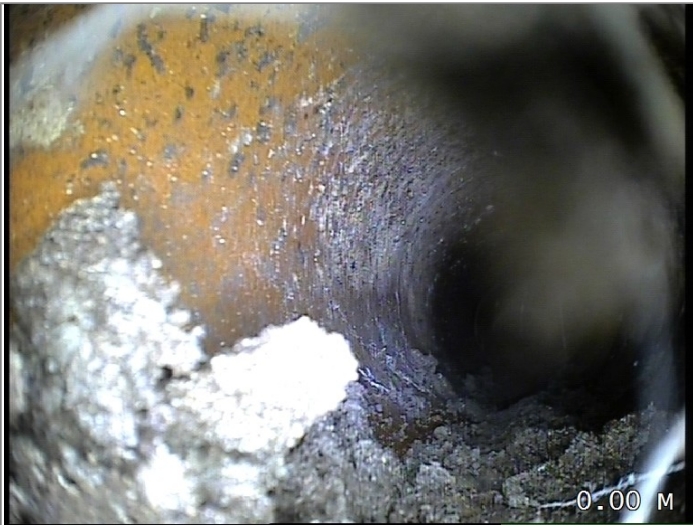
<p>Start node type, manhole, reference MH2</p>

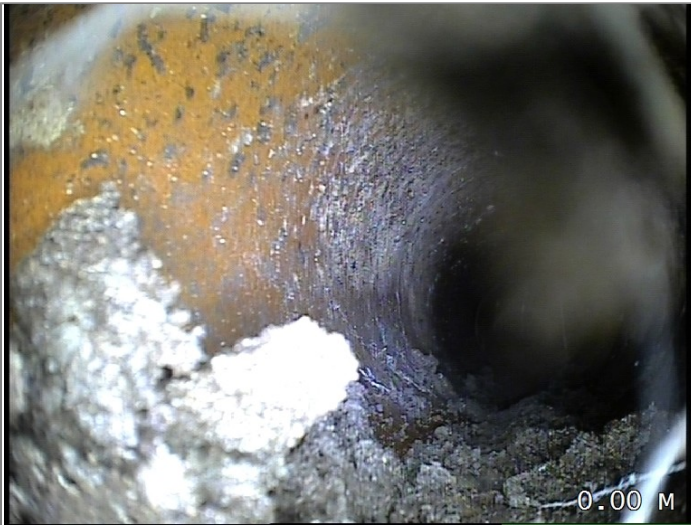
<p>Water level 0% height/diameter</p>			
<p>From: MH2 / To: MH3 Size: 150mm</p>

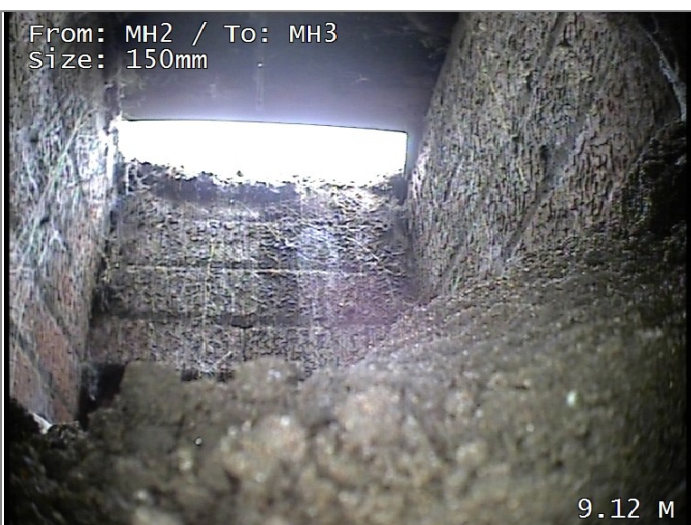
<p>REM-SURVEYED IN REVERSE DUE TO DEBRIS</p>

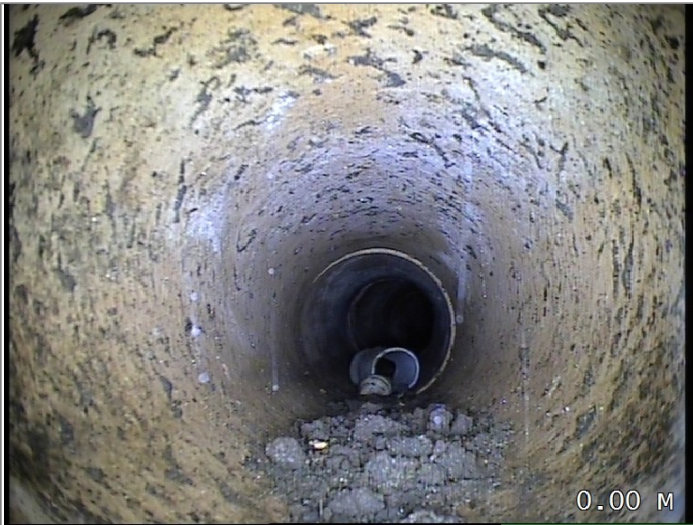
<p>0.00 M</p> <p>Start node type, manhole, reference MH4</p>

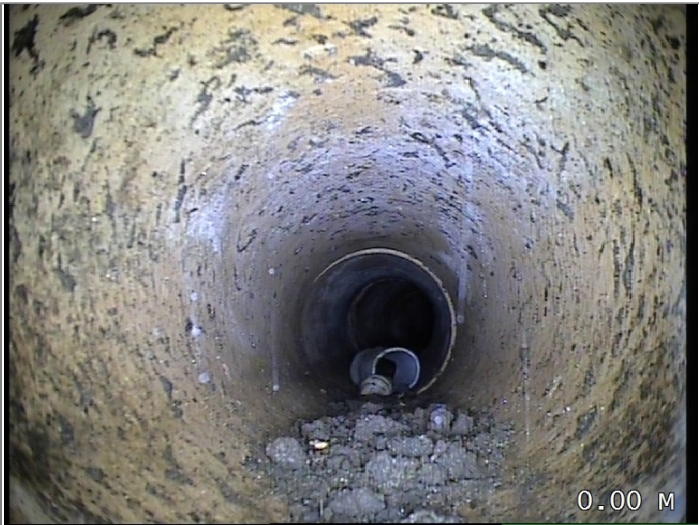
<p>0.00 M</p> <p>Water level 0% height/diameter</p>	
<p>From: MH4 / To: A/MH4 Size: 100mm</p>

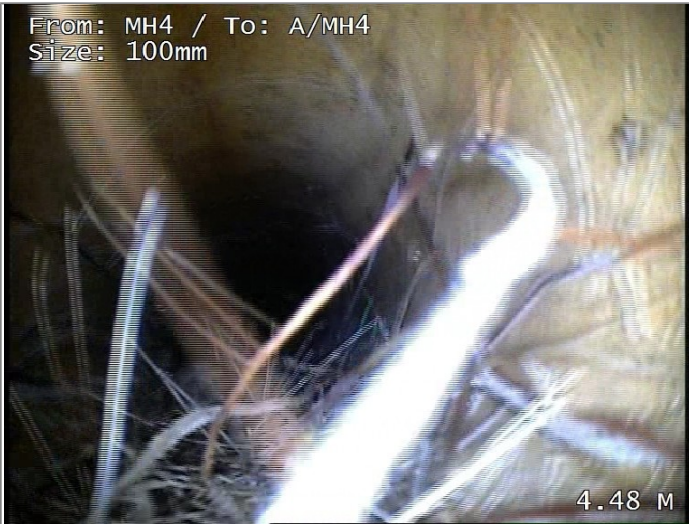
<div>4.48 M</div> <div>Roots mass 25% cross-sectional area loss</div> </div>			
<div> <div> From: MH4 / To: A/MH4 Size: 100mm </div>

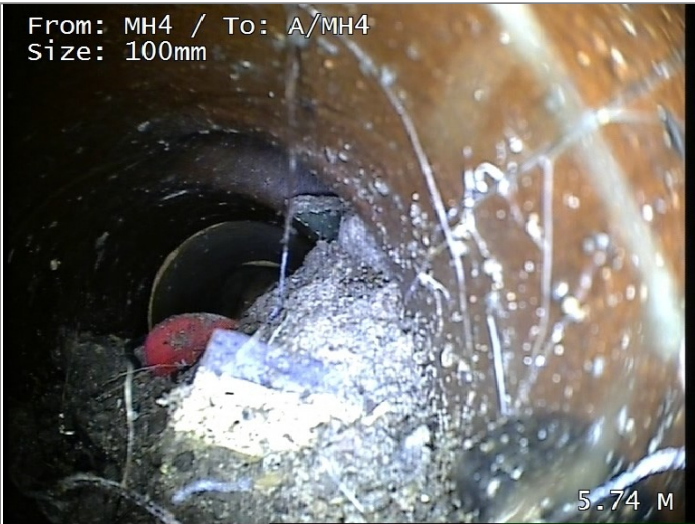
<div>5.74 M</div> <div>Junction at 1 o'clock, diameter 100mm</div> </div>			
<div> <div> From: MH4 / To: A/MH4 Size: 100mm </div>

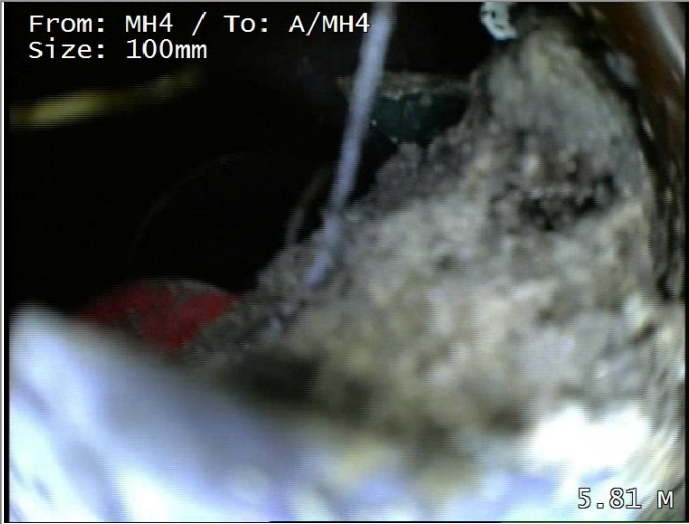
<div>5.81 M</div> <div>Roots mass 75% cross-sectional area loss</div> </div>			
<div> <div> From: MH4 / To: A/MH4 Size: 100mm </div>

<p>5: Pipe is already or will shortly be impermeable: Eg. collapsed pipe, deeply rooted pipe or other drainage obstructions. Pipe loses water or danger of backwater in basements etc.</p> <p>REHABILITATION IS URGENT AND SHORT-TERM. IN ORDER TO PREVENT FURTHER DAMAGE, NECESSARY TEMPORARY SPOT REPAIR HAS TO BE CONDUCTED ON EMERGENCY LEVEL.</p>

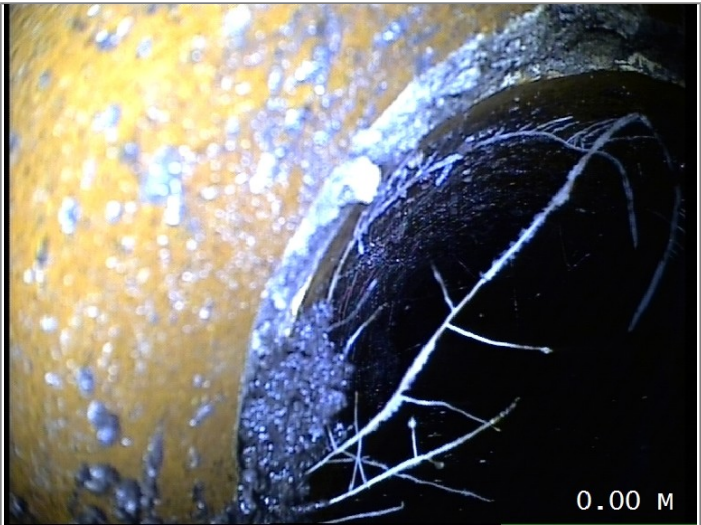
<p>0.00 M</p> <p>Start node type, manhole, reference MH4</p>

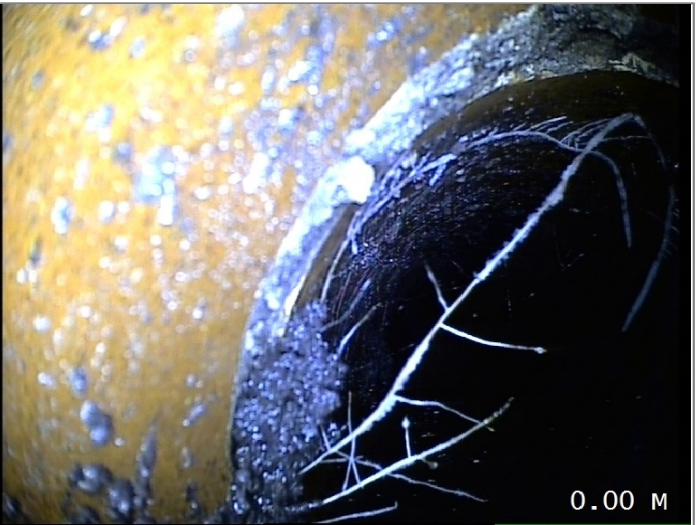
<p>0.00 M</p> <p>Water level 5% height/diameter</p>			
<p>From: MH4 / To: STW SEWER Size: 150mm</p>
