gleeds

Client Name	The National Museum of the Royal Navy (NMRV)
Client Address	HMS Naval Base (PP66), Portsmouth, PO1 3NH
Property Address	Fleet Air Arm Museum, RNAS Yeovilton, Ilchester BA22 8HT
Date of Inspection	09 March and 23 March 2021
Surveyor Involved	Claire Ramsay MRICS, Associate Director, Gleeds
Other Consultants	Amanda McLoughlin – Promode Building Services Consultants Limited
Involved	Graham Crisp – Promode Building Services Consultants Limited
Weather Conditions	Weather conditions at the time of survey were clear and dry.
Brief and Scope	This Planned Maintenance Programme was prepared under instruction from NMRN. The report is intended to provide an assessment of the condition of the various components of the property / properties and an indication of the likely works required in the future.
	Budget costs are provided to assist with future cost planning. These costs are provided as budget costs only and are not subject to detailed design or open market tendering.

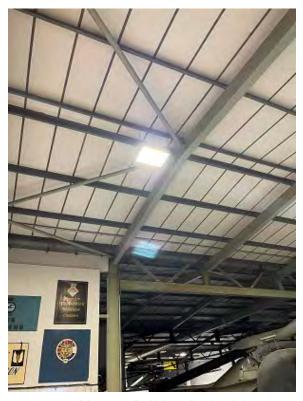
1 Museum Building display lighting

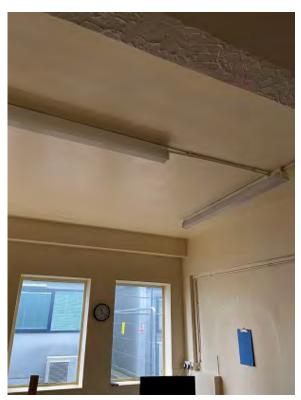
2 Museum Building office lighting

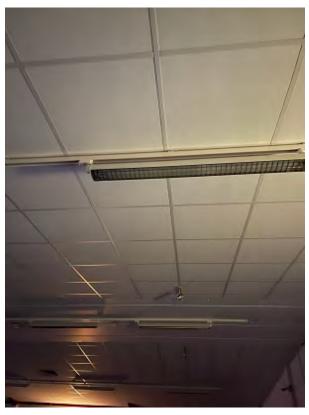
Swordfish Building lighting 5

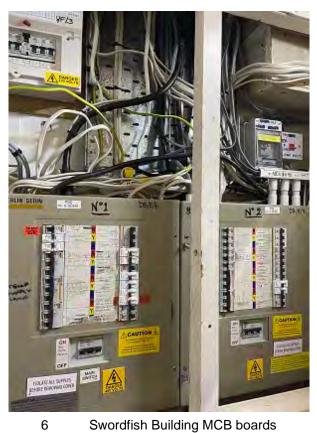
Swordfish Building MCB boards

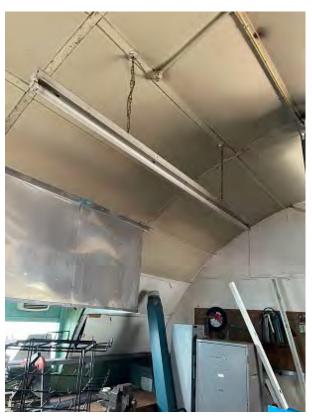
9 FM Workshop lighting

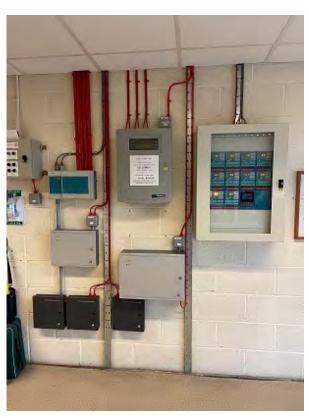
10 Cobham Hall fire alarm panels

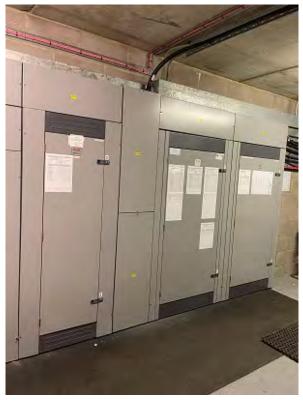
11 Cobham Hall main electrical switch panels

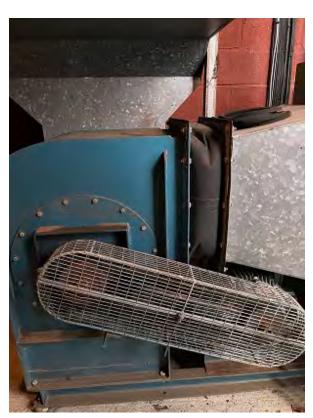
12 Fan

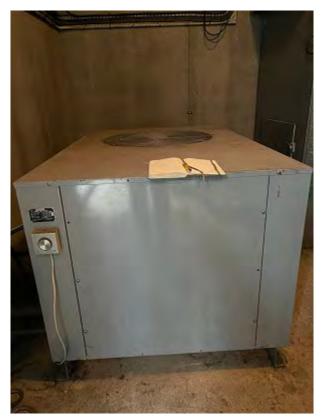
13 Condenser

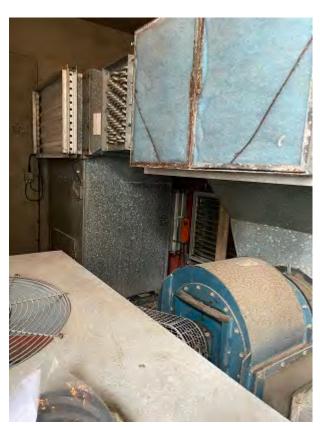
14 Air handling unit

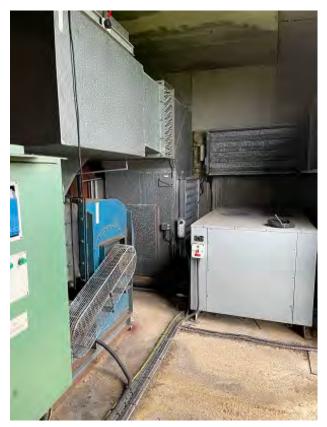
15 Air handling unit

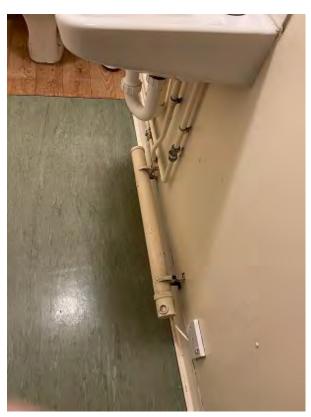
16 Tubular heater

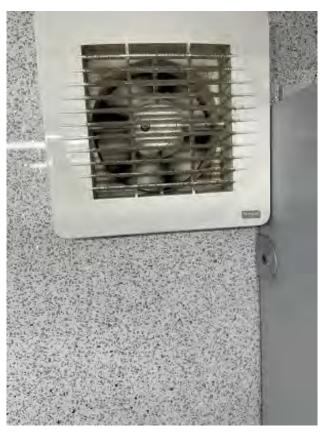
18 Extract fan

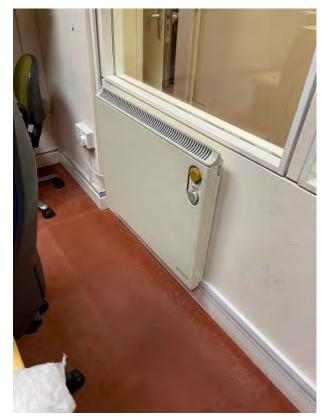
19 Electric radiator

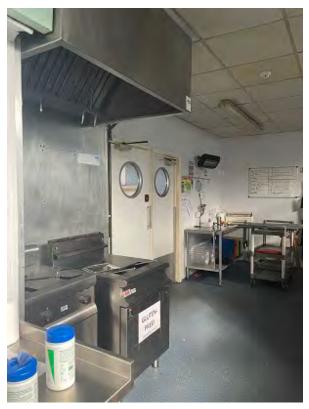
20 Kitchen

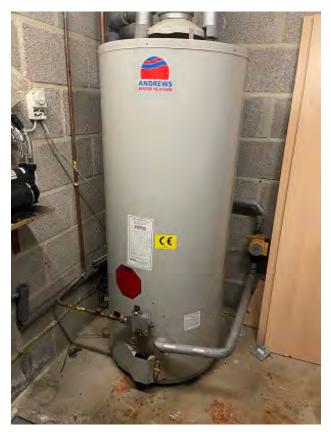
21 Hot water cylinder

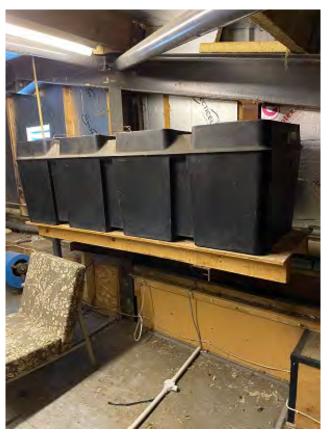
22 Water storage tank

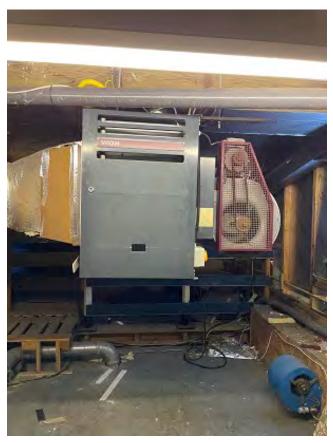
23 Air handling unit

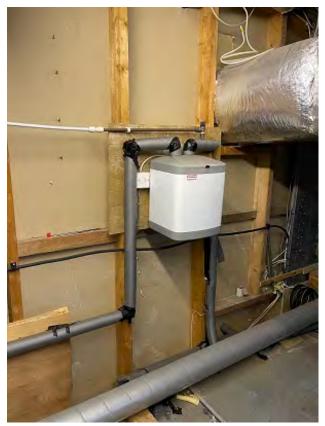
24 Water heater
