# Safety Inspection Report

Annual Inspection

## Bonnymead Recreation Ground Playground

25 September 2024

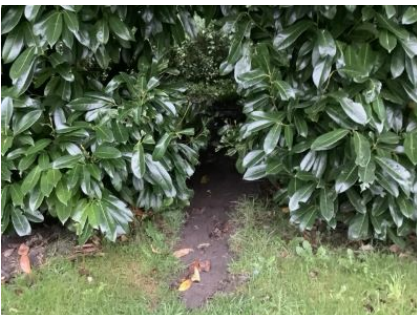
Additional comments are noted below.

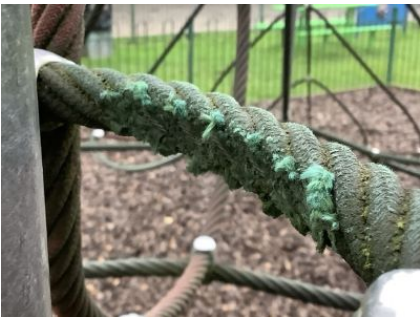
Centre rings. This is due to the net being loose and rubbing on the central pole.

Repair.

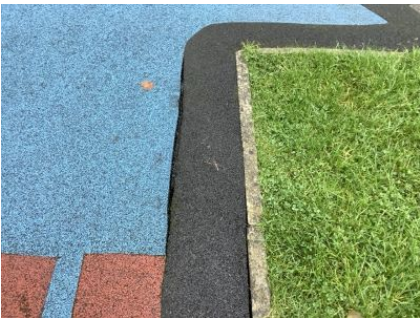
Shrinkage / separation of the surface. This may give a trip hazard.

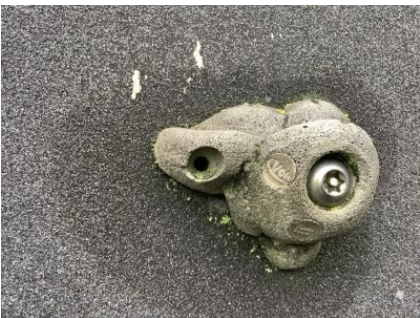
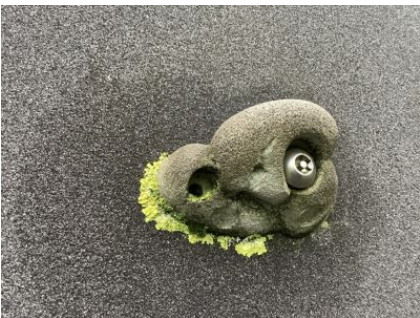
Fixtures loose or missing.

Secondary fixing missing from hand grips.

Replace.

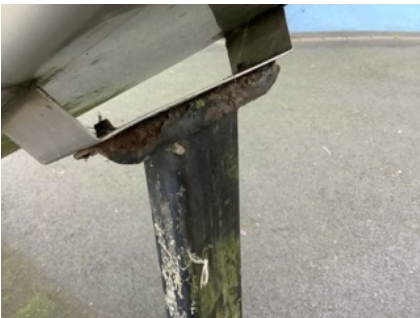
Item is rusting in places.

De-scale back to good metal and coat with lead free paint, using appropriate precautions. Repairs may be necessary where corrosion is severe.

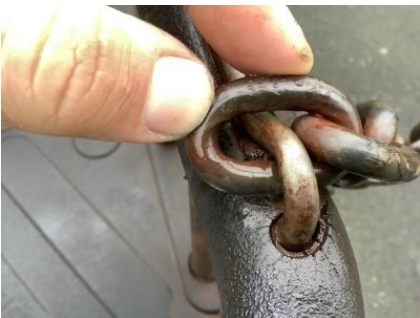
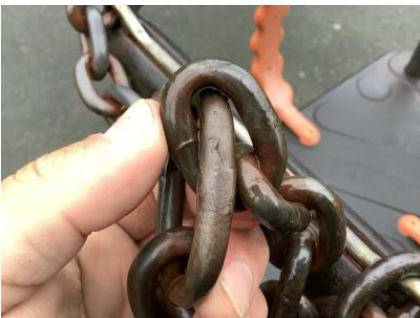
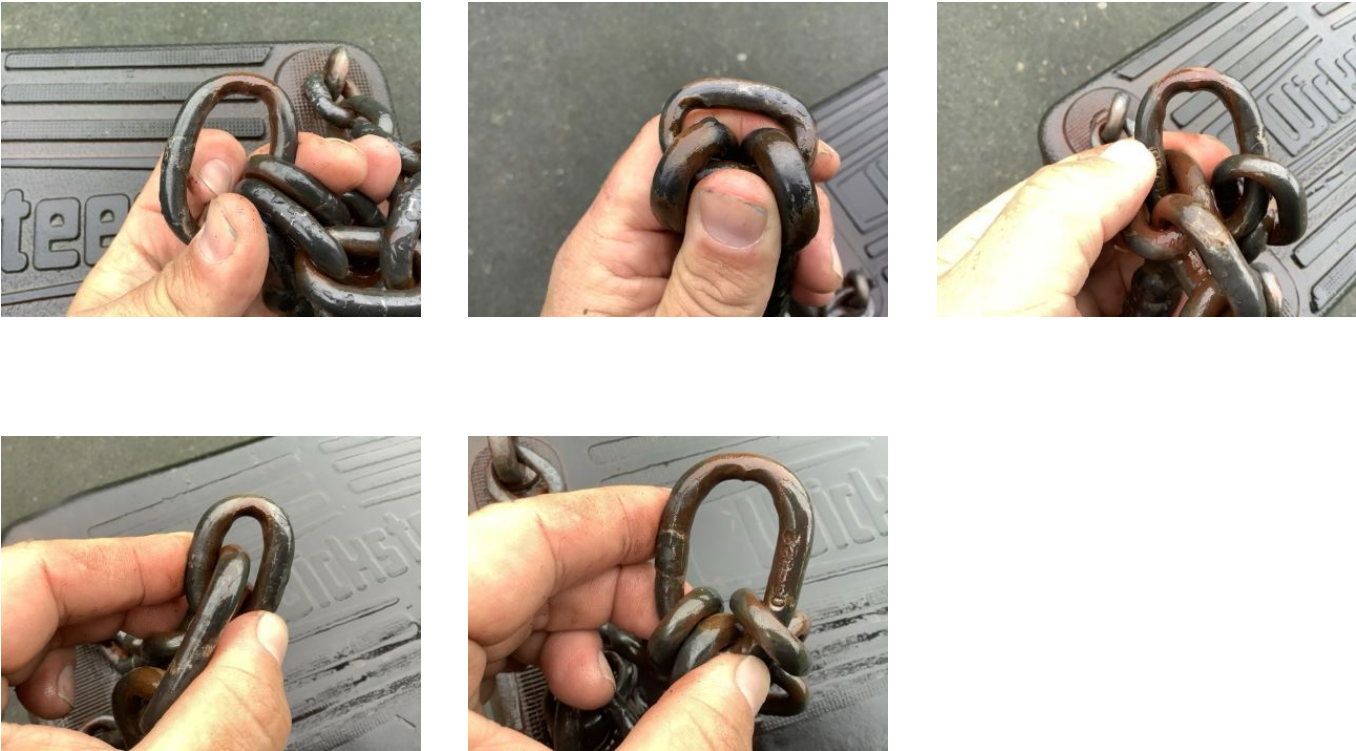
Some chain wear.

Monitor for further deterioration and replace before 40% wear.

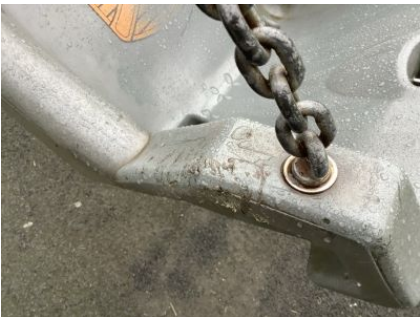
**Description**  
The swing seat has been damaged, but does not require immediate replacement.

Accessible swing. Damage appears due to dogs. Monitor.

**Tasks**  
Monitor and replace when hard material is exposed.

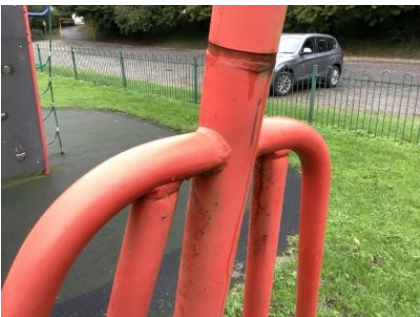
Wicksteed recommend that during routine inspections the area on the swing where the side frames meet the vertical support be checked for any cracks. In the event of cracks being found then remove the seats and contact Wicksteed for further advice.

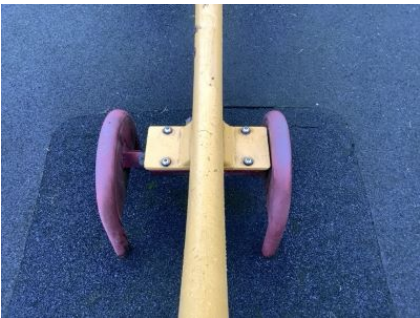
Central pivot has been pushed over to one side, monitor as this could be clashing with the side, which will increase wear.

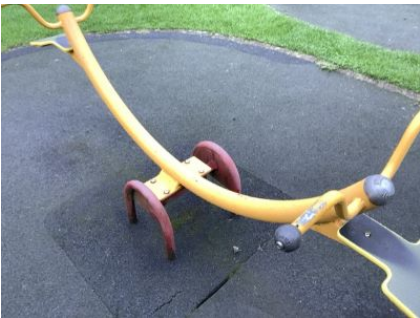
The main frame is full of water, which will be accelerating corrosion internally.  
Drain and prevent future accumulation.

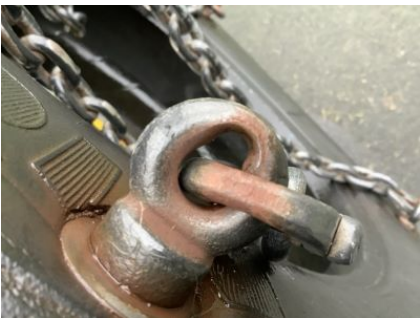
There is considerable wear to the chains.

Replace the worn chains or links.

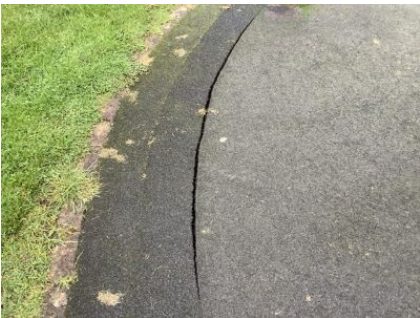
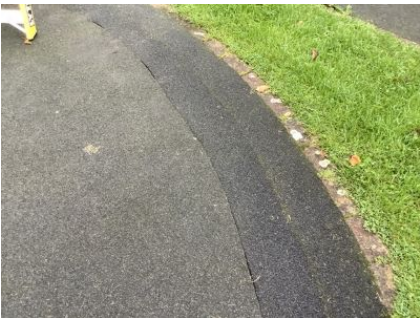
Shrinkage / separation of the surface. This may give a trip hazard.

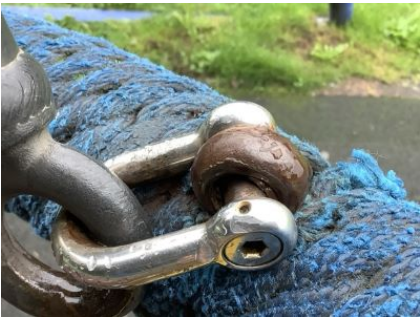
There is wear in the bushes.

Remove shackle bolt and check bush and shackle pin wear, replacing as necessary.

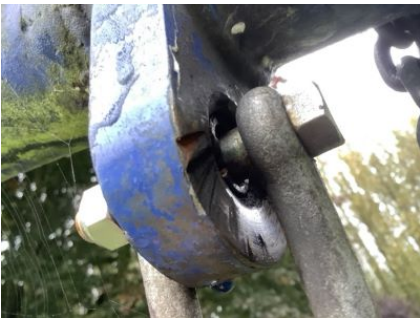
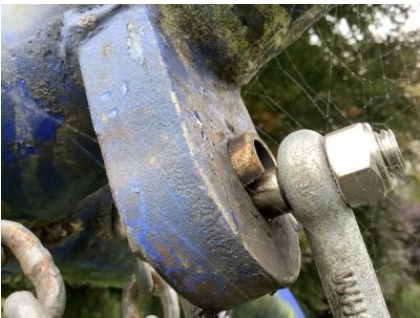
Excessive wear on shackles, bushes or associated connections.

Replace.

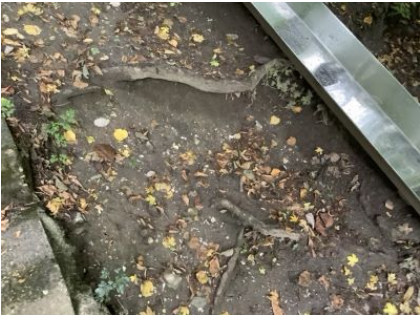
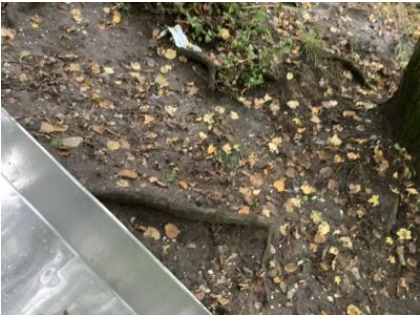
Worn ground areas.

Build up ground levels to remove trip hazard.
