## Asbestos Management Building Survey

**Uplands Manor Primary School, Addenbrooke Road, Smethwick, West Midlands, B67 6HT**

**SCOPE:** In Accordance With HSG 264 And SMBC Job No. 2177, Conduct An Asbestos Management Survey To The School Where Safe And Unrestricted Access Permits.

UPLANDS MANOR PRIMARY  
SCHOOL  
ADDENBROOKE ROAD  
SMETHWICK  
WEST MIDLANDS, B67 6HT  
REPORT NUMBER J125739

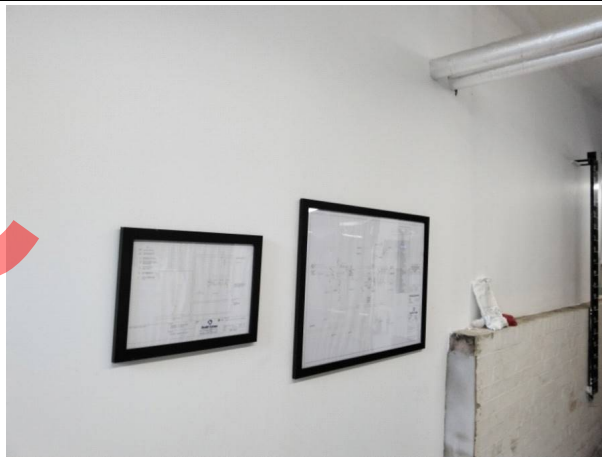
Location: Uplands Manor Primary School – Z-Sub Level 1 – Boiler house –B Tank Room No access within area							Survey Date: 15/08/2022 Review Date: N/A				
Level of ID P	Sample No. Visual/232	Quantity 20m²	Product 3 Asbestos Insulation/Coating	+	Condition 1 Low Damage	+	Surface Treatment 1 Surface Sealed	+	Result 3 Crocidolite (or unknown)	=	Material Assessment (MA) 8
Normal Occupancy Activity	Main activity 0	+	Secondary Activity 0	+	–	÷ 2 =	Averages 0

Likelihood of Disturbance	Location	+	Accessibility 0	+	Extent / Amount	÷ 3 =	+ 0				
Human Exposure Potential	Number of Occupants	+	Frequency of Use	+	Average Time Per Use	÷ 3 =	+ 0				
Maintenance Activity	Type of Maintenance	+	Freq. of Maintenance	+	–	÷ 2 =	+ 0				
Recommended Action: Inspect prior disturbance				Priority Assessment Sum of averages		(PA) =	0				
				Total Risk Score		(MA + PA)=	8

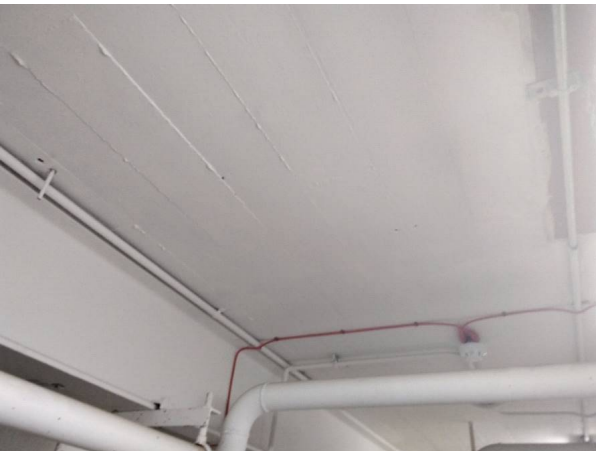
Location: Uplands Manor Primary School – Z-Sub Level 1 – Pump room –B1 Ceiling Lagging residue to ceiling							Survey Date: 15/08/2022 Review Date: N/A		
Level of ID	Sample No.	Quantity	Product	Condition	Surface Treatment	Result	Material Assessment (MA)		
P	Visual/237	18m²	3 Thermal Insulation Lagging	+	1 Low Damage	+	2 Sealed	+	3 Crocidolite (or unknown) = 9
Normal Occupancy Activity	Main activity 0	+	Secondary Activity 0	+	–	÷ 2 =	Averages 0		
Likelihood of Disturbance	Location	+	Accessibility 1	+	Extent / Amount	÷ 3 =	+	1	
Human Exposure Potential	Number of Occupants	+	Frequency of Use	+	Average Time Per Use	÷ 3 =	+	0	
Maintenance Activity	Type of Maintenance	+	Freq. of Maintenance	+	–	÷ 2 =	+	0	
Recommended Action: Inspect prior disturbance				Priority Assessment Sum of averages (PA)		=	1		
				Total Risk Score		(MA + PA)=	10

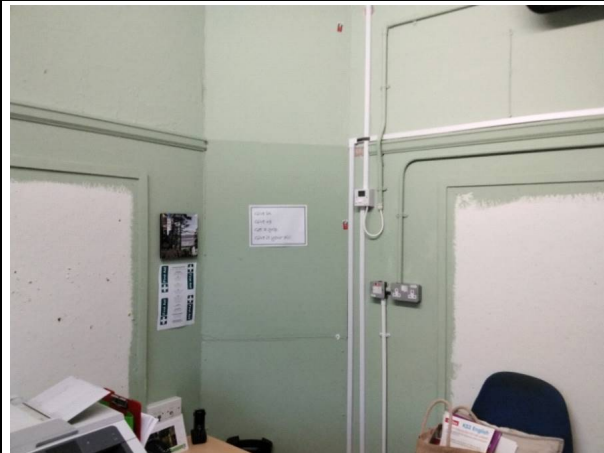
Location: Uplands Manor Primary School – 1st Floor – Safeguarding office –29 Wall - Panel Cement panel to wall										Survey Date: 15/08/2022 Review Date: N/A	
Level of ID	Sample No.	Quantity	Product		Condition	Surface Treatment		Result	Material Assessment (MA)		
ID	AT004718/173	3m²	1 Asbestos Cement	+	1 Low Damage	+	1 Surface Sealed	+	1 Chrysotile	= 4	
Normal Occupancy Activity	Main activity 0	+	Secondary Activity 0	+	–	÷ 2 =	Averages 0

Likelihood of Disturbance	Location	+	Accessibility 1	+	Extent / Amount	÷ 3 =	+ 1				
Human Exposure Potential	Number of Occupants	+	Frequency of Use	+	Average Time Per Use	÷ 3 =	+ 0				
Maintenance Activity	Type of Maintenance	+	Freq. of Maintenance	+	–	÷ 2 =	+ 0				
Recommended Action: Consider labelling, and manage in place					Priority Assessment Sum of averages (PA) =		1				
					Total Risk Score (MA + PA)=		5

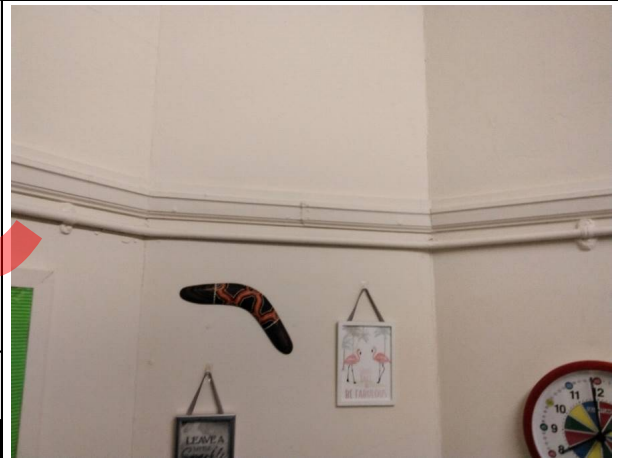
Location: Uplands Manor Primary School – 1st Floor – Office –30 Wall - Panel Cement panel to wall							Survey Date: 15/08/2022 Review Date: N/A					
Level of ID SP	Sample No. As AT004718/175	Quantity 3m²	Product 1 Asbestos Cement	+	Condition 1 Low Damage	+	Surface Treatment 1 Surface Sealed	+	Result 1 Chrysotile	=	Material Assessment (MA) 4	
Normal Occupancy Activity	Main activity 0	+	Secondary Activity 0	+	–	÷ 2 =	Averages 0

Likelihood of Disturbance	Location	+	Accessibility 1	+	Extent / Amount	÷ 3 =	+					1
Human Exposure Potential	Number of Occupants	+	Frequency of Use	+	Average Time Per Use	÷ 3 =	+					0
Maintenance Activity	Type of Maintenance	+	Freq. of Maintenance	+	–	÷ 2 =	+					0
Recommended Action: Consider labelling, and manage in place			Priority Assessment Sum of averages		(PA)	=	1					
			Total Risk Score		(MA +	PA)=	5

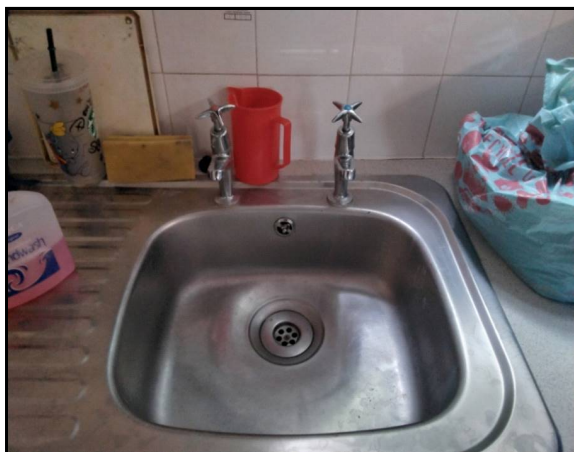
Ground Floor Senior leadership (18a 18b)  
Composite Bitumen  
Under Sink Mat 21

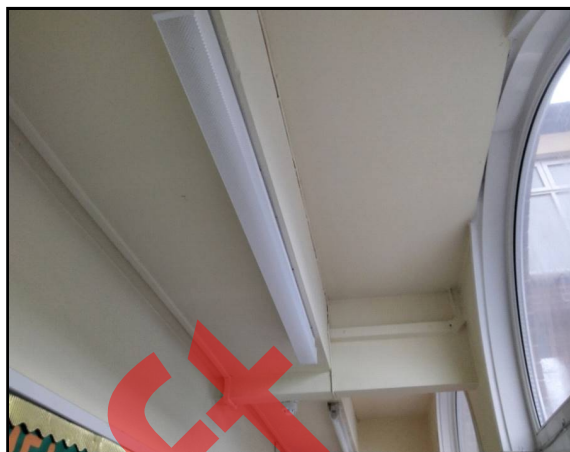
Ground Floor Corridor (32)  
Insulating Board  
Ceiling and boxing 29

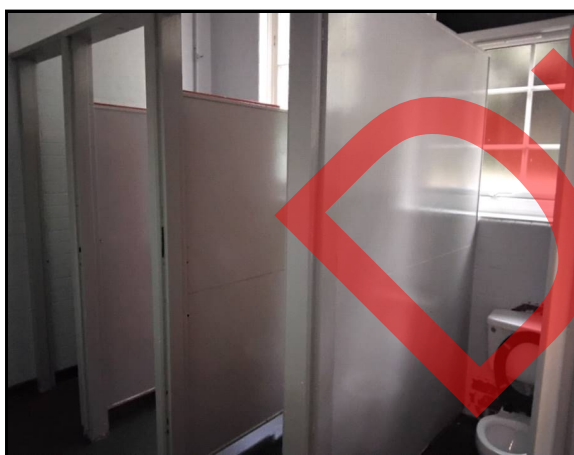
Ground Floor Boys toilets (28)  
Cement Products  
Toilet partitions 48

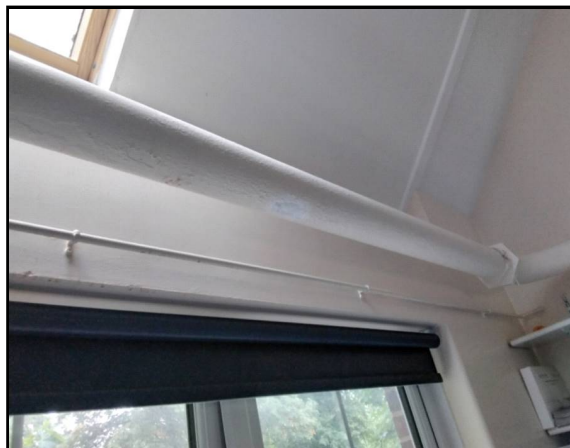
1st Floor Classroom 4S (51)  
Thermal Insulation Lagging  
Pipework 103

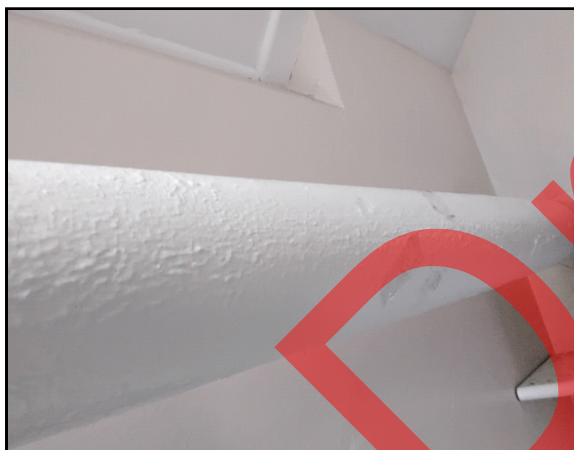
1st Floor Classroom 4ks (52)  
Thermal Insulation Lagging  
Pipework 104

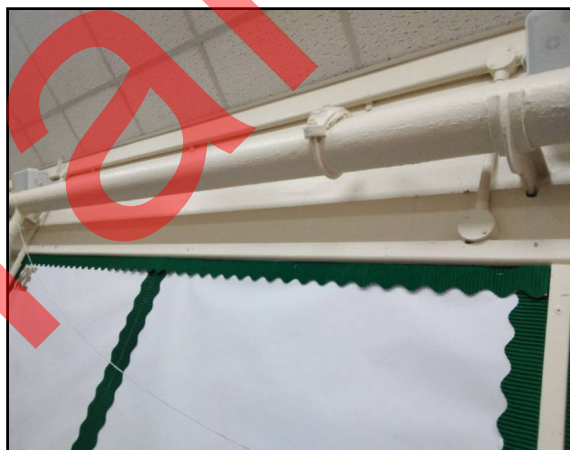
1st Floor Classroom 4 (54)  
Thermal Insulation Lagging  
Pipework 105

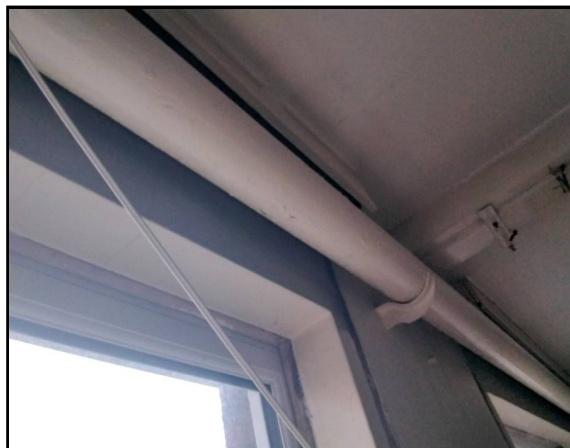
1st Floor Classroom 5D (56)  
Thermal Insulation Lagging  
Pipework 108

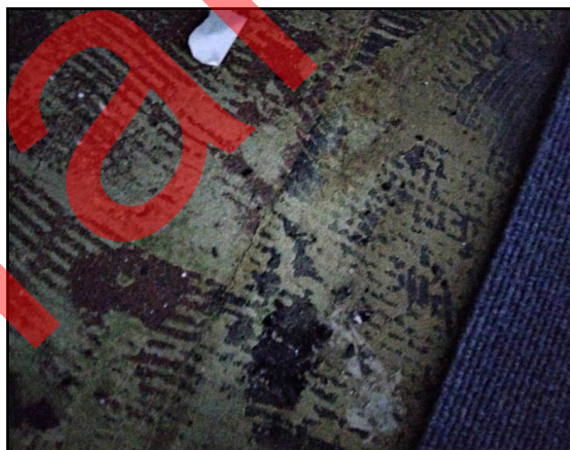
1st Floor Corridor (53)  
Composite Resinous/Reinforced Plastics  
Floor 113

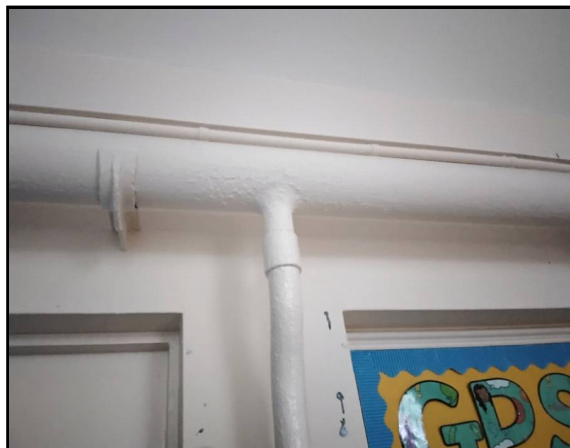
1st Floor Classroom 6T (61)  
Thermal Insulation Lagging  
Pipework 116

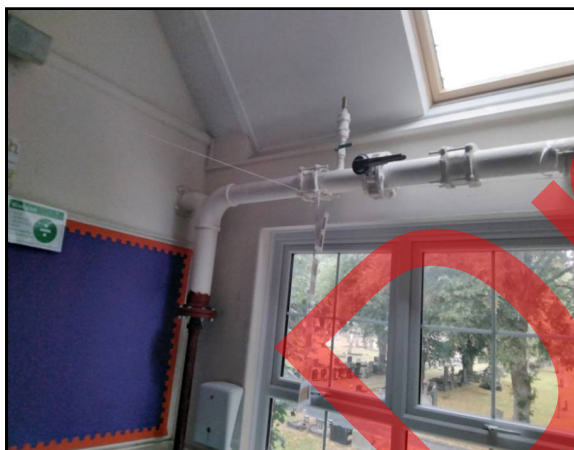
1st Floor Classroom 6T (61)  
Joint/Gasket  
Pipework Gasket(s) 117

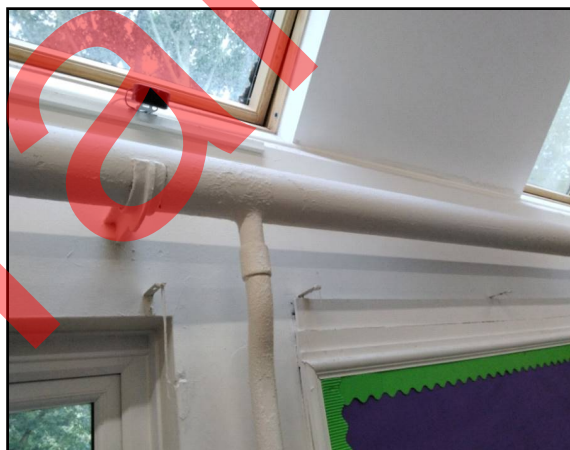
1st Floor Classroom 6A (63)  
Thermal Insulation Lagging  
Pipework 120

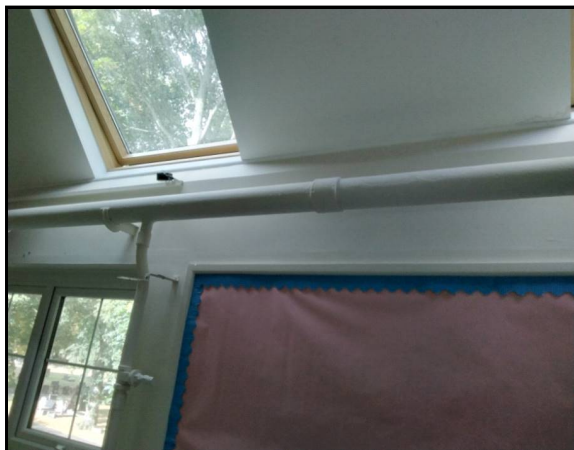
1st Floor Classroom 6s (64)  
Thermal Insulation Lagging  
Pipework 121

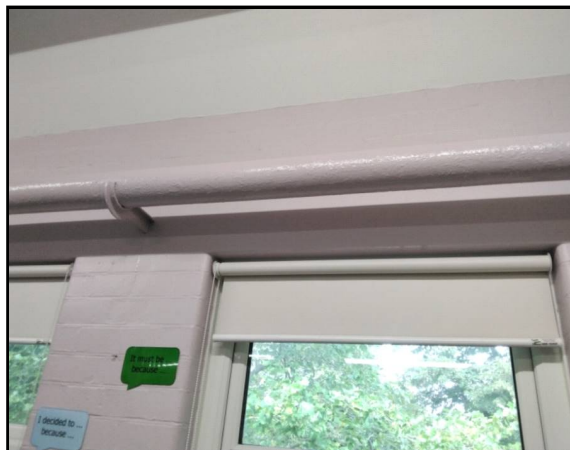
1st Floor Classroom 6B (65)  
Thermal Insulation Lagging  
Pipework 122

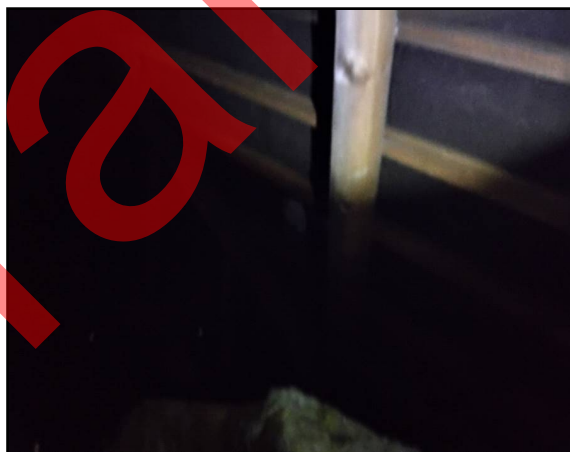
1st Floor Disable toilet lobby (81)  
Composite Bitumen  
Roof - Felt 131

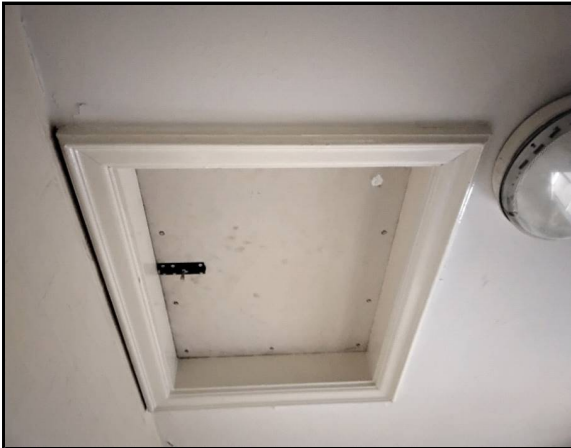
1st Floor Disable toilet lobby (81)  
Insulating Board  
Access hatch 132

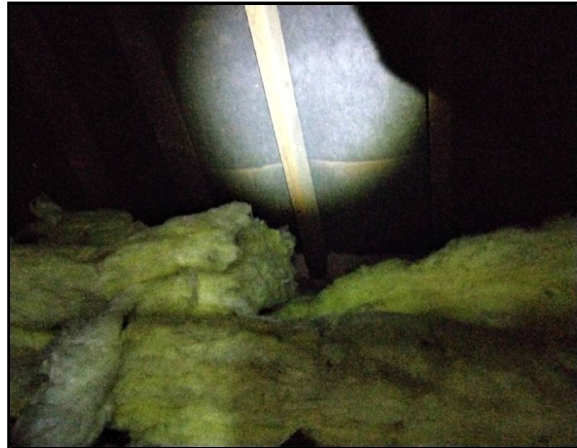
1st Floor Toilet lobby (6)  
Composite Bitumen  
Roof - Felt 133

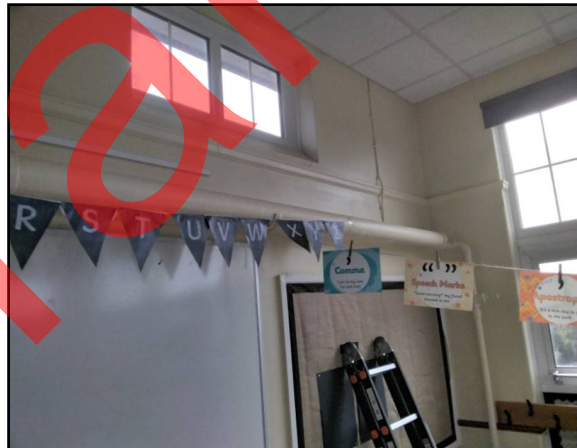
1st Floor Classroom 2J (9)  
Thermal Insulation Lagging  
Pipework 137

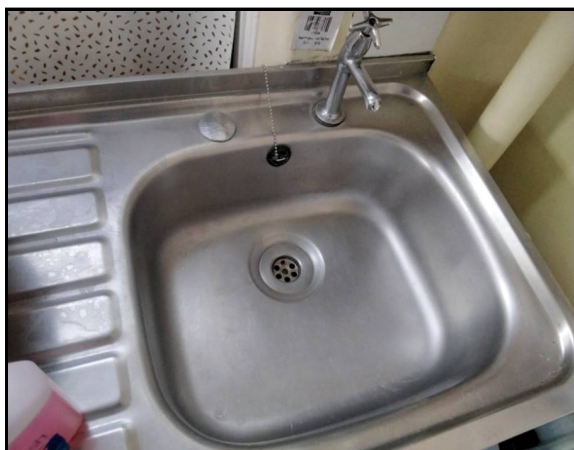
1st Floor Classroom 2J (9)  
Composite Bitumen  
Under Sink Mat 138

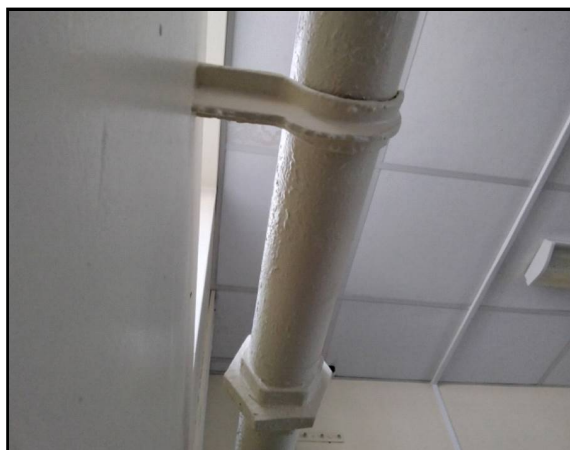
1st Floor Classroom 2s (10)  
Thermal Insulation Lagging  
Pipework 139

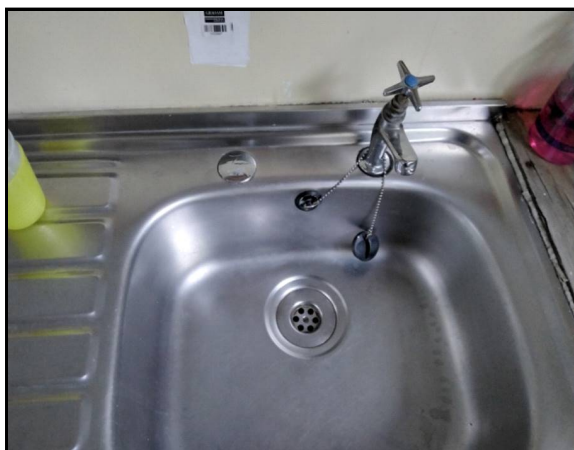
1st Floor Classroom 2C (11)  
Thermal Insulation Lagging  
Pipework 141

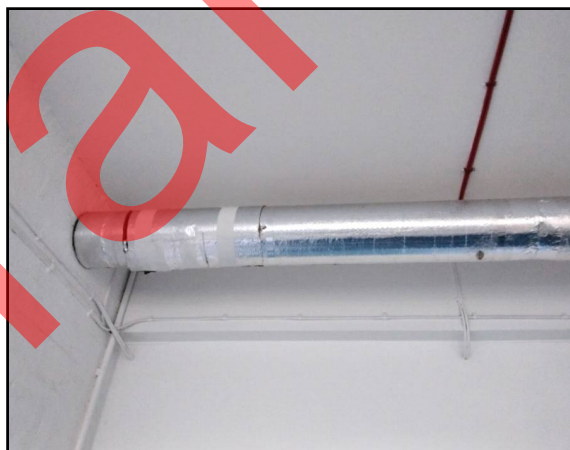
1st Floor Sensory room (2)  
Thermal Insulation Lagging  
Pipework 154

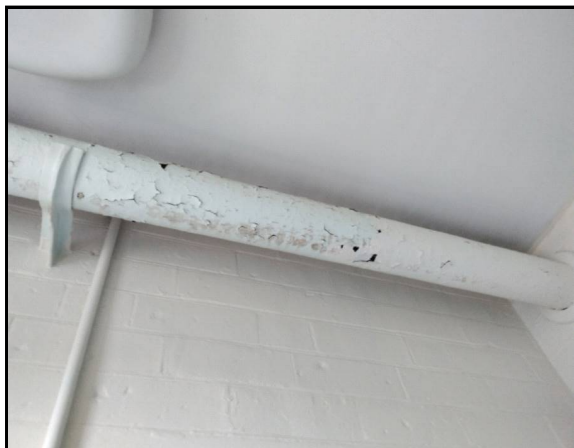
1st Floor Stairs (1)  
Thermal Insulation Lagging  
Pipework 155

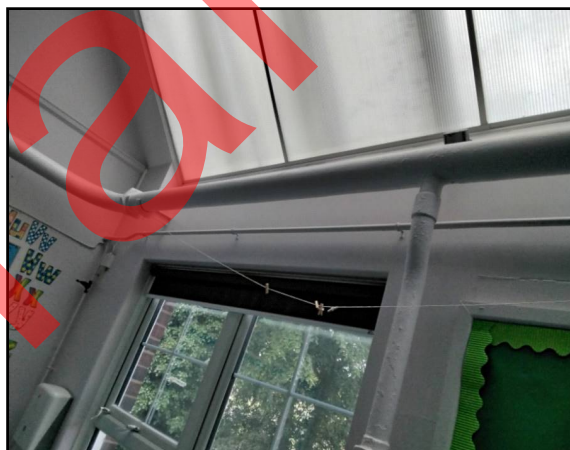
1st Floor Classroom 2B (19)  
Thermal Insulation Lagging  
Pipework 164

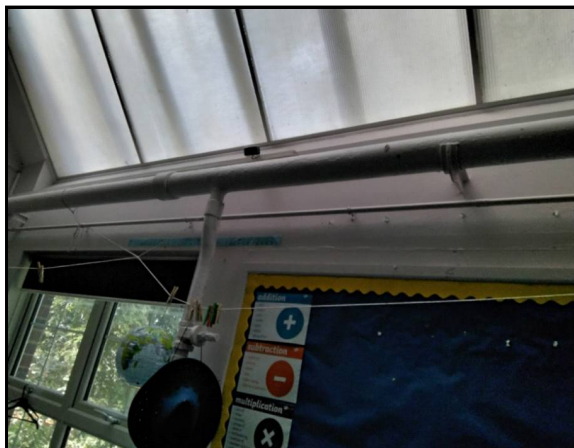
1st Floor Classroom 3B (20)  
Thermal Insulation Lagging  
Pipework 166

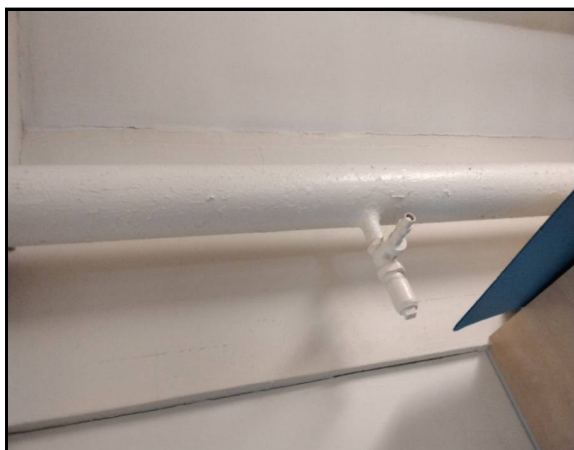
1st Floor Classroom 4G (24)  
Thermal Insulation Lagging  
Pipework 189

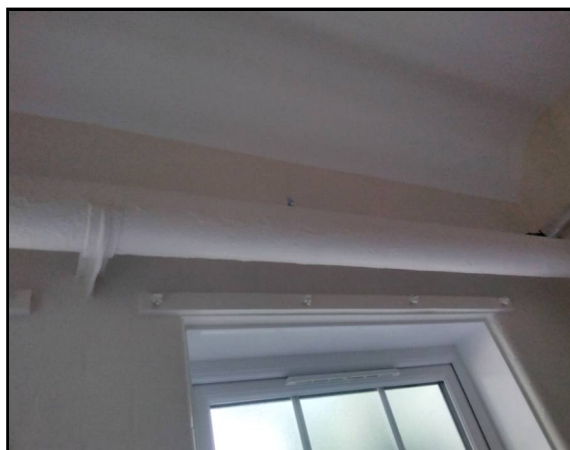
1st Floor Maths class (35a)  
Thermal Insulation Lagging  
Pipework 194

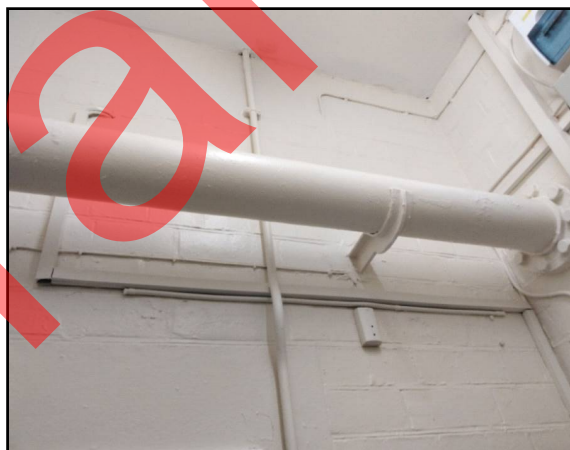
1st Floor Disabled toilet (35b)  
Thermal Insulation Lagging  
Pipework 196

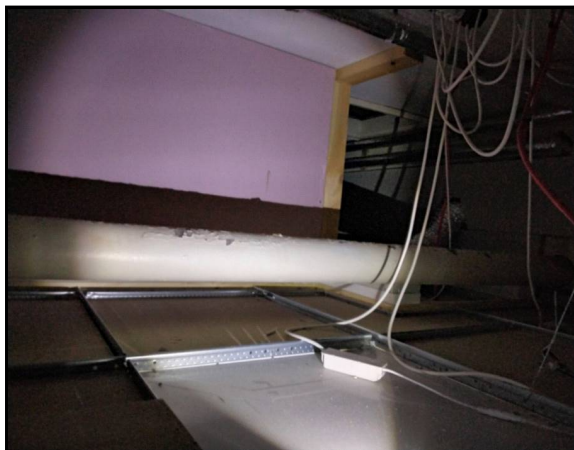
1st Floor Cleaners cupboard (36)  
Thermal Insulation Lagging  
Pipework 197

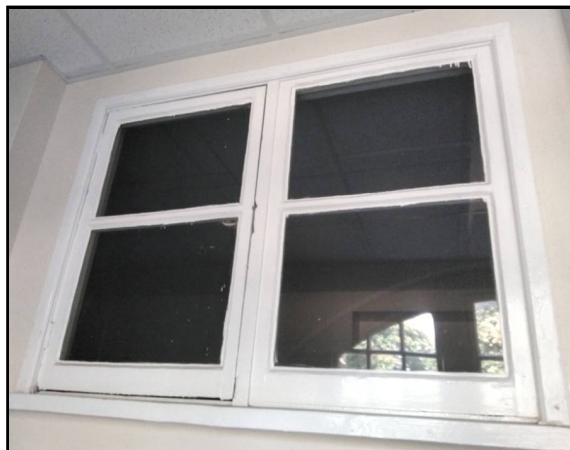
1st Floor Girls toilets (37)  
Thermal Insulation Lagging  
Pipework 198

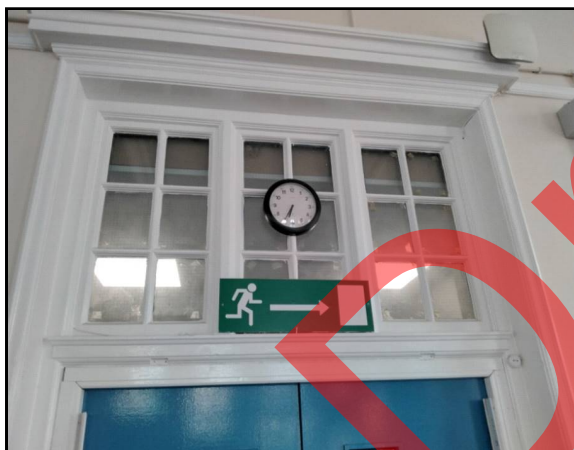
1st Floor Corridor (41)  
Putty  
Windows 199

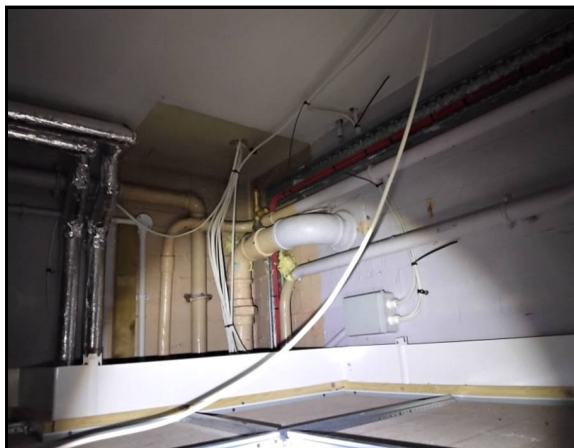
1st Floor Cleaners cupboard (45)  
Thermal Insulation Lagging  
Pipework 202

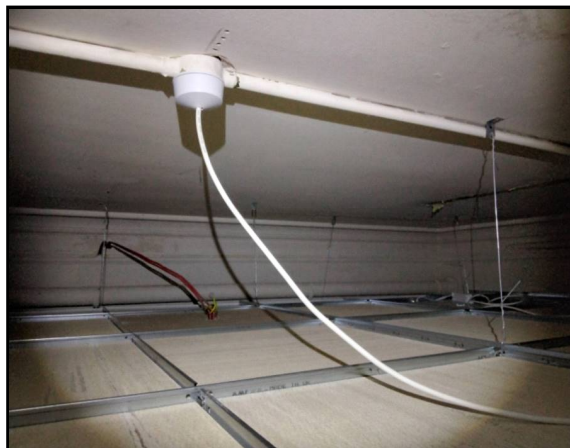
1st Floor Boys toilets (45a)  
Thermal Insulation Lagging  
Pipework 204

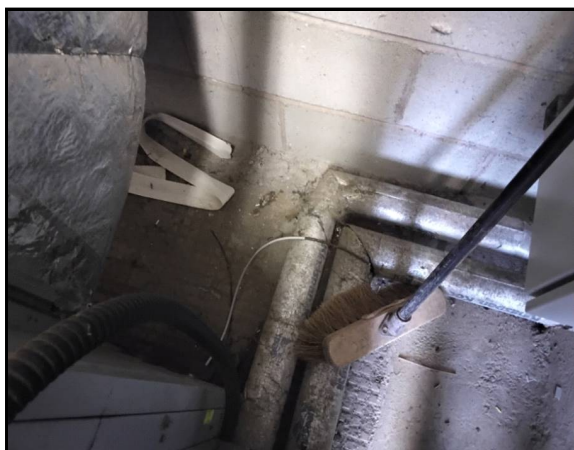
Z-Sub Level 1 Boiler room 1 (83)  
Thermal Insulation Lagging  
Wall 222

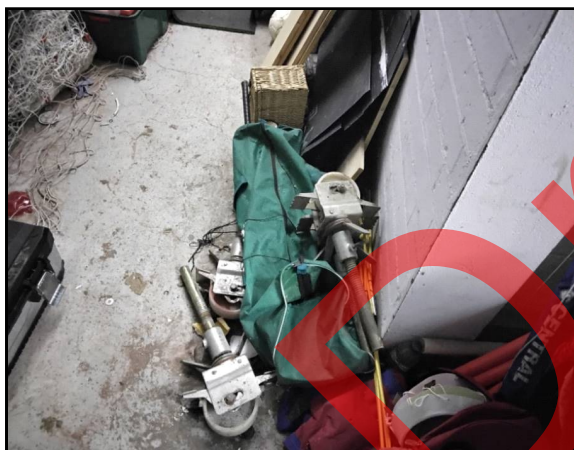
Z-Sub Level 1 Storage (84)  
Thermal Insulation Lagging  
Wall 228

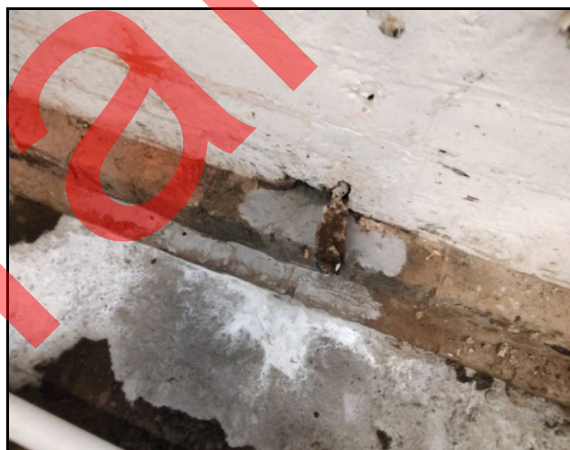
Z-Sub Level 1 Storage (84)  
Thermal Insulation Lagging  
Floor 229

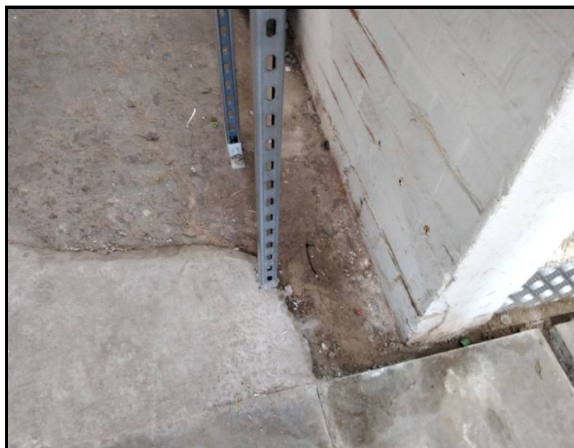
Z-Sub Level 1 Boiler house (B)  
Textile Woven/Cloth  
Outlet pipe 233

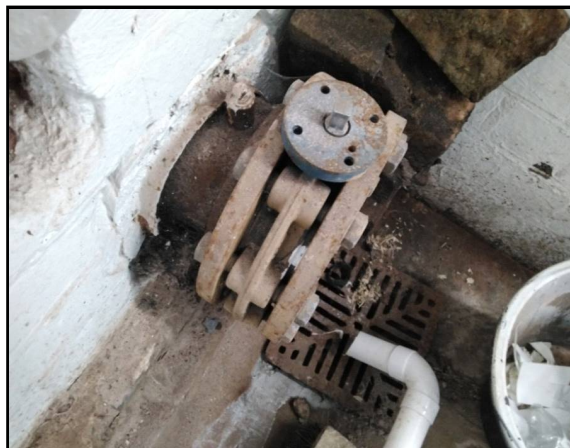
Z-Sub Level 1 Boiler house (B)  
Thermal Insulation Lagging  
Floor 234

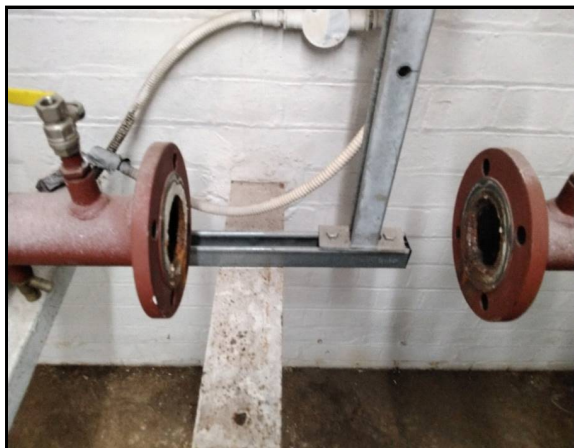
Z-Sub Level 1 Pump room (B1)  
Thermal Insulation Lagging  
Wall 238

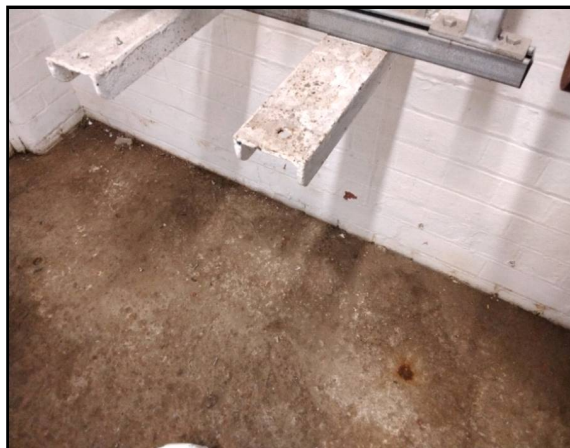
Z-Sub Level 1 Pump room (B1)  
Joint/Gasket  
Pipework Gasket(s) 239

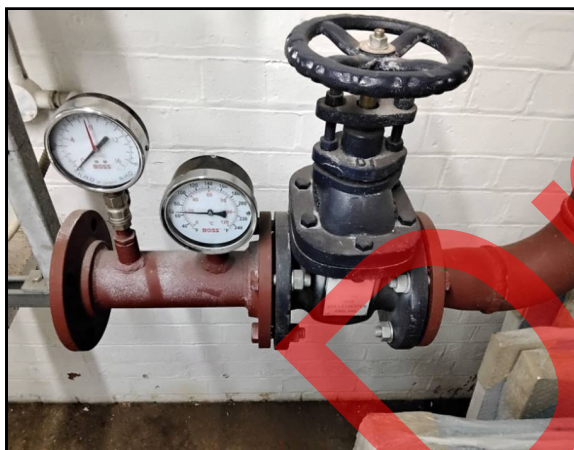
Z-Sub Level 1 Pump room (B1)  
Thermal Insulation Lagging  
Floor 240

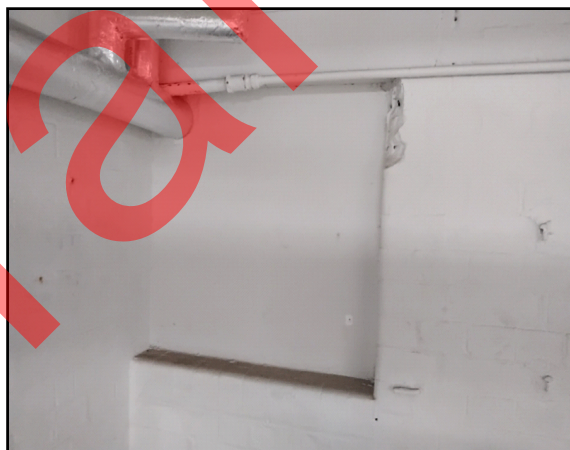
Z-Sub Level 1 Pump room (B1)  
Insulating Board  
Wall - Panel 244

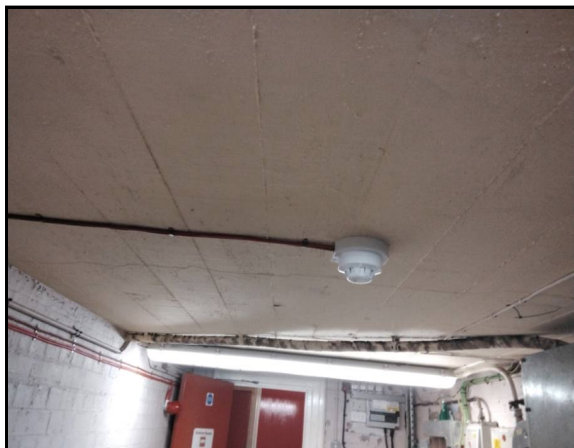
Z-Sub Level 1 Switch room (86)  
Thermal Insulation Lagging  
Ceiling 246

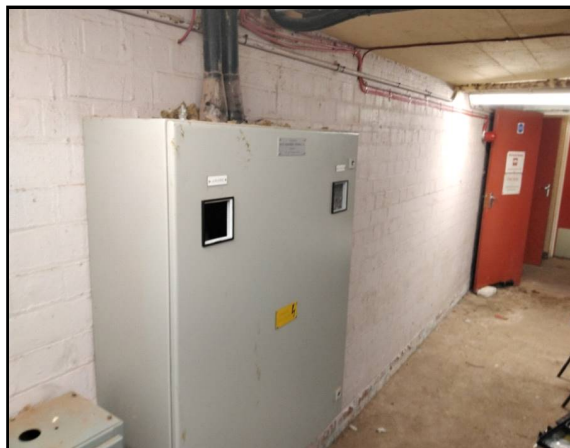
Z-Sub Level 1 Switch room (86)  
Thermal Insulation Lagging  
Wall 247

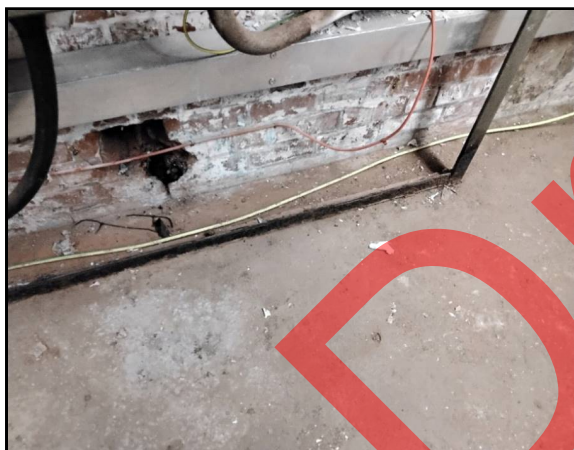
Z-Sub Level 1 Switch room (86)  
Thermal Insulation Lagging  
Floor 249

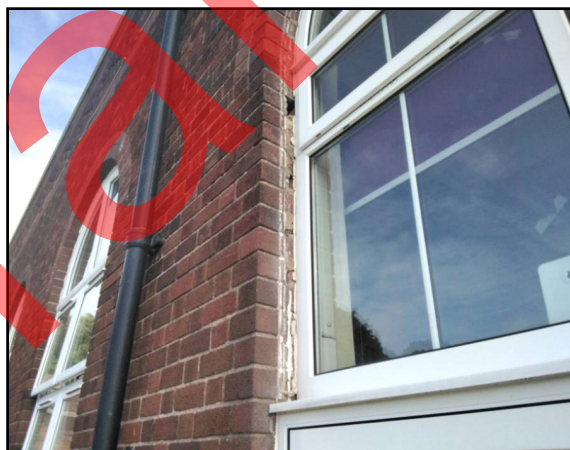
External External (E01)  
Putty  
Window 252

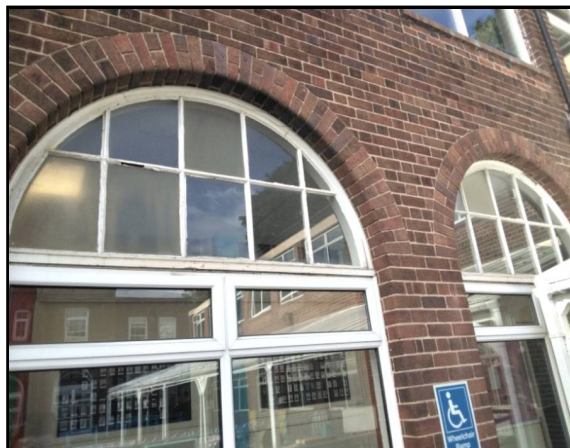
External External (E01)  
Putty  
Window 255

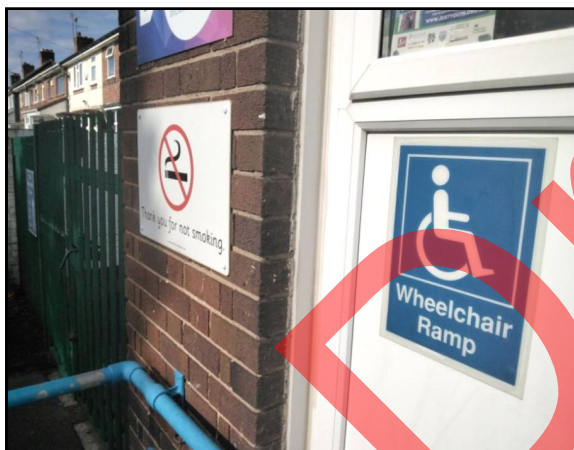
External External (E01)  
Putty  
Window 257

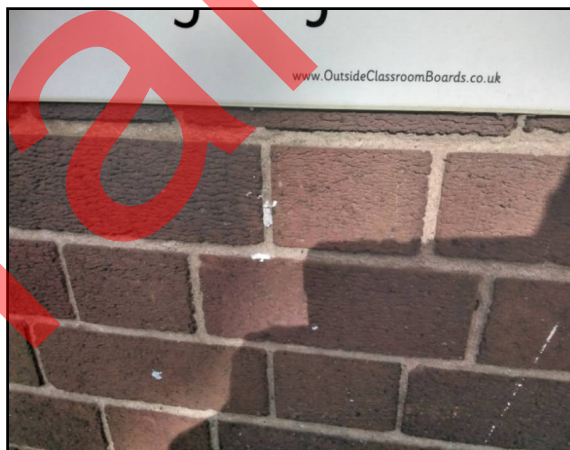
External External (E01)  
Putty  
Wall 258

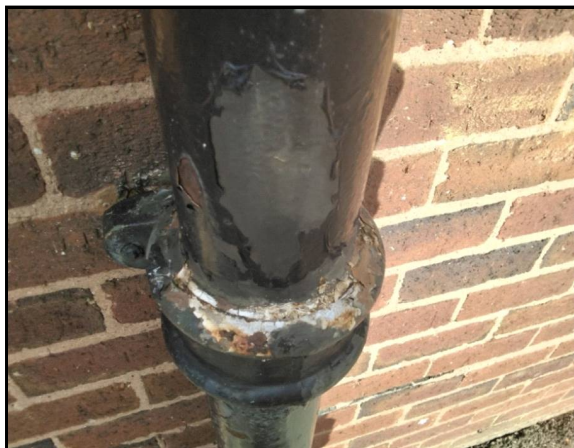
External External (E01)  
Putty  
Drain pipes 259

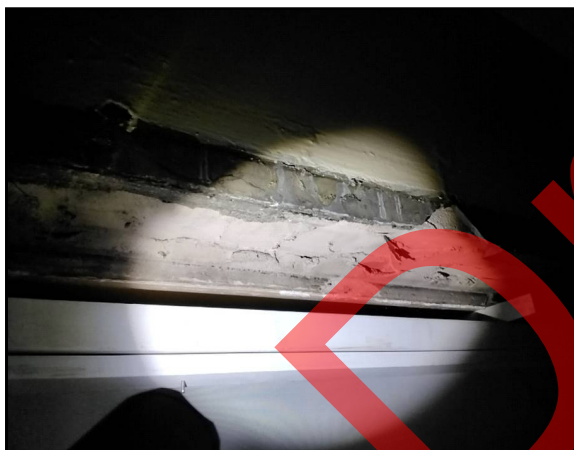
Ground Floor Classroom 6 (90)  
Putty  
Window 262

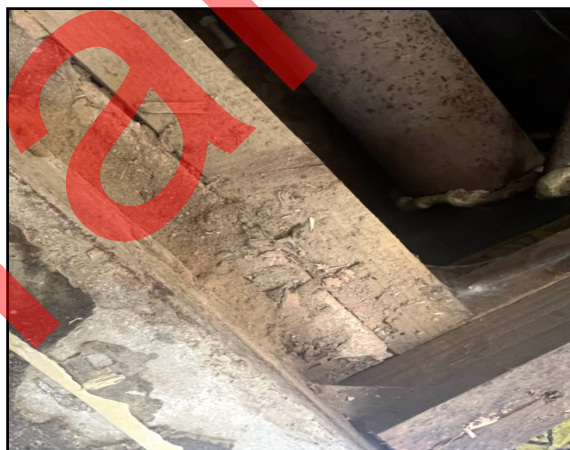
Ground Floor First aid room (25 c)  
Thermal Insulation Lagging  
Floor duct 264

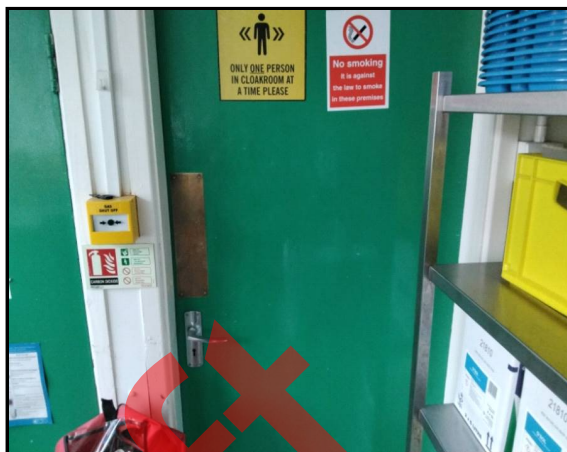
Ground Floor Cloakroom (D)  
Inaccessible

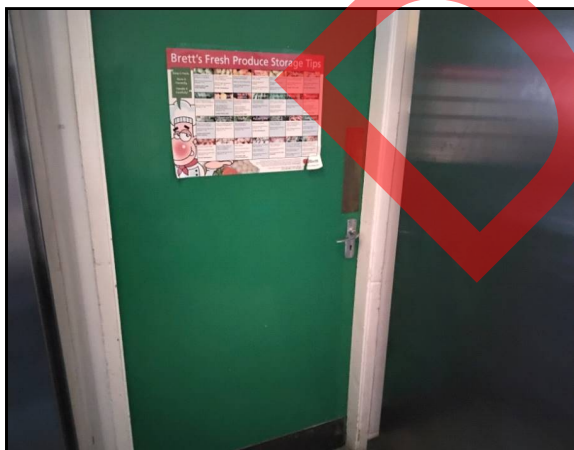
Ground Floor Food store (E)  
Inaccessible
