Condition Survey of Significant Fabric

Radford House (Former Ramsgate Fire Station),
18 – 20 Effingham Street, Ramsgate CT11 9AT

For Ramsgate Town Council

May 2020

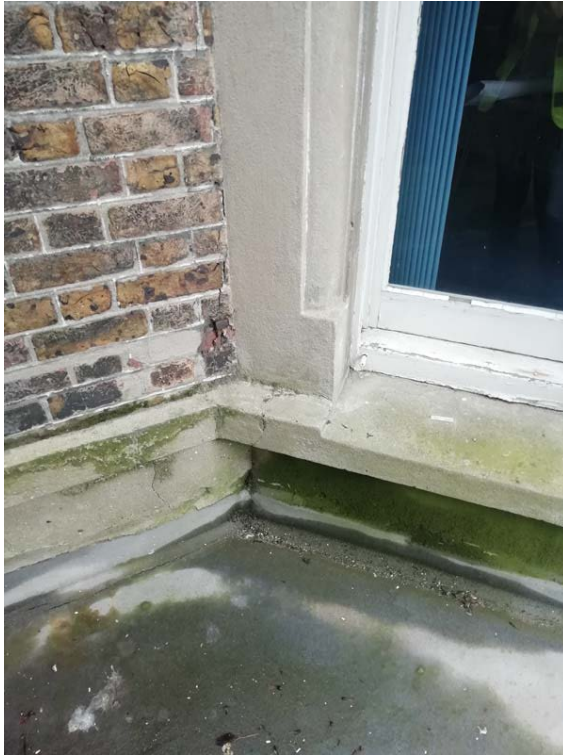
Figure 11 – Typical example of extant tuck pointing to south east and rear south west facing elevation façade brickwork

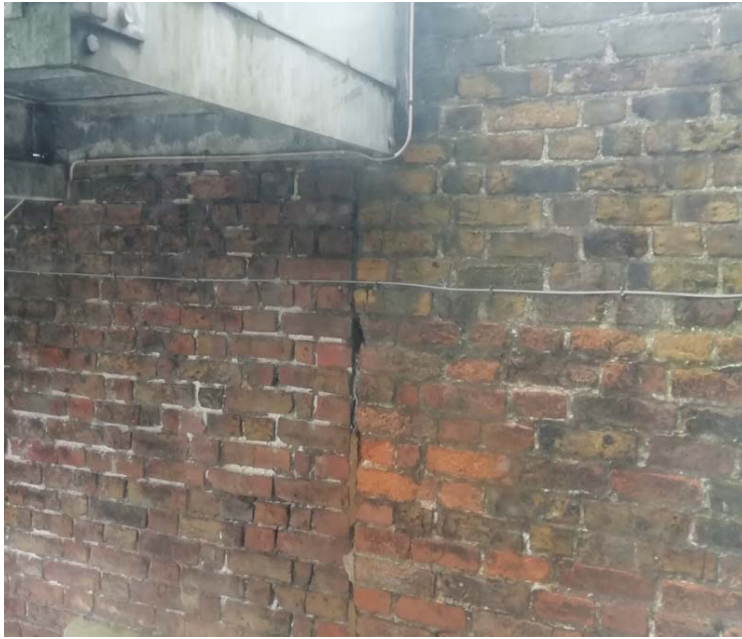
Figure 17 – Historic abutment to adjacent party wall with No. 22

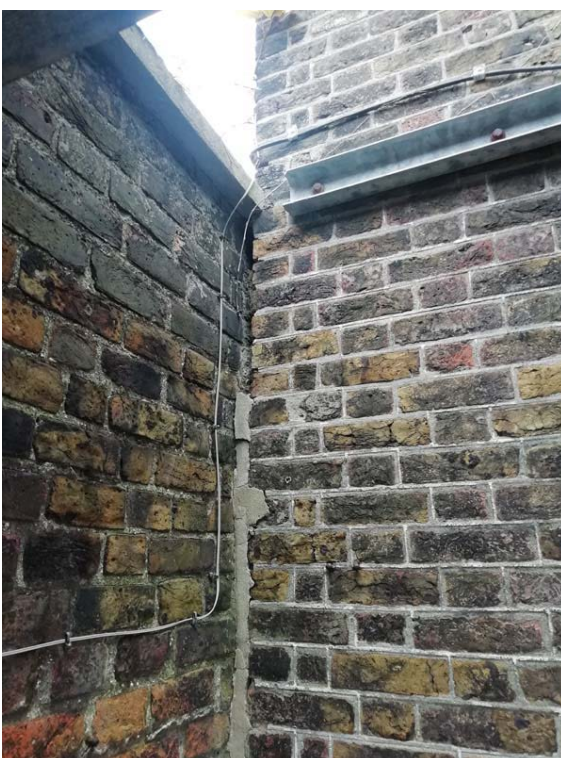
Figure 26– Typical rear abutment with No 22

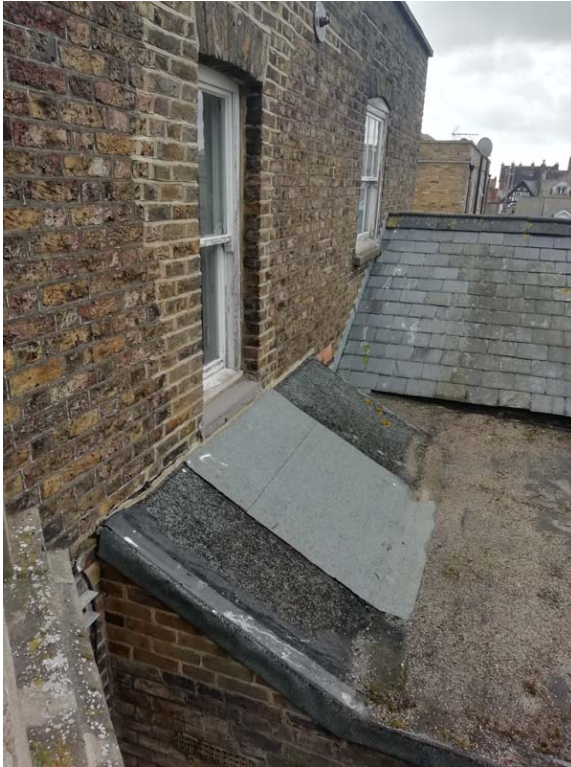
Figure 33 – Typical example of abutment of modern extension to rear annex

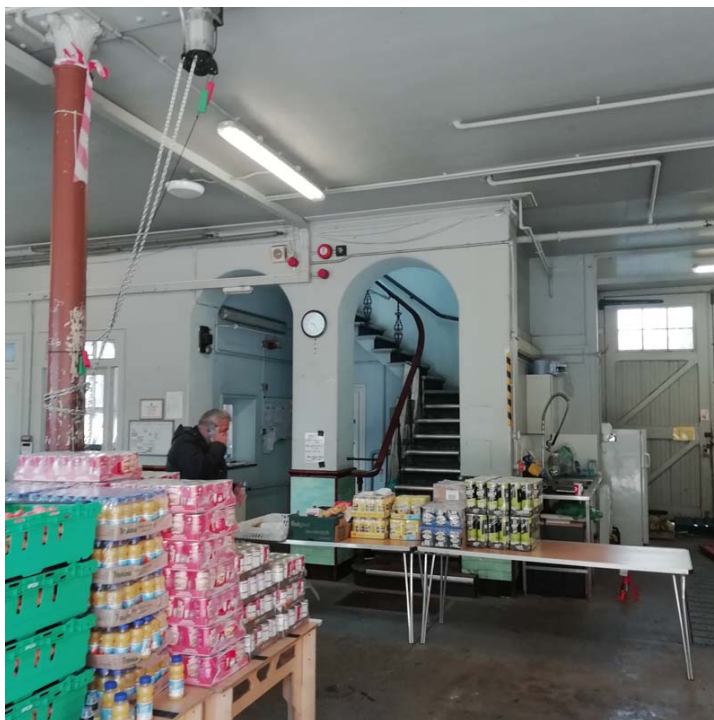
Author
Figure 38 – Ground Floor detailing and extant original cornices – Ground Floor 00-01

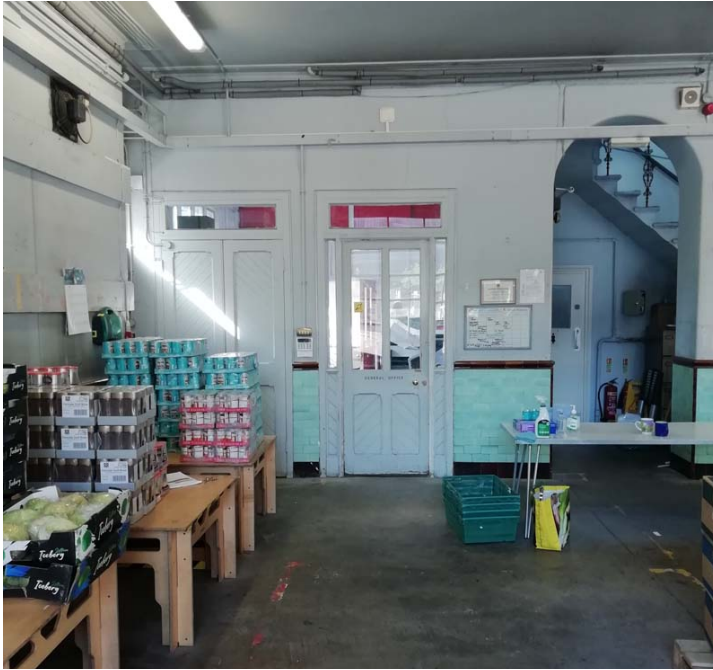
Figure 39 – Detailing of 1909 interventions– Ground Floor 00-01

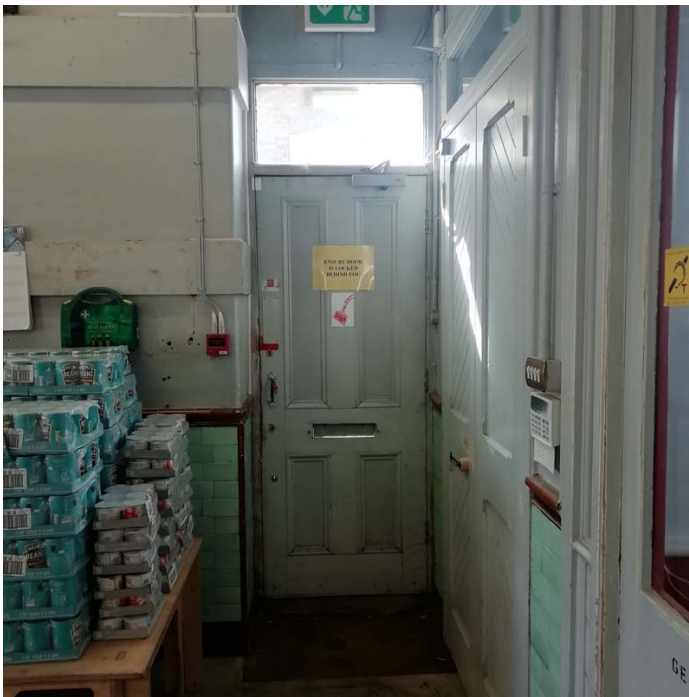
Figure 40 – Detailing of 1909 interventions– Ground Floor 00-01

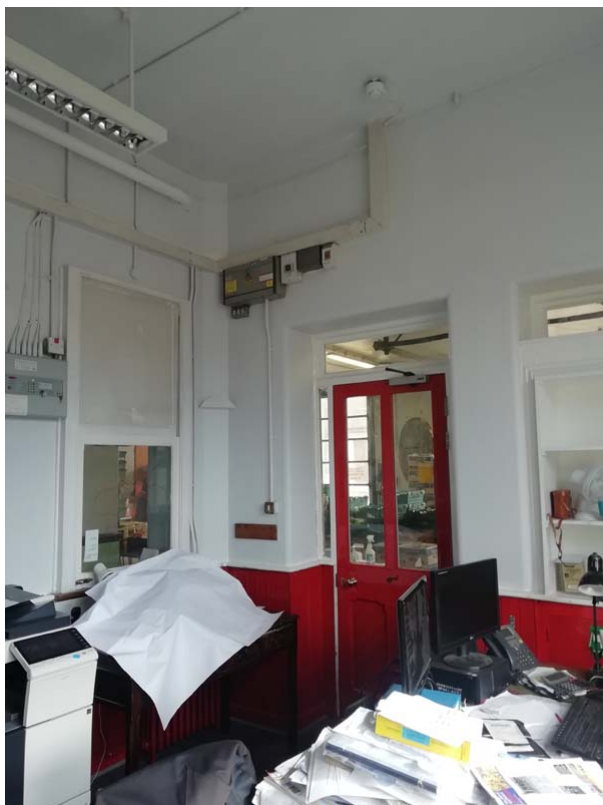
Figure 41 – Detailing extant window which may be an original opening– Ground Floor 00-03

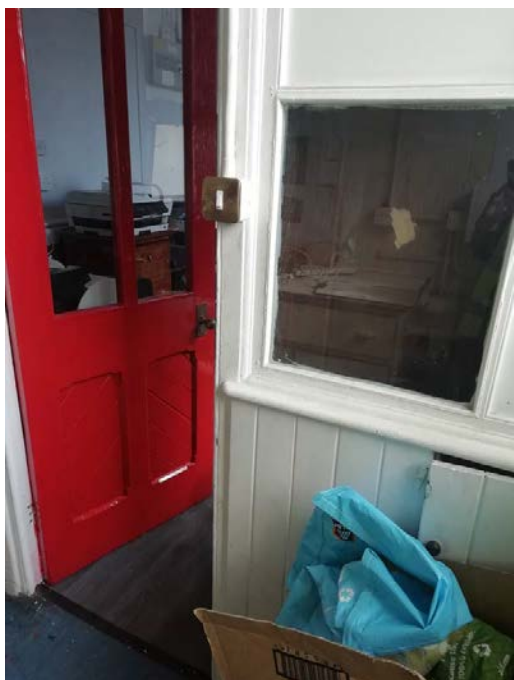
Figure 42 – Detailing of early 20th century door and extant match boarding– Ground Floor 00-04

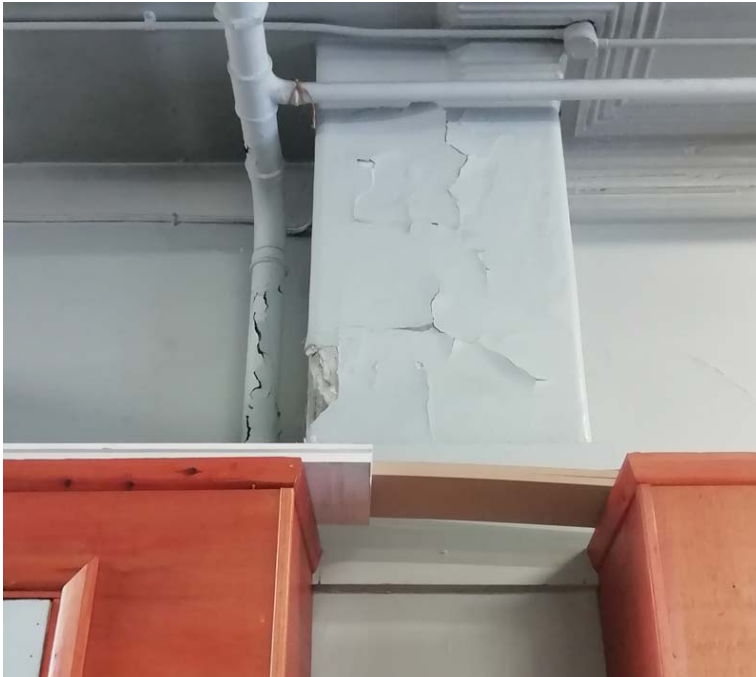
Figure 43– Typical example of existing decorative state to Ground Floor and abutment of original internal cornice at the original rear wall to the house 00-01

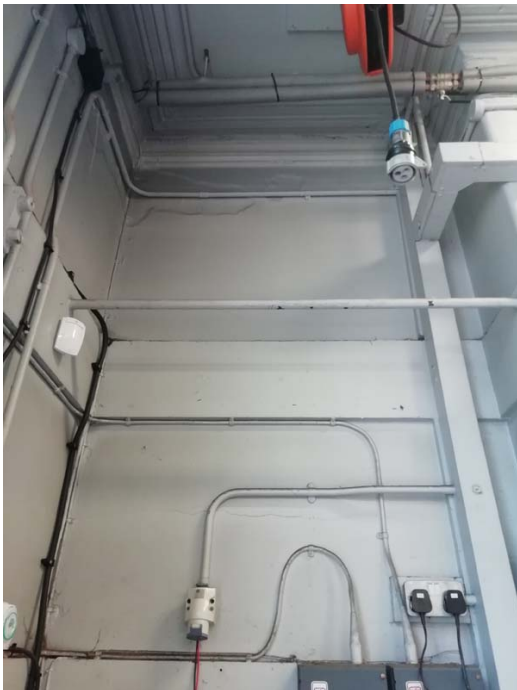
Figure 48 – Typical view of original cornice extant – Ground Floor 00-01

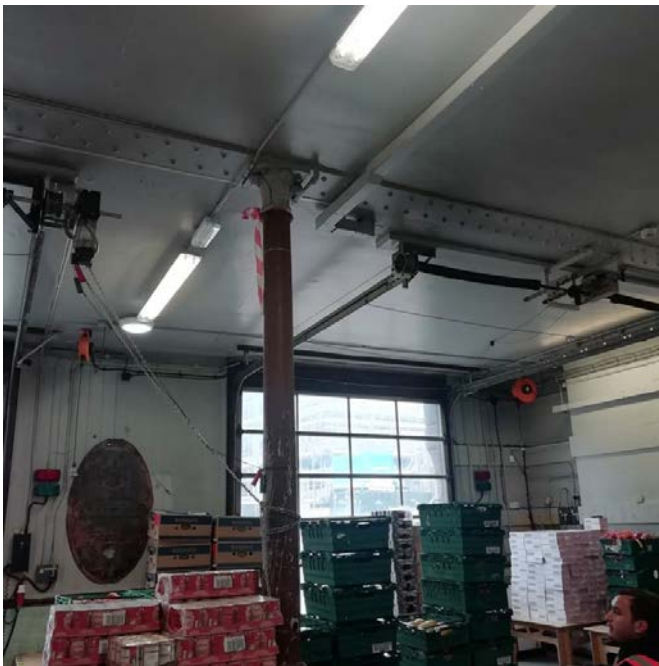
Figure 50 – Typical view of 20th century intervention with decorative column and riveted steel beams 00-01

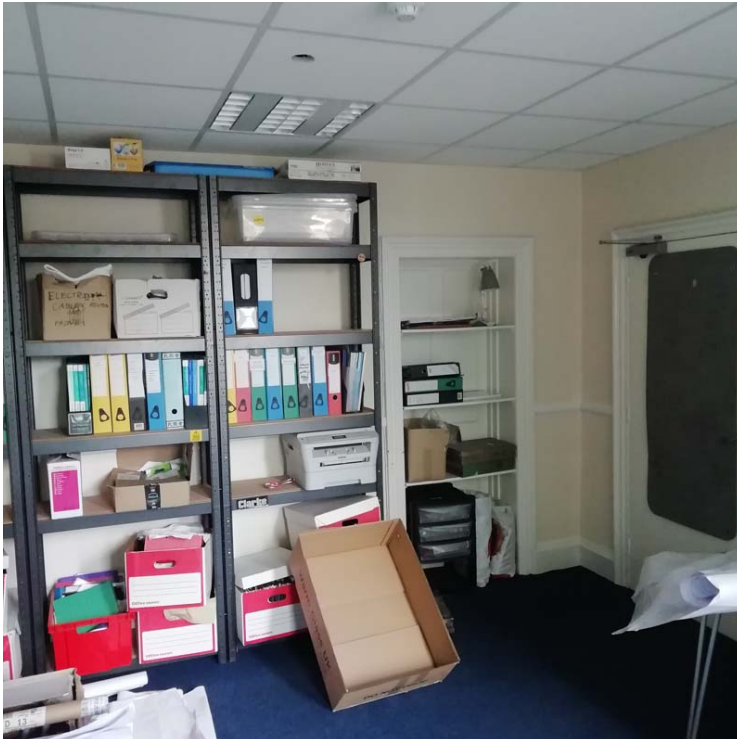
Figure 52 - Extant original? Door blocked up – First Floor 01-09

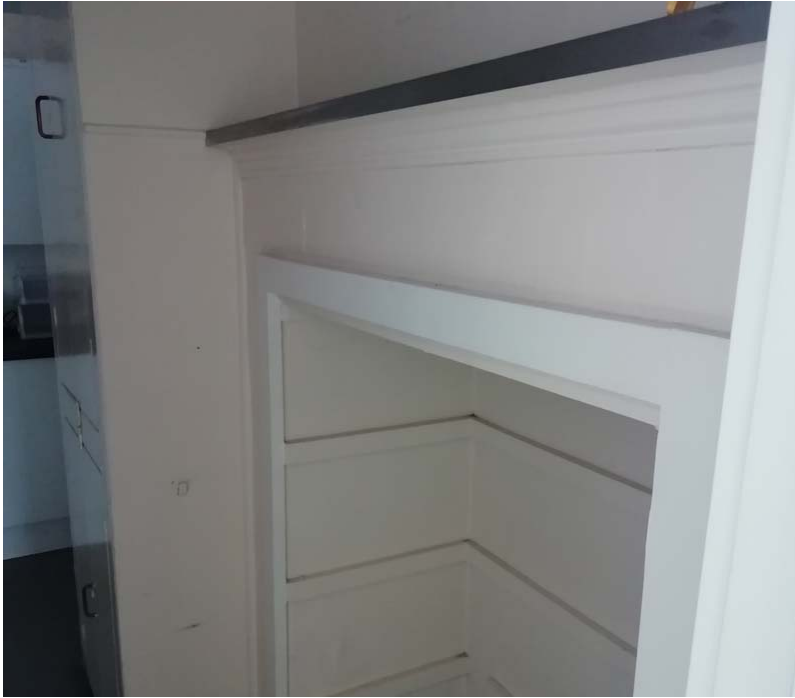
Figure 55 – Extant detail of fireplace surround to modern annexe extension – First floor 01-06

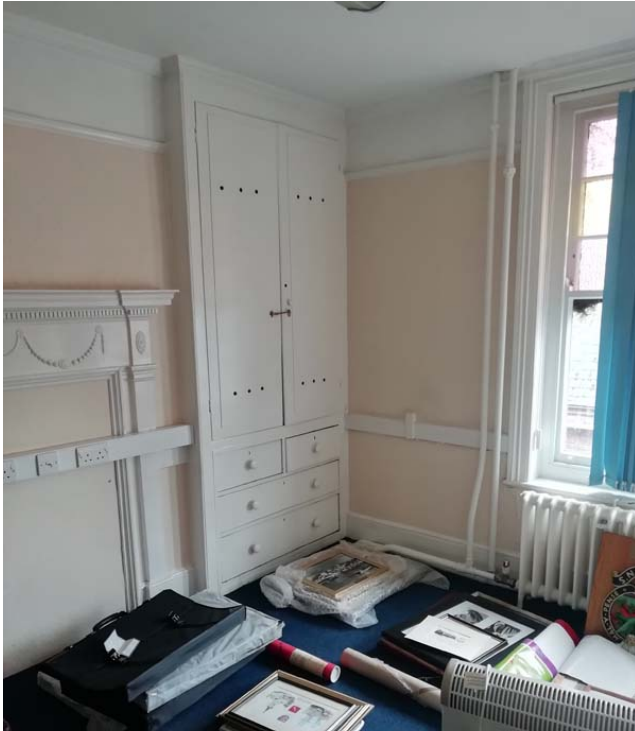
Figure 59 – Typical example of extant joinery and extant painted chimney piece, opening to fireplace blocked 01-01

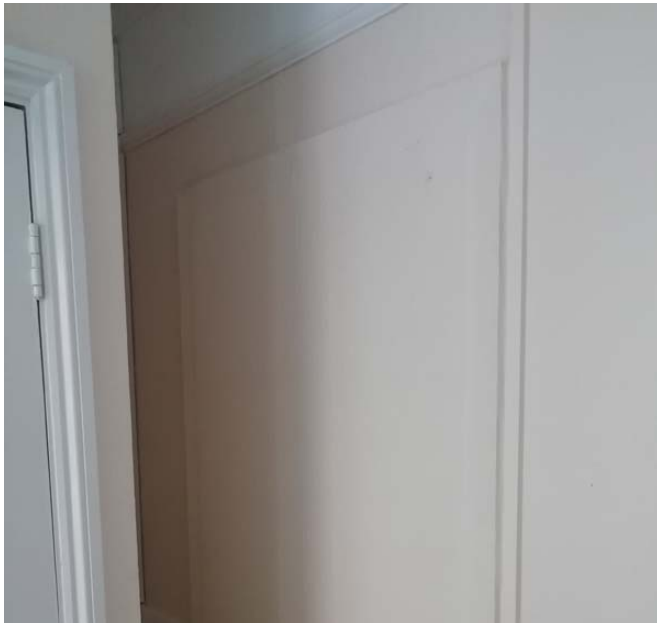
Figure 61 - Rear of blocked doorway which may be original 01-01

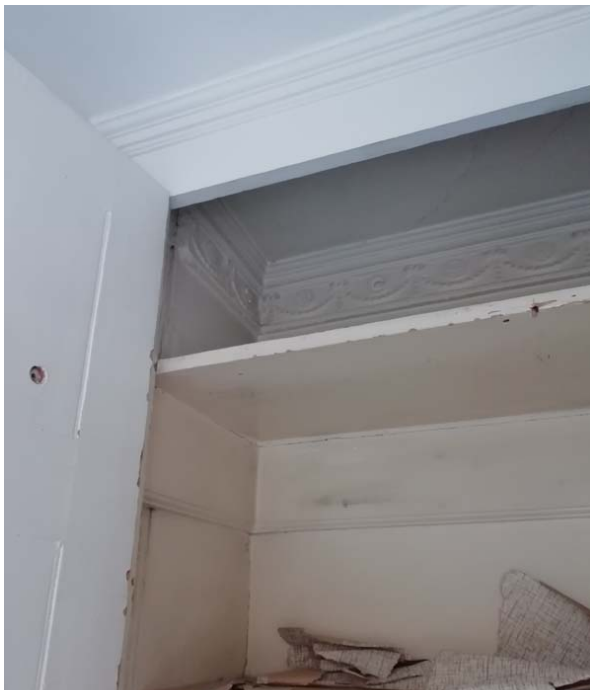
Figure 62 – Evidence of what is likely to be an original cornice detail 01-01

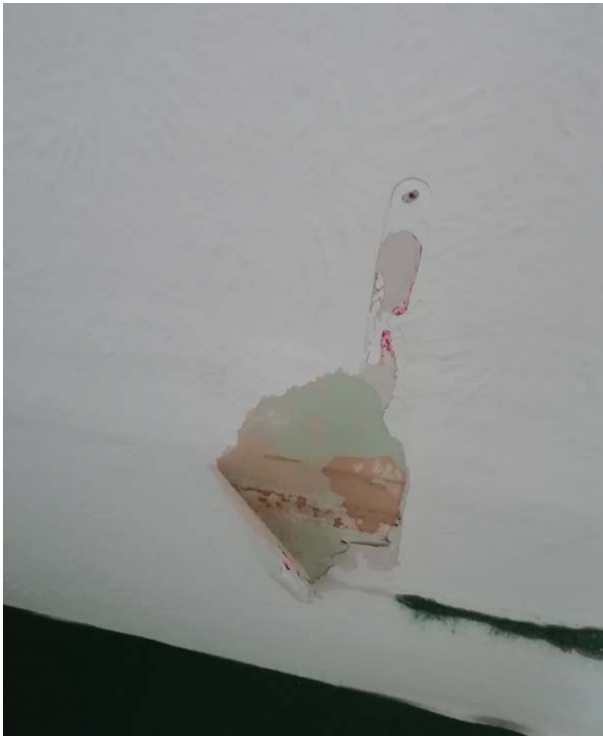
Figure 65 – Typical example of potential evidence of earlier decorative scheme beneath modern finishes 01-04

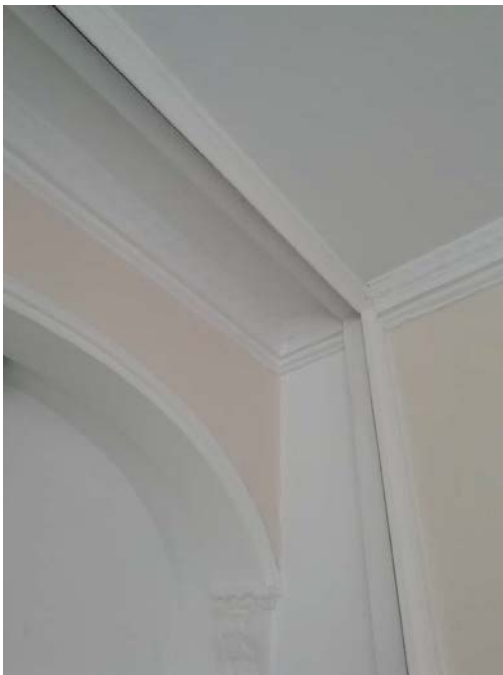
Figure 66 - Typical example of potentially original detailing and later interventions - First floor 01-08

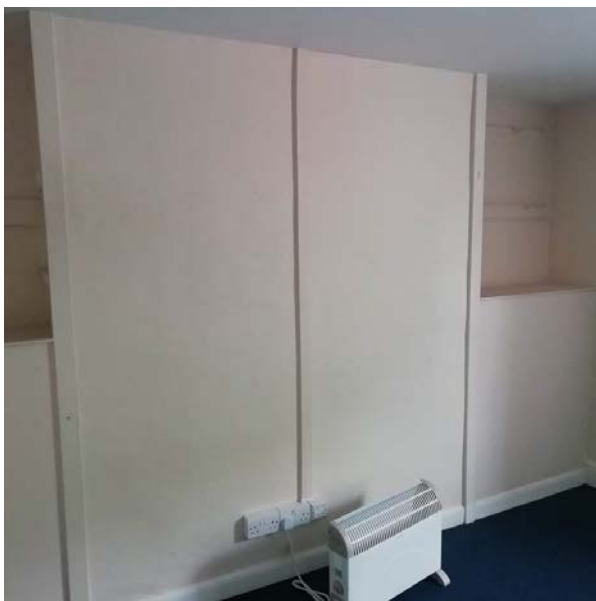
Figure 71 – Extant chimney breast currently blocked up with no ventilation 02-02

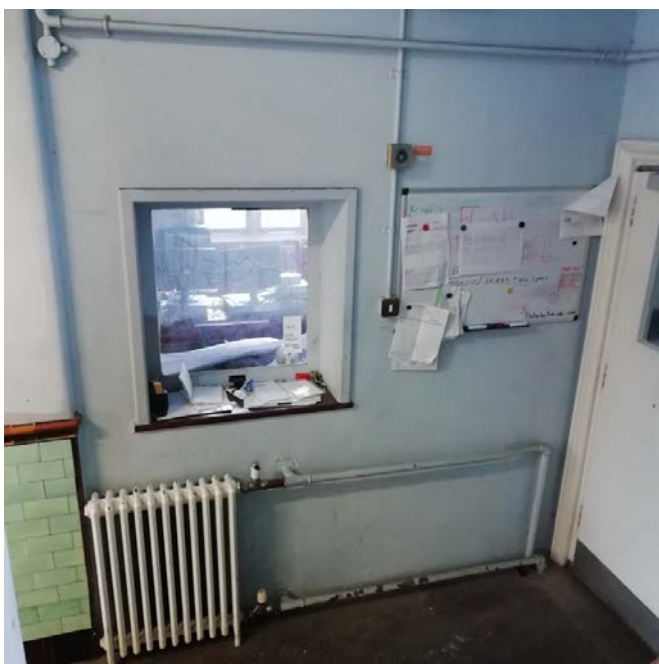
Figure 72 – Extant twentieth century radiators – Ground floor 00-01

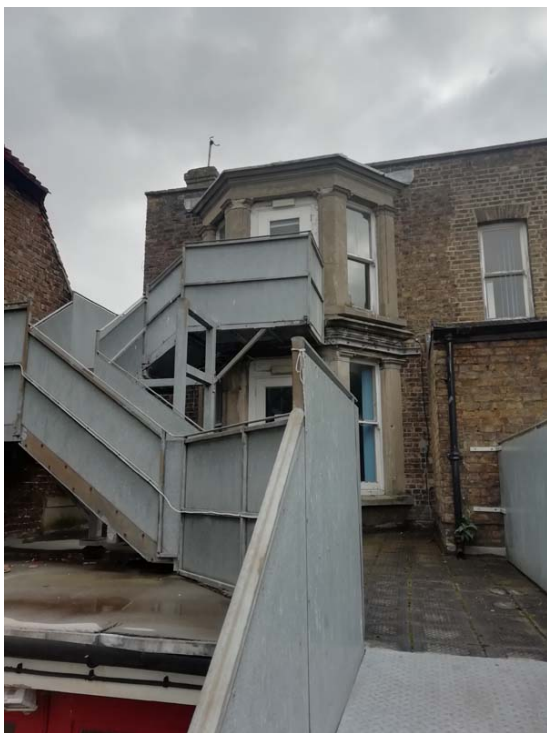
Figure 73 – Modern rear fire escape stair – Rear South west facing elevation

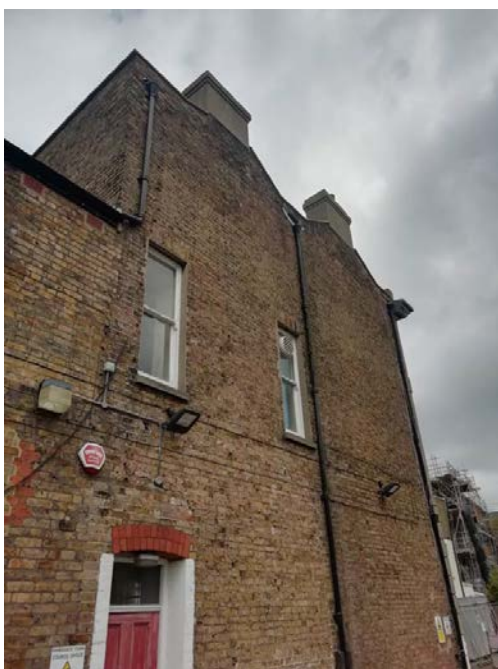
Figure 74 – Modern air bricks – South East facing elevation

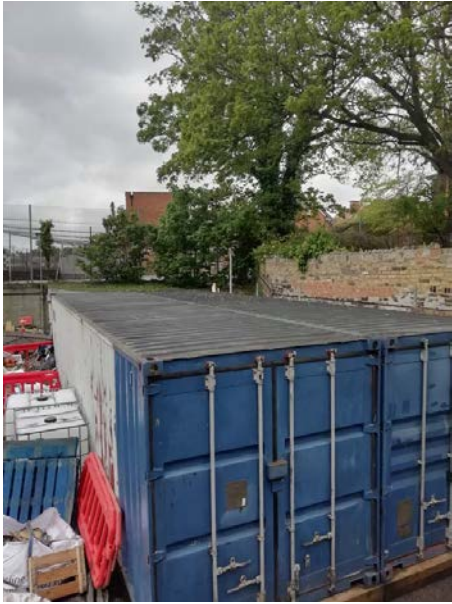
Figure 75 – Mature tree to the rear of No. 22 and modern storage containers to the rear of the building

The rear boundary wall is a modern retaining wall (with the land to the other side being at a much higher level). To the north west of the site, the rear boundary wall to No. 22 appears in the 1872 map and is therefore considered to be original with some later interventions. The wall is in reasonable condition but not all of it is visible due to the storage containers and residual storage sheds etc. Where No. 22 lies adjacent to or abutting Radford House, the party wall is in a poor state of repair and there are visible losses from damaged tiles that have fallen and lie as broken pieces on the roof of the rear annexe. The boundary walls should be reviewed by a suitably qualified and experienced conservation accredited Structural Engineer to establish their current condition and any works required together with any obligations under the Party Wall Act. There is a previous attempt to close the joint of the main 3 storey part of Radford House to the party wall with No. 22 with a mortar joint, which has failed at the top. The tree that appears to be in the rear garden of No. 22 is mature and should be reviewed in terms of its health and implications to the boundary conditions of the Radford House boundary. It appears to be on much higher ground suggesting that the rear boundary of Radford House was once much higher and has been excavated to provide a level car parking facility. This should be reviewed by a suitably qualified and experienced conservation accredited Structural Engineer in tandem with an experienced arboriculturalist.
