Beverley Town Council New Town Hall Project Manager

TENDER PACK

Beverley Town Council New Town Hall

Condition Report

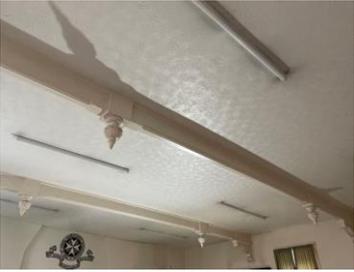
Inspection Date	Surveyor	Survey Type	Floor	Analysis	
	11/11/2022	Robin Walker	Refurbishment	Ground Floor	NAD	
	Building	Room	Description	Extent		
	St Johns Ambulance	Main hall 008	Ceiling	110 m ²		
	Sample No / Inspection Ref	Product Type	Surface Treatment	Damage Extent	Material Risk Score	Priority Total
	A-20386 / S001 203527	Textured Coating	N/A	N/A	0	N/A
	Normal Occupant Activity	Likelihood of Disturbance	Human Exposure Potential	Maintenance Activity	Risk Rating	Total Assessment Score
N/A	N/A	N/A	N/A	N/A	N/A	
Recommendations / Actions	No action required					
Surveyor Comments	Textured coating to ceiling of main hall				Review Date	N/A

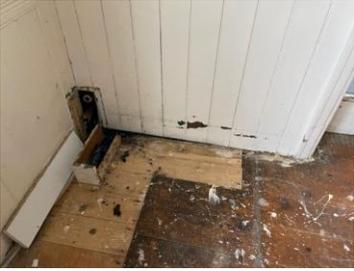
Inspection Date	Surveyor	Survey Type	Floor	Analysis	
	11/11/2022	Robin Walker	Refurbishment	Ground Floor	NAD	
	Building	Room	Description	Extent		
	St Johns Ambulance	Main hall 008	Pipework	Small amounts m ²		
	Sample No / Inspection Ref	Product Type	Surface Treatment	Damage Extent	Material Risk Score	Priority Total
	A-20386 / S002 203507	Pipe Lagging (Fibrous)	N/A	N/A	0	N/A
	Normal Occupant Activity	Likelihood of Disturbance	Human Exposure Potential	Maintenance Activity	Risk Rating	Total Assessment Score
N/A	N/A	N/A	N/A	N/A	N/A	
Recommendations / Actions	No action required					
Surveyor Comments	Thermal insulation to metal pipework within corner boxing				Review Date	N/A

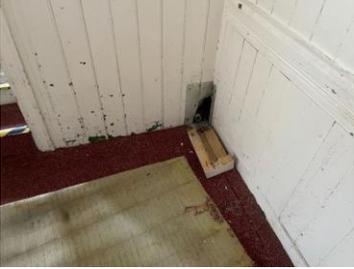
Inspection Date	Surveyor	Survey Type	Floor	Analysis	
	11/11/2022	Robin Walker	Refurbishment	Ground Floor	NAD	
	Building	Room	Description	Extent		
	St Johns Ambulance	Main hall 008	Pipework	Small amounts m ²		
	Sample No / Inspection Ref	Product Type	Surface Treatment	Damage Extent	Material Risk Score	Priority Total
	A-20386 / S003 203502	Pipe Lagging (Fibrous)	N/A	N/A	0	N/A
	Normal Occupant Activity	Likelihood of Disturbance	Human Exposure Potential	Maintenance Activity	Risk Rating	Total Assessment Score
N/A	N/A	N/A	N/A	N/A	N/A	
Recommendations / Actions	No action required					
Surveyor Comments	Thermal insulation to metal pipework within corner boxing				Review Date	N/A

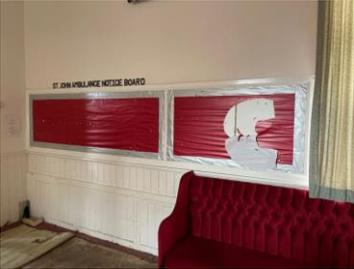
Inspection Date	Surveyor	Survey Type	Floor	Analysis	
	11/11/2022	Robin Walker	Refurbishment	Ground Floor	NAD	
	Building	Room	Description	Extent		
	St Johns Ambulance	Main hall 008	Wall	4 m ²		
	Sample No / Inspection Ref	Product Type	Surface Treatment	Damage Extent	Material Risk Score	Priority Total
	A-20386 / S004 203504	Insulating Board	N/A	N/A	0	N/A
	Normal Occupant Activity	Likelihood of Disturbance	Human Exposure Potential	Maintenance Activity	Risk Rating	Total Assessment Score
N/A	N/A	N/A	N/A	N/A	N/A	
Recommendations / Actions	No action required					
Surveyor Comments	Insulation board notice board				Review Date	N/A

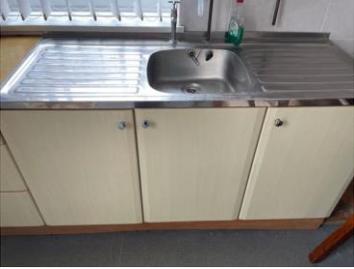
Inspection Date	Surveyor	Survey Type	Floor	Analysis	
	11/11/2022	Robin Walker	Refurbishment	Ground Floor	NAD	
	Building	Room	Description	Extent		
	St Johns Ambulance	Kitchen 009	Sink unit	3 no		
	Sample No / Inspection Ref	Product Type	Surface Treatment	Damage Extent	Material Risk Score	Priority Total
	A-20386 / S005 203510	Bituminous pad to underside of sink	N/A	N/A	0	N/A
	Normal Occupant Activity	Likelihood of Disturbance	Human Exposure Potential	Maintenance Activity	Risk Rating	Total Assessment Score
	N/A	N/A	N/A	N/A	N/A	N/A
Recommendations / Actions	No action required					
Surveyor Comments	Bitumen acoustic sink pads beneath metal sink unit			Review Date	N/A

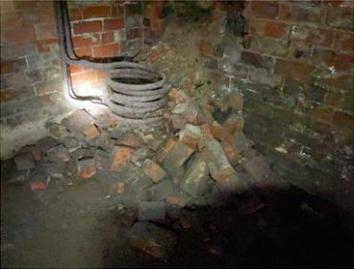
Inspection Date	Surveyor	Survey Type	Floor	Analysis	
	11/11/2022	Robin Walker	Refurbishment	Basement	NAD	
	Building	Room	Description	Extent		
	St Johns Ambulance	Store 016	Pipework	3 lin m		
	Sample No / Inspection Ref	Product Type	Surface Treatment	Damage Extent	Material Risk Score	Priority Total
	A-20386 / S008 203518	Pipe Lagging (Fibrous)	N/A	N/A	0	N/A
	Normal Occupant Activity	Likelihood of Disturbance	Human Exposure Potential	Maintenance Activity	Risk Rating	Total Assessment Score
	N/A	N/A	N/A	N/A	N/A	N/A
Recommendations / Actions	No action required					
Surveyor Comments	Thermal insulation residue to coil of metal pipework			Review Date	N/A

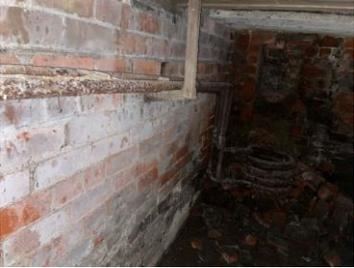
Inspection Date	Surveyor	Survey Type	Floor	Analysis	
	11/11/2022	Robin Walker	Refurbishment	Basement	NAD	
	Building	Room	Description	Extent		
	St Johns Ambulance	Store 016	Pipework	3 lin m		
	Sample No / Inspection Ref	Product Type	Surface Treatment	Damage Extent	Material Risk Score	Priority Total
	A-20386 / S009 203525	Pipe Lagging (Fibrous)	N/A	N/A	0	N/A
	Normal Occupant Activity	Likelihood of Disturbance	Human Exposure Potential	Maintenance Activity	Risk Rating	Total Assessment Score
N/A	N/A	N/A	N/A	N/A	N/A	
Recommendations / Actions	No action required					
Surveyor Comments	Thermal insulation residue to metal pipework				Review Date	N/A

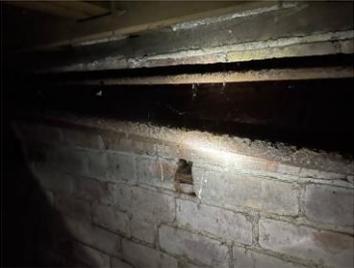
Inspection Date	Surveyor	Survey Type	Floor	Analysis	
	11/11/2022	Robin Walker	Refurbishment	Basement	NAD	
	Building	Room	Description	Extent		
	St Johns Ambulance	Store 016	Pipework	3 lin m		
	Sample No / Inspection Ref	Product Type	Surface Treatment	Damage Extent	Material Risk Score	Priority Total
	A-20386 / S010 203503	Pipe Lagging (Fibrous)	N/A	N/A	0	N/A
	Normal Occupant Activity	Likelihood of Disturbance	Human Exposure Potential	Maintenance Activity	Risk Rating	Total Assessment Score
N/A	N/A	N/A	N/A	N/A	N/A	
Recommendations / Actions	No action required					
Surveyor Comments	Thermal insulation residue to metal pipework				Review Date	N/A

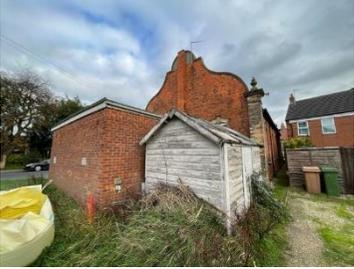
Inspection Date	Surveyor	Survey Type	Floor	Analysis	
	11/11/2022	Robin Walker	Refurbishment	Basement	NAD	
	Building	Room	Description	Extent		
	St Johns Ambulance	Externals 017	Roofs	30 m ²		
	Sample No / Inspection Ref	Product Type	Surface Treatment	Damage Extent	Material Risk Score	Priority Total
	A-20386 / S011 203490	Bituminous Product	N/A	N/A	0	N/A
	Normal Occupant Activity	Likelihood of Disturbance	Human Exposure Potential	Maintenance Activity	Risk Rating	Total Assessment Score
	N/A	N/A	N/A	N/A	N/A	N/A
Recommendations / Actions	No action required					
Surveyor Comments	Bitumen felt coverings to external shed and garage roofs			Review Date	N/A

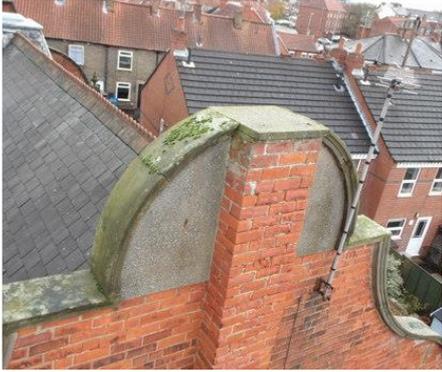
Chimney has been capped.

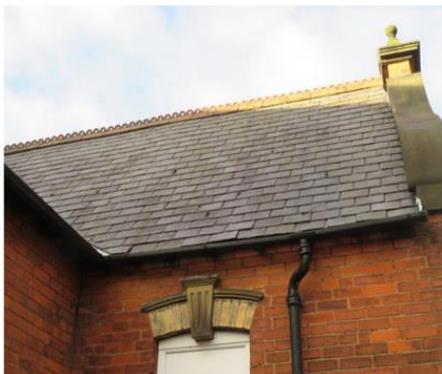
Open joints to ridges to entrance roof.

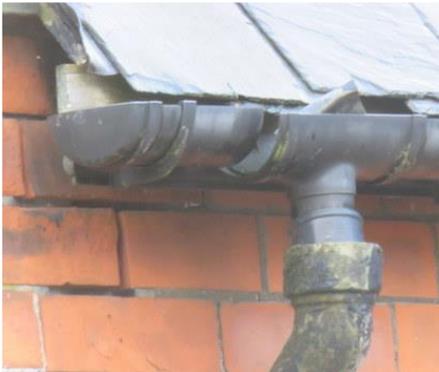
Gutters generally poor.

The gutters are a combination of metal and PVC as are the rainwater pipes. No significant defects was observed to the gutters or rainwater pipes. Although there will probably be some corrosion to the metal gutters and rainwater pipes and we recommend that you budget to overhaul the rainwater goods.

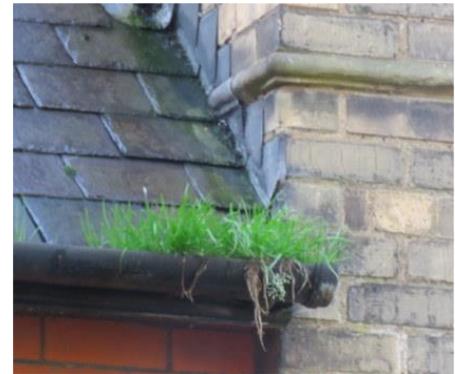
Gutter generally poor.

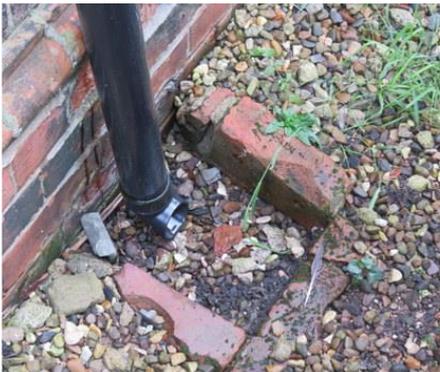
Soak aways to some rainwater
outlets.

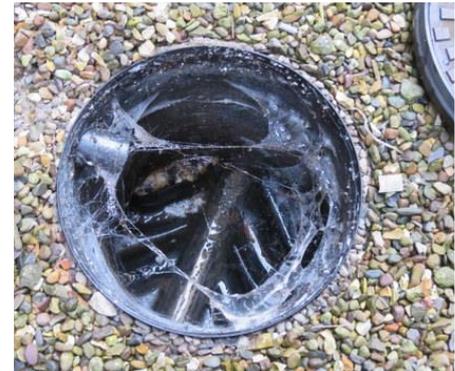
Rainwater outlet into new
development manhole to real.

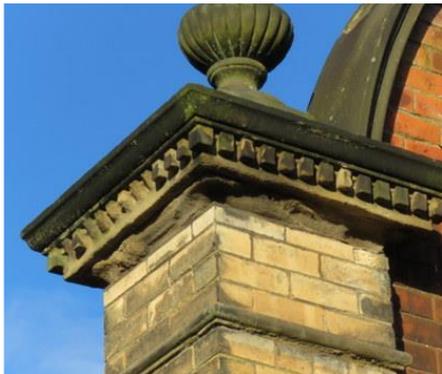
Eroding stone to most stone details.

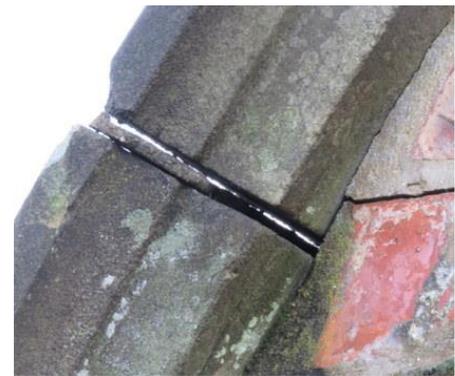
Open joints to gable parapet capping stones.

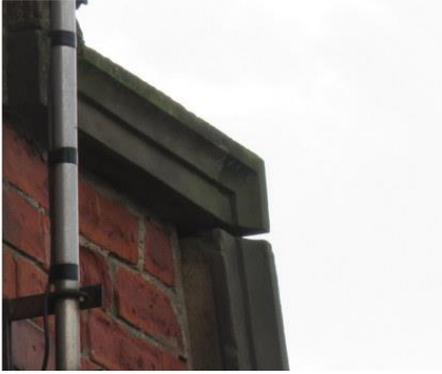
Open joints to gable parapet capping stones.

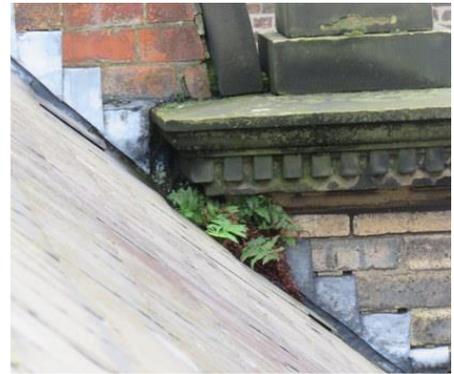
Plant growth in flashings behind gables.

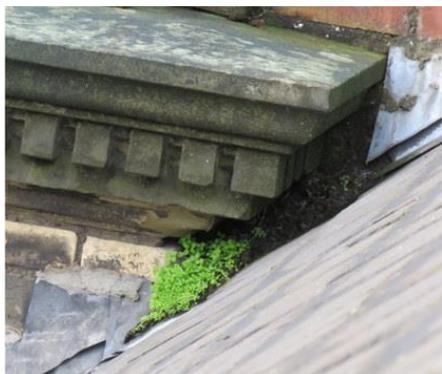
Plant growth in flashings behind gables.

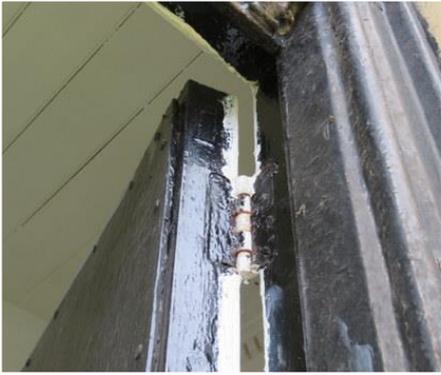
Panels fixed to original entrance doors.

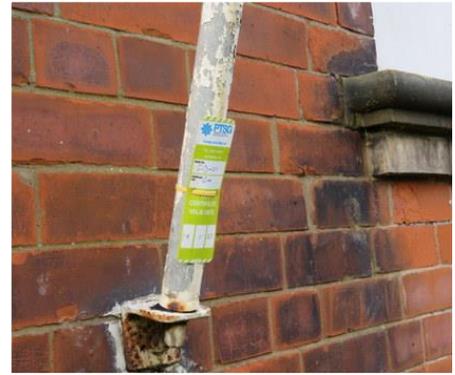
Steel flag pole, inspections carried out by 3rd party.

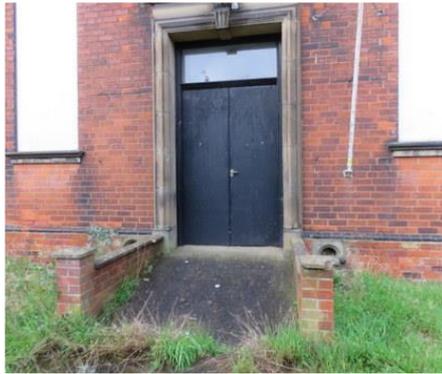
Steep ramp to Wilbert Lane entrance.

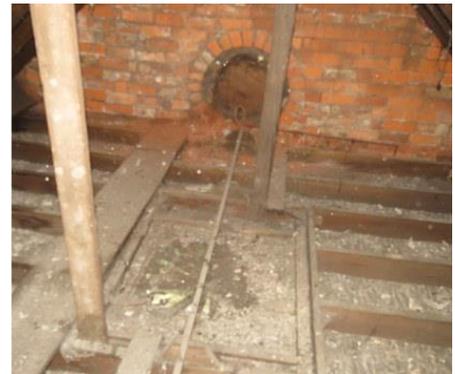
Plaster lath evident. Mech fitted behind ceiling vents.

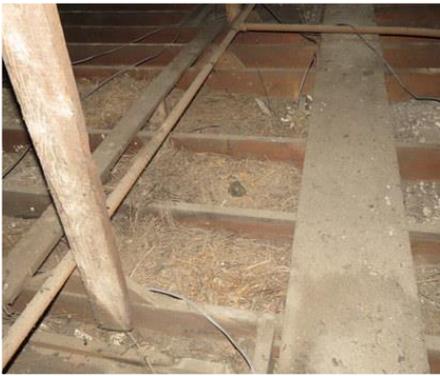
Nesting material evident to a number of areas.

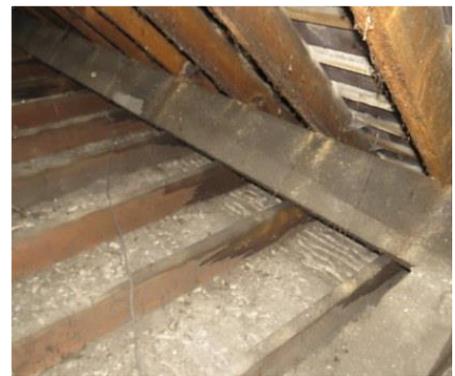
A number of rafters and joist were wet at the time of inspection.

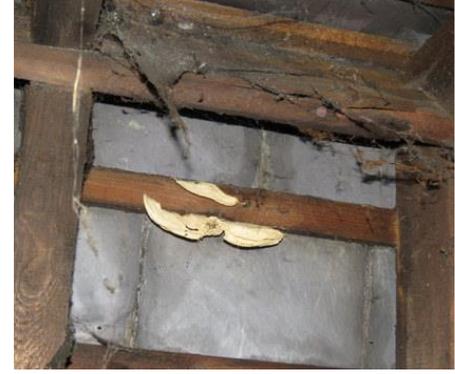
Fruiting body on timber lats beneath cupola.

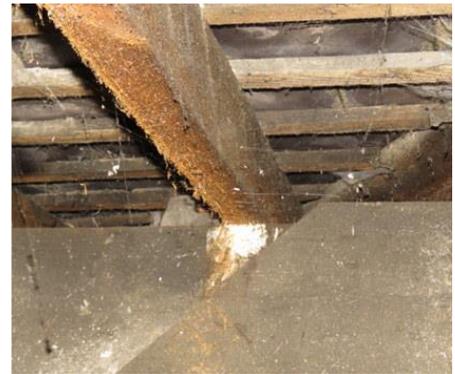
Wet purlin and rafter adjacent to Morton Lane entrance roof.

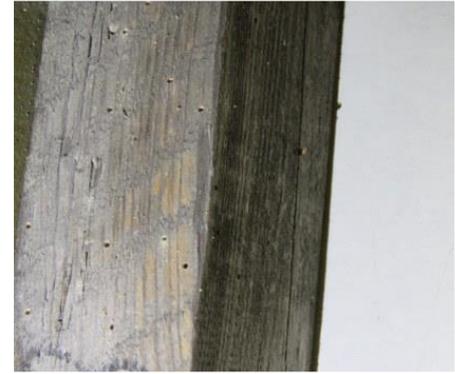
Beetle flight holes in timbers to rear roof slope eaves.

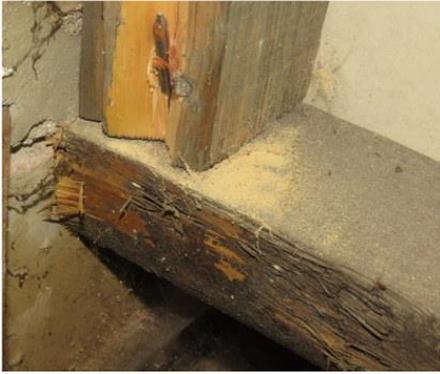
Frass evident to the rear slope eaves construction.

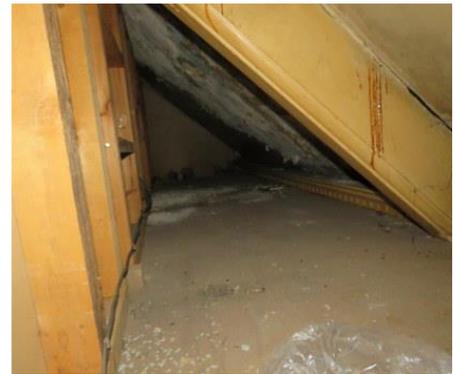
Condensation mold growth to plaster lath in eaves voids.

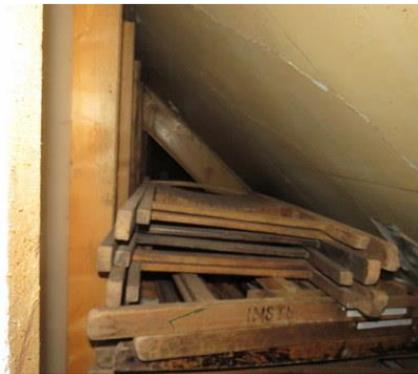
Rubbish stored in the eaves.

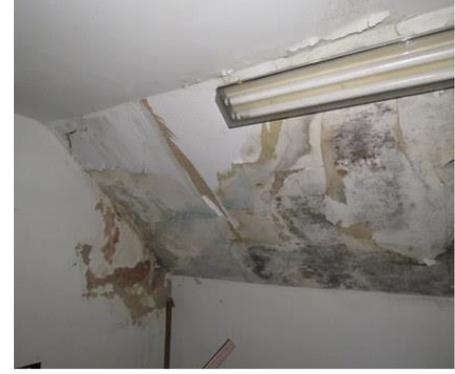
Plaster lath ceilings in top floor blown/effected by condensation.

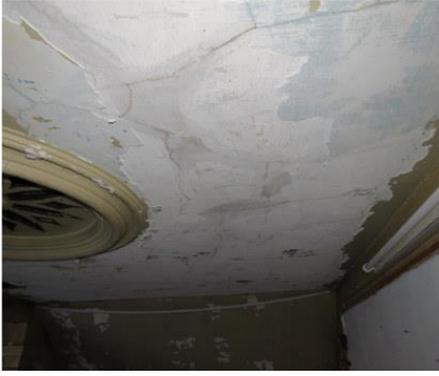
Plaster lath ceilings in top floor blown/effected by condensations.

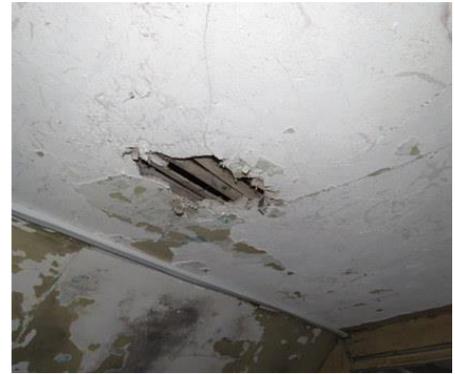
Delaminated sections of plaster lath throughout first floor areas.

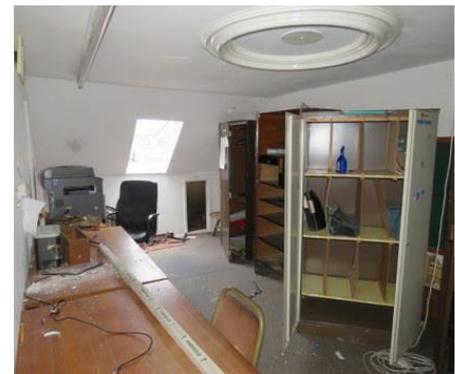
Excessive of large items left in property by previous owners.

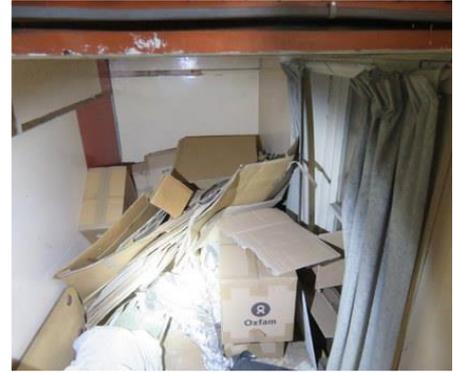
Rubbish and debris stored in room between floors.

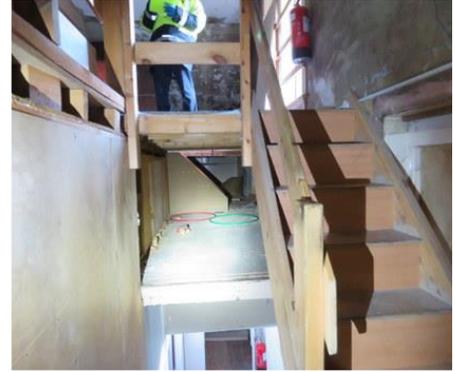
Balustrade not compliant with current regulations.

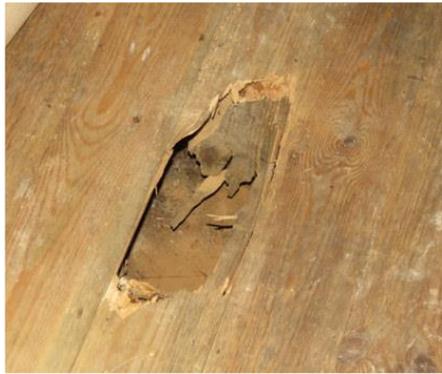
Beetle activity to floor void at corner of Wilbert and Morton lane.

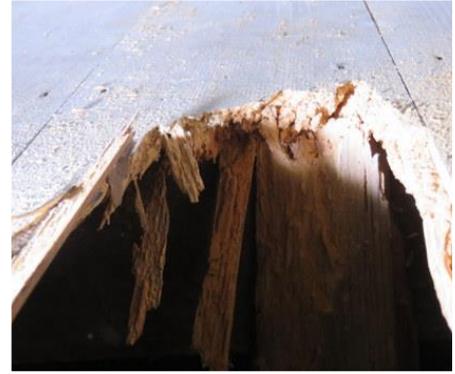
Beetle activity to floor void at corner of Wilbert and Morton lane.

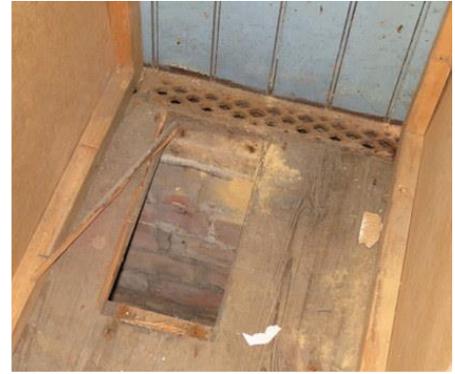
Frass evident to floor beneath cupboard in kitchen.

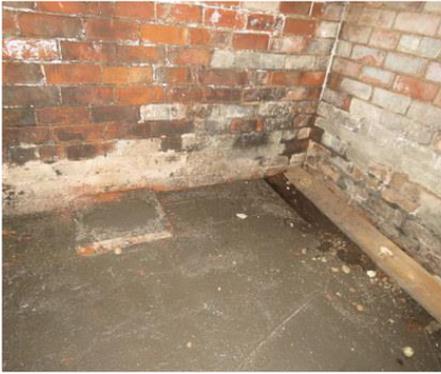
Potential floor detritus in reception room void.

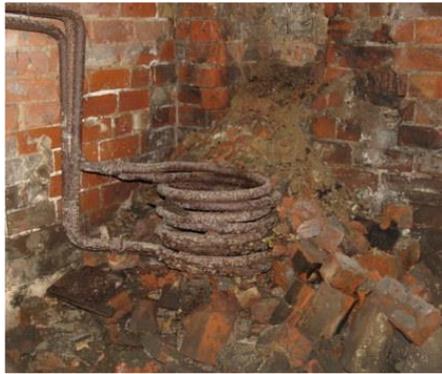
Redundant heating coil to perimeter underfloor heating.

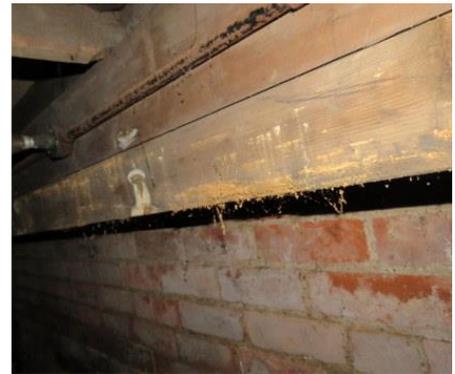
Beetle activity to floor joists beneath main reception room.

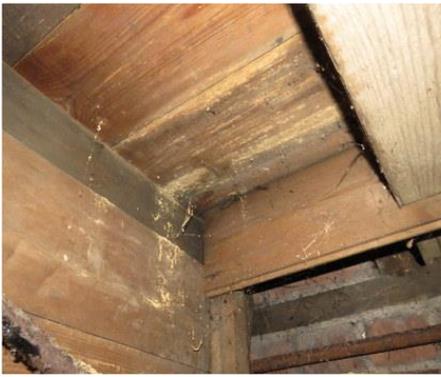
Beetle activity to underside of floor boards.

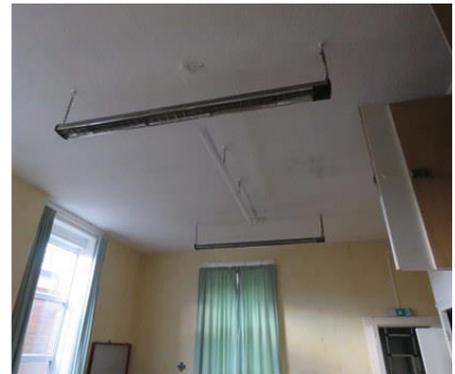
Heating via wall and ceiling mounted electric radiant heaters.

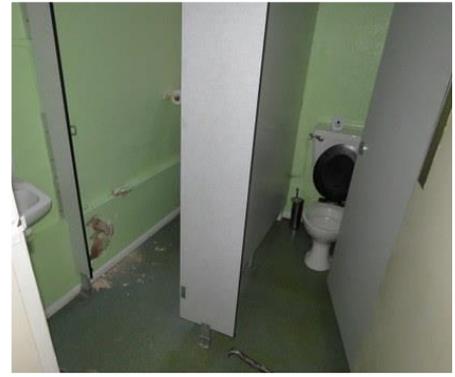
Toilet provision poor.

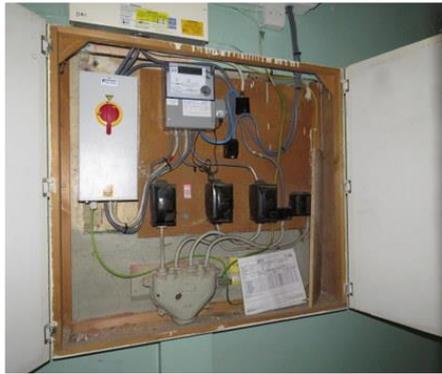
Electrical services.

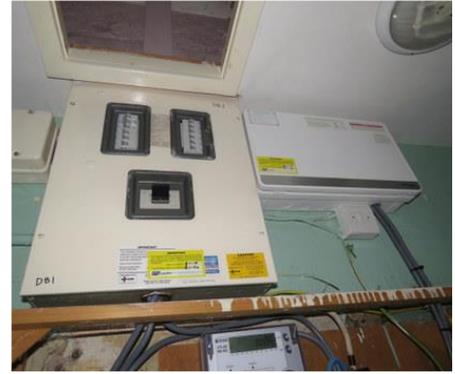
Electrical services.

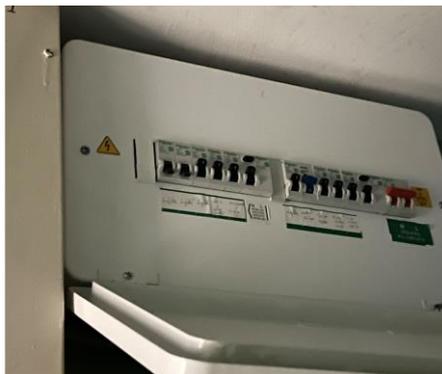
Main electrical board tripped during survey.
